## Summary: Factors Affecting Bond and Friction Losses in Multi-Strand Post-Tensioning Tendons Including the Effect of Emulsifiable Oils

The main objectives of the first phase (2005-2006) of Project O-4562 were to assess the corrosion-inhibiting performance of emulsifiable oils, to investigate how the oils affect friction losses during post-tensioning, and to determine the impact of the oils on bond strength in multi-strand tendons. The second, ongoing phase is evaluating a variety of new materials that could improve durability in post-tensioned concrete systems. This document summarizes the first phase only.

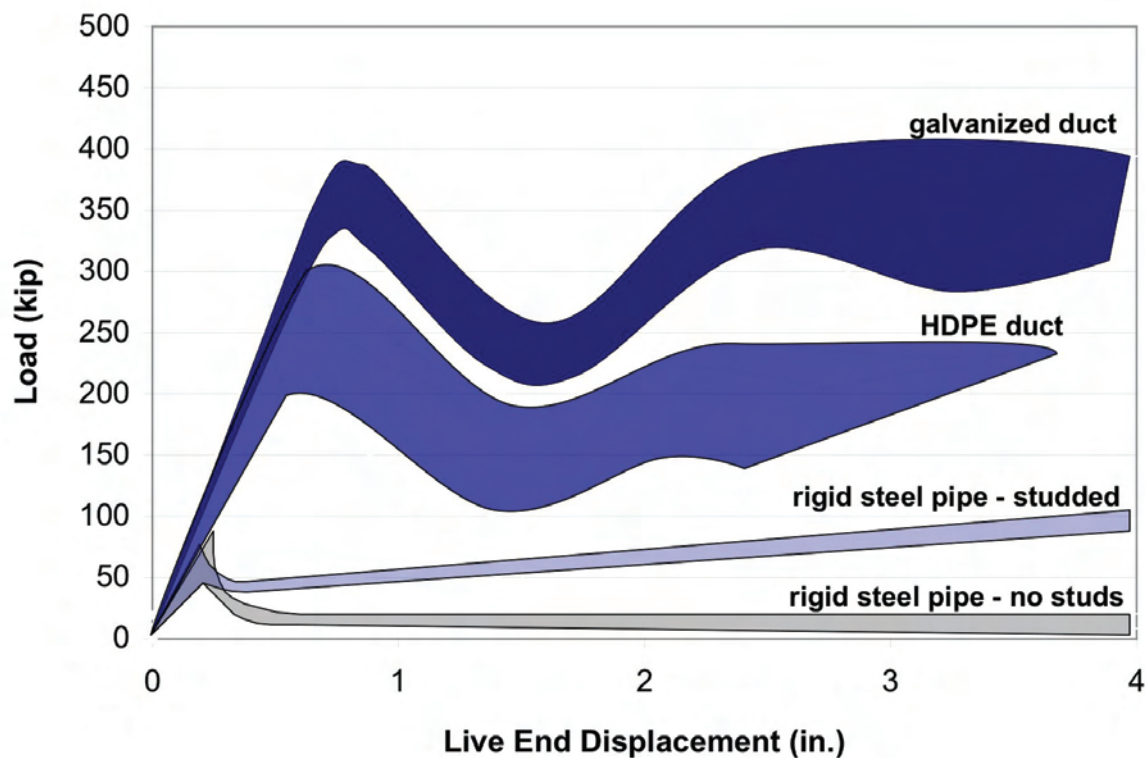
Figure 1 – Live End Load-Displacement Behavior, Unooled Tendons

Peak loads for specimens with galvanized ducts were 20% to 40% higher than peak loads for specimens with HDPE ducts, as shown in Figure 1. Galvanized ducts therefore allow bonded tendons to be developed in shorter lengths than HDPE ducts.

Peak loads for specimens with rigid steel pipes were 70% to 90% lower than peak loads for specimens with galvanized or HDPE ducts, as shown in Figure 1. This poor behavior was due to failure at the interface of the concrete and the smooth steel pipe. Shear

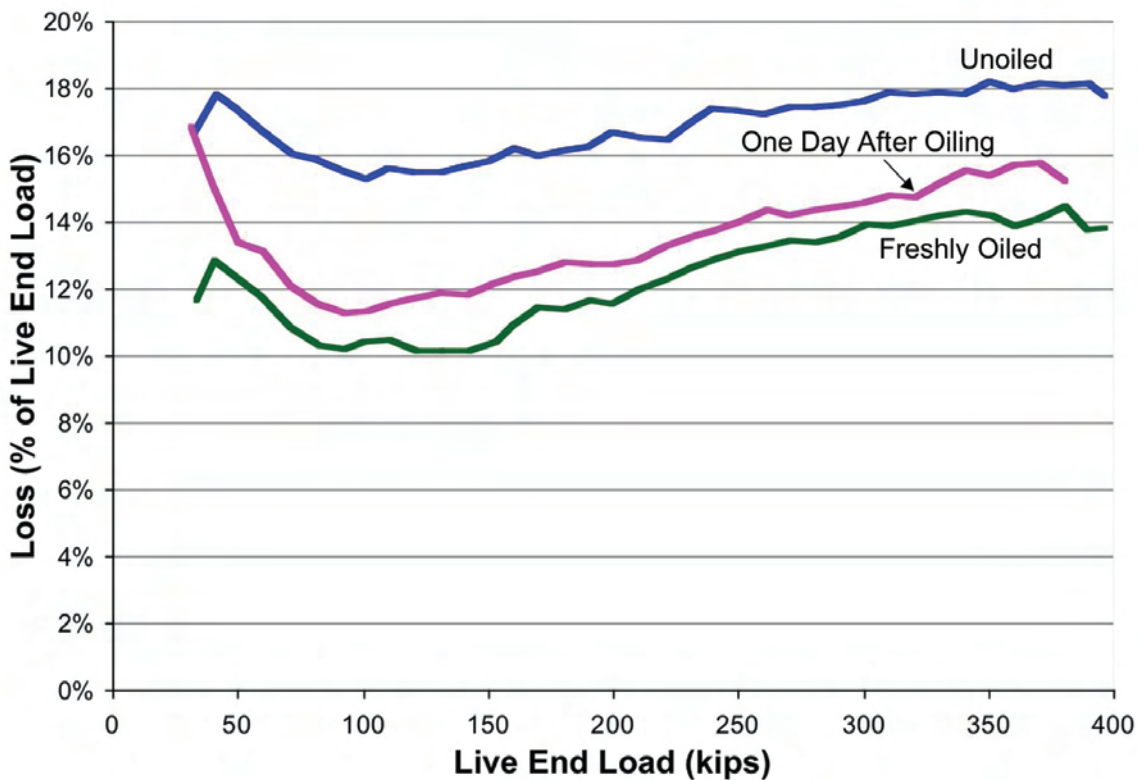
Figure 2 – Average Friction Losses, HDPE Duct, 10 ft Radius, Oil NC205

Tendons which were lubricated with oil and stressed immediately after oiling experienced lower friction losses than unooled tendons, as shown in Figure 2. Oiling caused the greatest reductions in the friction coefficient for steel pipe specimens, on the order of 20% to 30%. Reductions for HDPE duct specimens were smaller but still significant, on the order of 20%. Reductions for galvanized ducts specimens were the least significant, on the order of 10%.

For tendons stressed one day after oiling, the data was highly scattered. The results indicate that dried oil is less effective in reducing friction losses than fresh oil, as shown in Figure 2, but
