1. Report No. FHWA/TX-11/0-4889-1	2. Government Accession No.	3. Recipient's Catalog No.	
4. Title and Subtitle Laboratory and Field Evaluations of External Sulfate Attack in Concrete		5. Report Date February 2010, Rev. January 2011

Laboratory and Field Evaluations of External Sulfate Attack in Concrete

Chapter 7 summarizes the findings of various field investigations of transportation structures in the state of Texas exposed to sulfate-rich conditions.

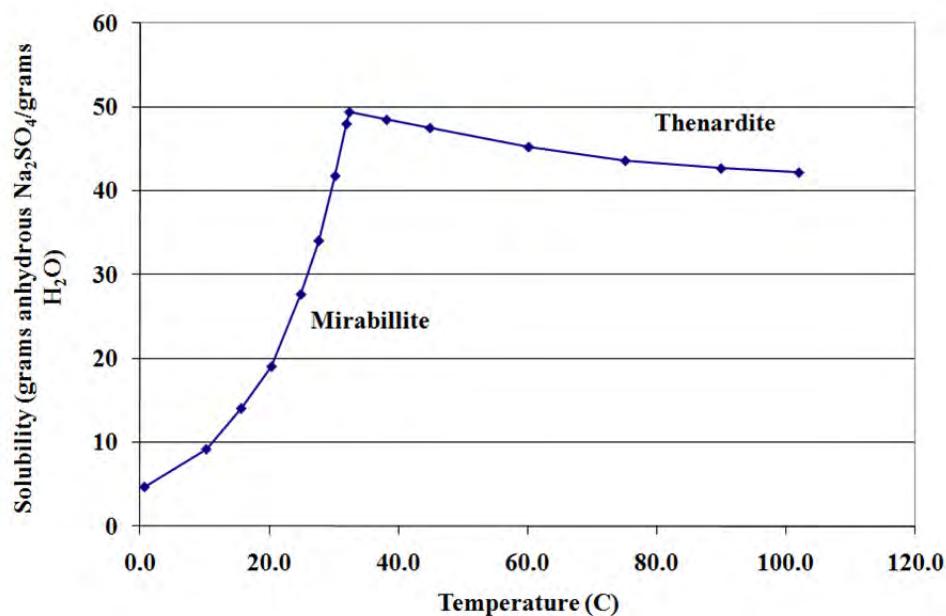
Figure 2.1: Solubility Curve for Sodium Sulfate /Water System (Berkeley 1904)

In the early 1990's, Folliard and Sandberg (1994) proposed that crystallization of sodium sulfate within concrete, triggered by temperature changes, was the predominant cause of distress due to physical salt or sulfate attack. Figure 2.4 shows the solubility curve for sodium sulfate, which shows the change between thenardite and mirabilite at approximately 91 °F (33 °C). After cycling concrete specimens in 30% sodium sulfate solution from 41° to 86 °F (5° to 30 °C), substantial mass loss occurred in the samples. X-ray diffraction on these samples did not show any sign of ettringite formation or any other deleterious product from chemical attack. In parallel tests, it was shown that the total volume of the sodium sulfate/water solution increased by approximately 3 % as crystallization was triggered upon a temperature drop. In essence, this type of distress is similar to freeze-thaw distress in that physical distress is triggered by a volume change of the water or solution inside concrete. Samples cycled from 95° to 230 °F (35° to 110 °C) did not show any weight loss and the majority of these samples gained weight (Sandberg and Folliard 2004), confirming that the distress only occurs when temperatures drop below about 91 °F (33 °C) and when a high concentration of sodium sulfate is present in the pores of concrete.

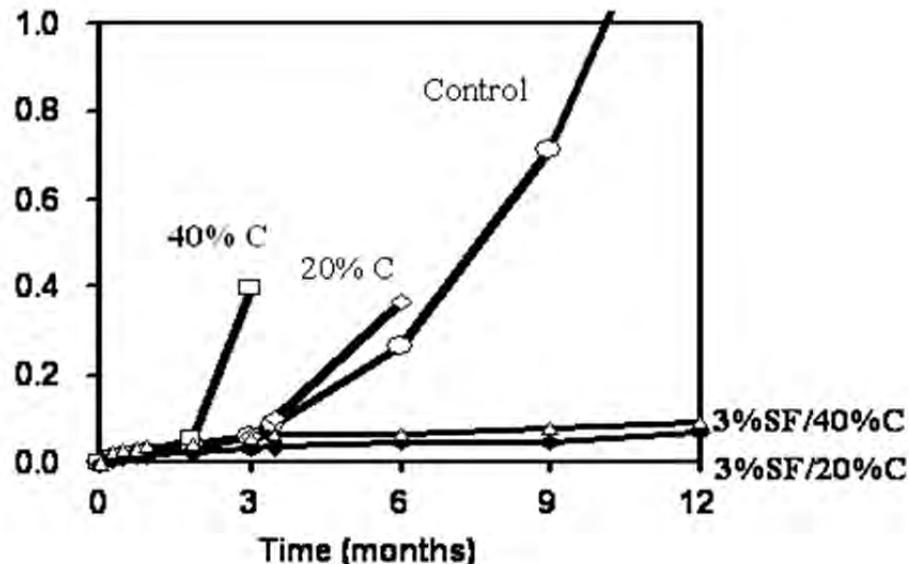
Figure 2.3: The use ternary blends with silica fume and Class C fly ash reduces the expansion of mortars compared to only using Class C fly ash as a pozzolan. (Shashiprakash and Thomas 2001)

In addition to linking the mineralogy and chemistry of fly ashes to sulfate resistance, Shashiprakash and Thomas (2001) also performed significant research on combining high-CaO ashes with silica fume, with emphasis on mixtures between 3% and 6% percent silica fume (by mass of total cementitious materials). Figure 2.3 shows the effects of just a small dosage of silica fume (3%) on the sulfate resistance of concrete with a high-calcium fly ash.

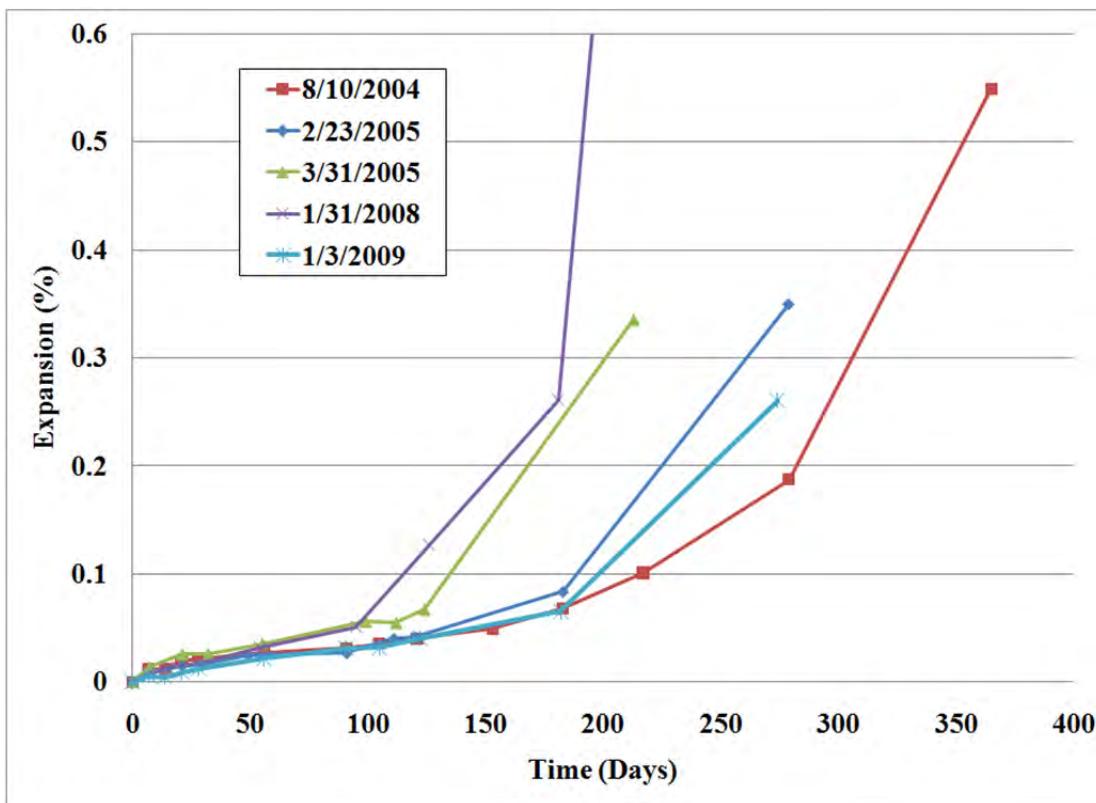
Figure 4.1: Variability in Cement Performance from a Producer with Time

Cements designated C1 and C4 are from the same source, but were acquired one year apart. Cement from this producer is commonly used at the Concrete Durability Center (CDC) in Austin, Texas and has been evaluated five times since this project began. Figure 4.1 shows the expansion of mortar bars tested in accordance with ASTM C 1012. The expansion results varied considerably between cements, with three samples passing the six-month, 0.10 percent expansion limit and two failing this limit. This variability in performance from one cement sources, as a function of production date, raises some concern about using “standard” cements for ASTM C 1012. Certainly, this validates the need to always test a control sample, along with SCM mixtures, so that proper comparisons can be made. Six-month expansion criteria should only be used for ranking SCM mixtures when the parallel control mixture exceeds the designated expansion limit.

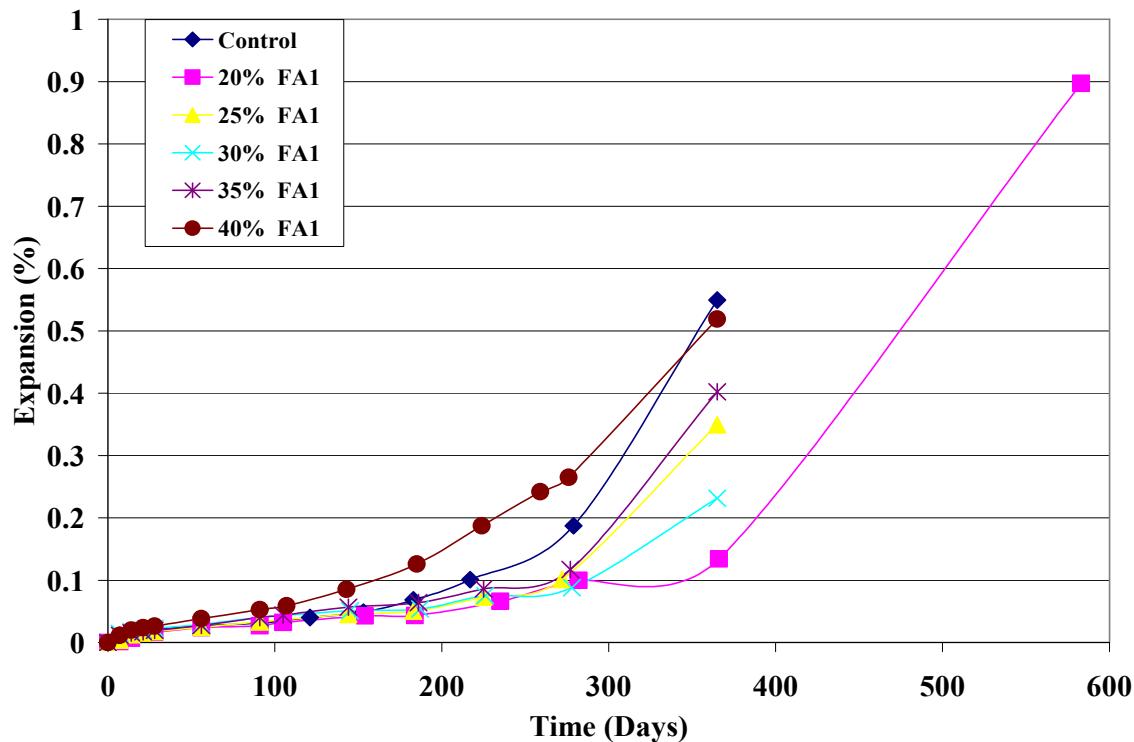
Figure 4.3: Expansions of FA1 at Different Replacement Dosages

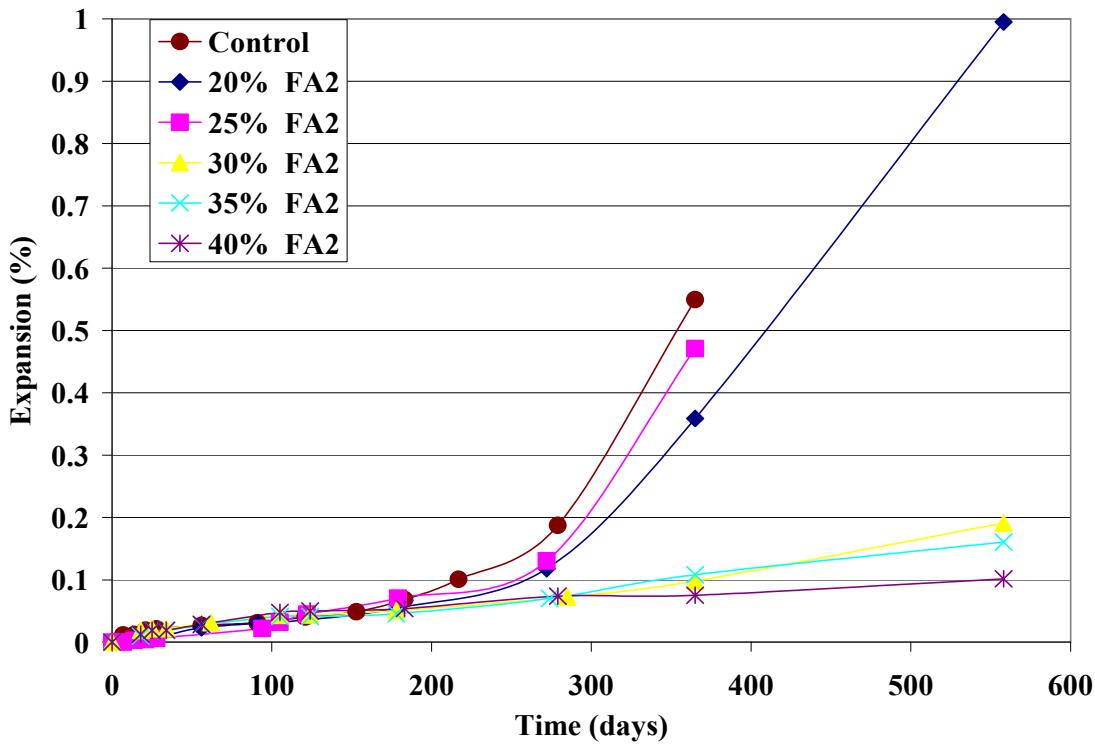
Figure 4.4: Expansions of FA2 at different replacement dosages

All but one of the other Class C fly ashes tested in this program performed similarly to FA1, with increasing fly ash dosages leading to increasing deterioration. The only exception was FA2, which had similar bulk chemistry to FA1, but performed quite differently in ASTM C 1012 testing, as shown in Figure 4.4. Increasing the dosage of FA2 did not result in an increase in expansion, and in fact, after six months, all of the mixtures containing FA2 showed exhibited expansions less than 0.1%. After one year, mixtures containing 20 and 25% FA2 expanded more than the nominal 0.1% expansion limit, mixtures containing 30 and 35% FA2 were approximately at this expansion limit, and the mixture containing 40% FA2 was below this expansion limit. After 18 months, all the mixtures containing FA2 expanded greater than 0.1%.

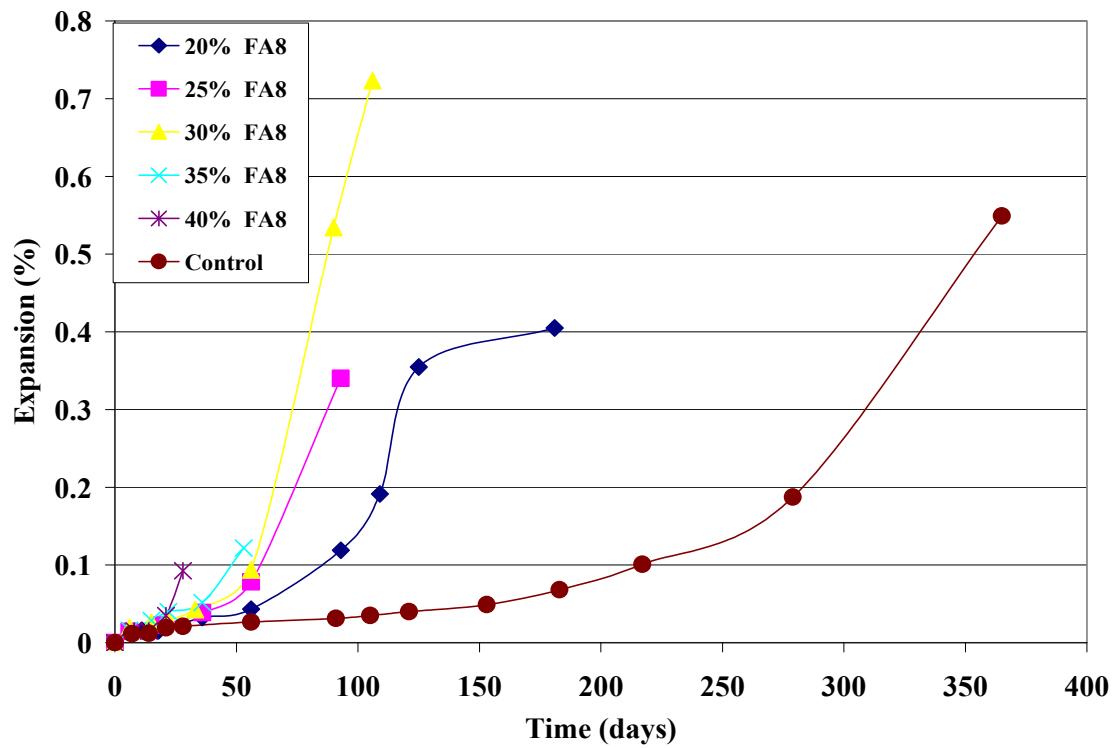
Figure 4.5: Expansion of FA8 fly ash at different replacements

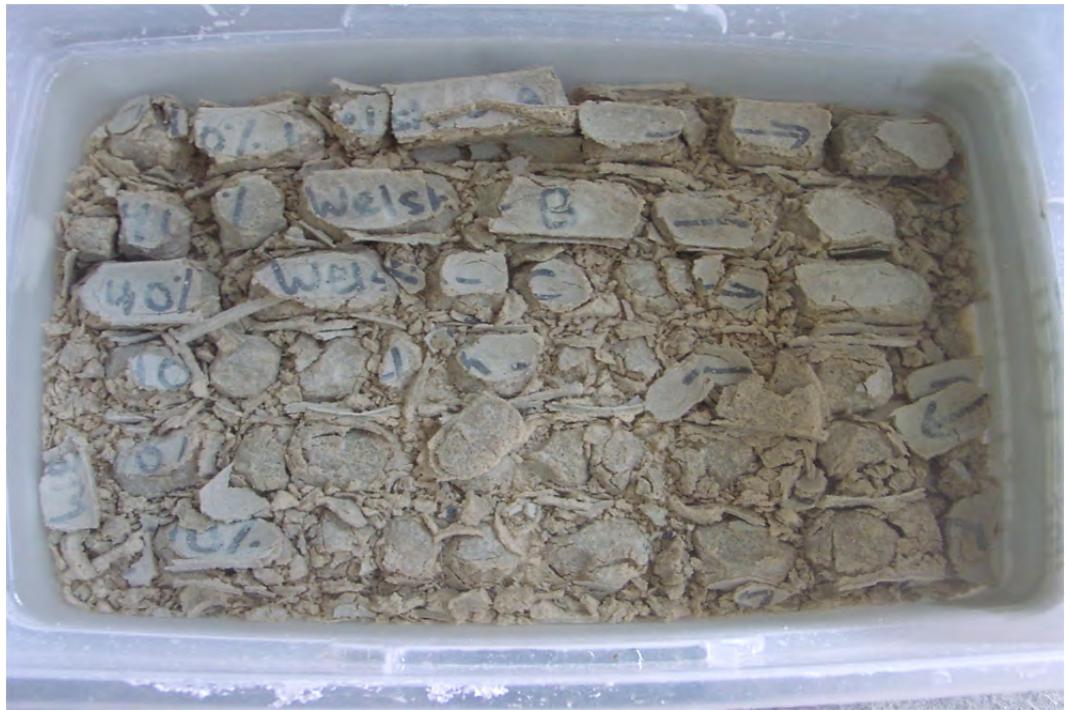
Figure 4.6: FA8 after 56 days in ASTM C 1012 testing

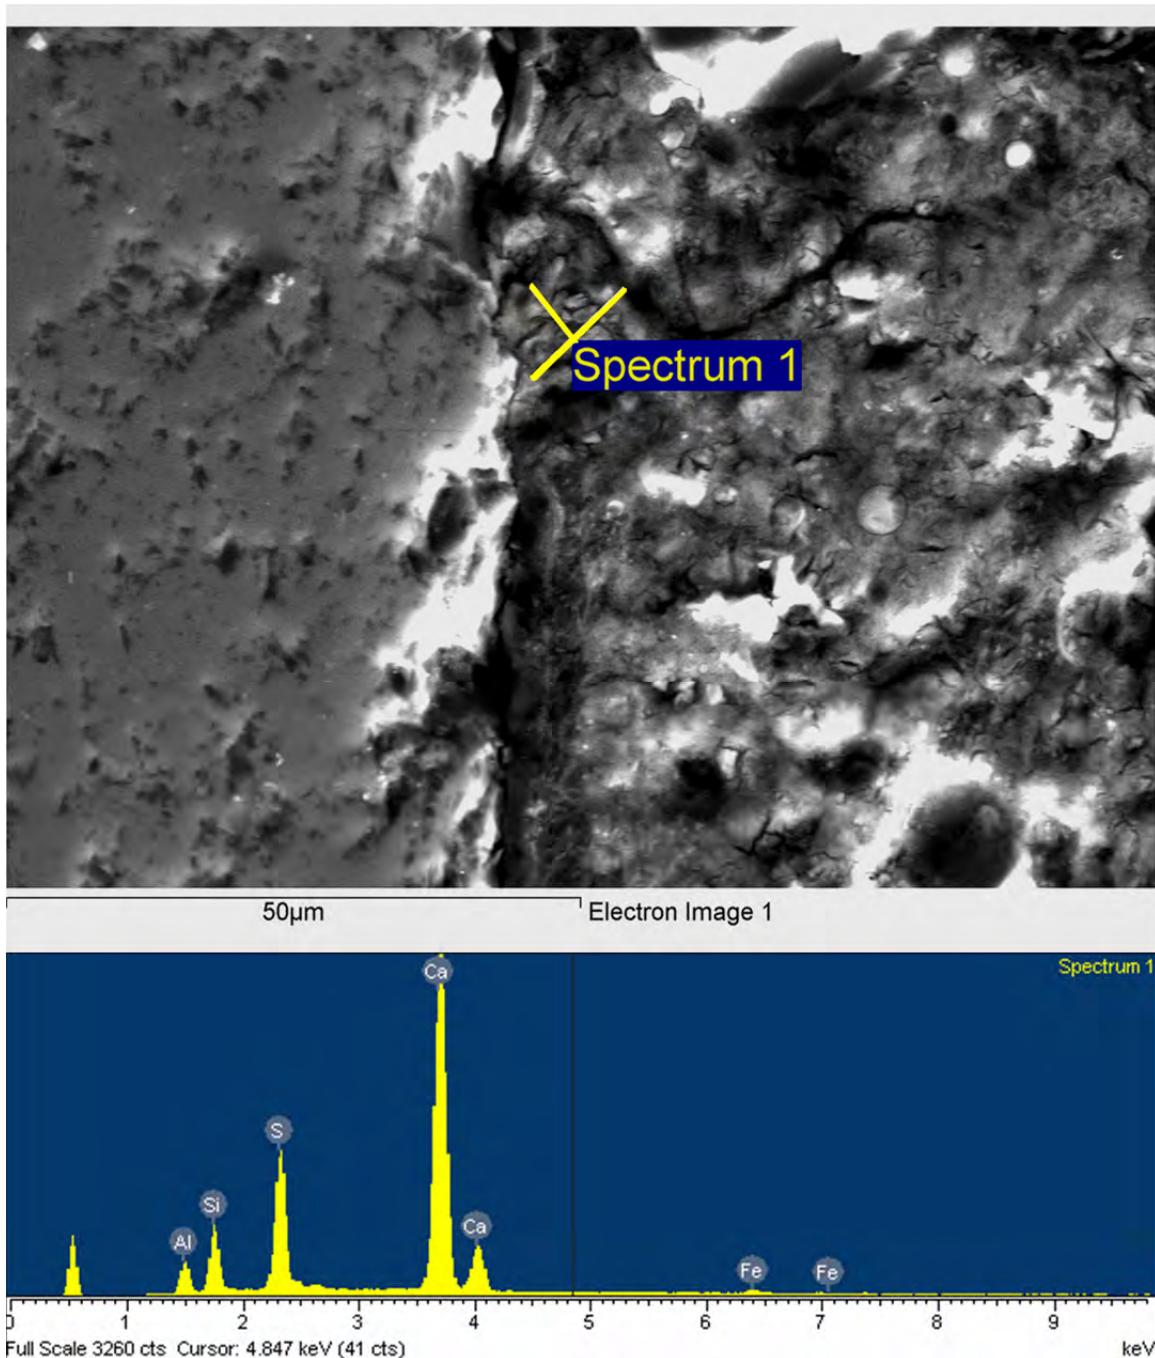
Figure 4.7: SEM and EDS Spectrum of 25% FA2 after 18 months storage in sodium sulfate solution.
Ettringite formation has occurred in pockets in the sample

of the aggregates in the system. There was more gypsum observed around aggregates and very little ettringite was detected within the paste. The EDS spectrum shows large amounts of Ca and S, reflecting gypsum in the system. In parts of the mortar bars, it is evident that gypsum could be converting to ettringite. The late expansion of 20% FA1 is noticed from the conversion of gypsum to ettringite in the sample. At 20% FA1 replacement there is less reactive calcium aluminates than compared to 40% which may suggest attack is occurring more on the calcium hydroxide in the 20% FA1 mortar bars and could contribute to the later formation of ettringite from its conversion from gypsum. Figure 4.9 shows this possible conversion in an area of ettringite and gypsum formed in the same area. Gypsum and ettringite are in this same area as seen in the EDS spectrum.

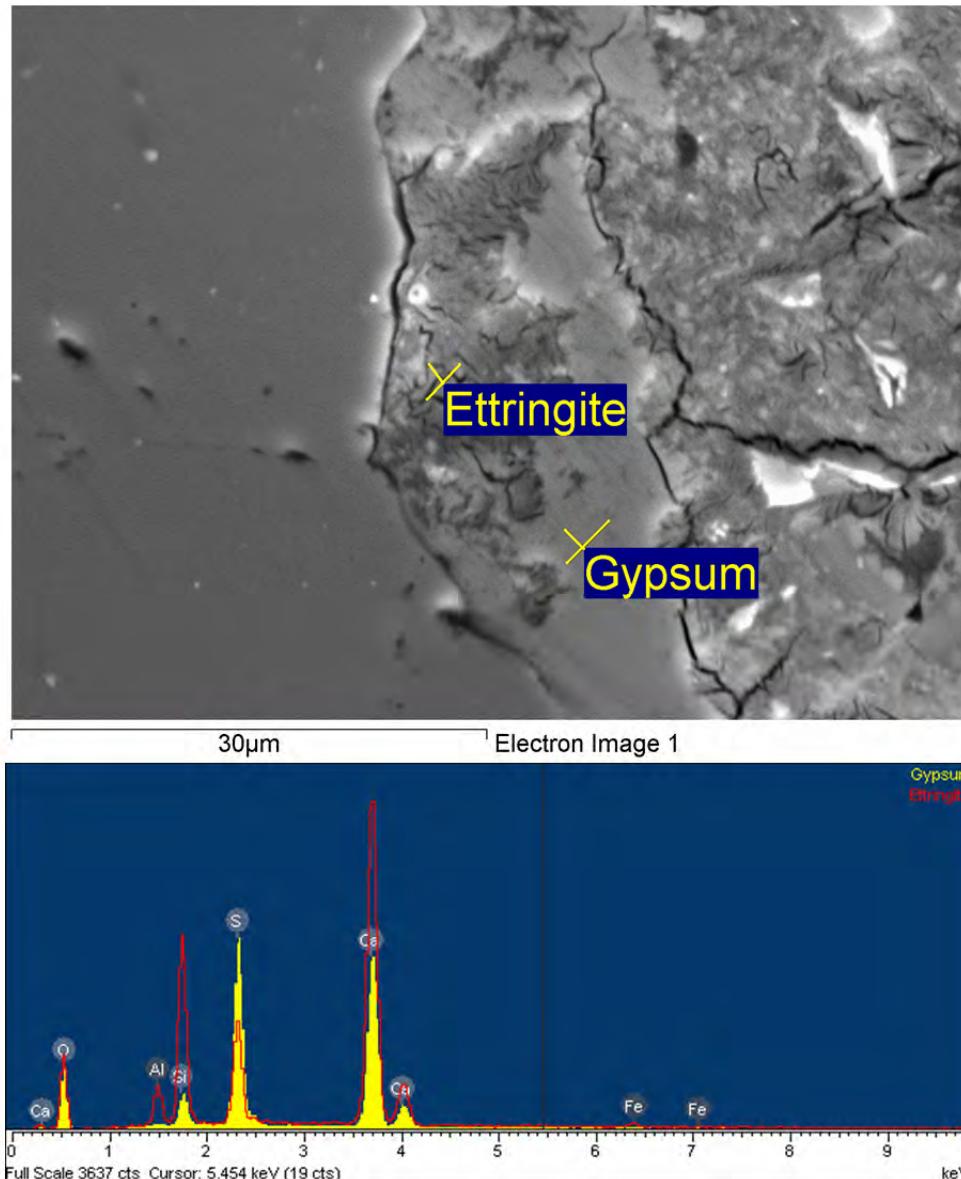
Figure 4.9: SEM Image and EDS spectrum of possible conversion of gypsum into ettringite in 20% FA1 mortar after 18 months storage in sodium sulfate

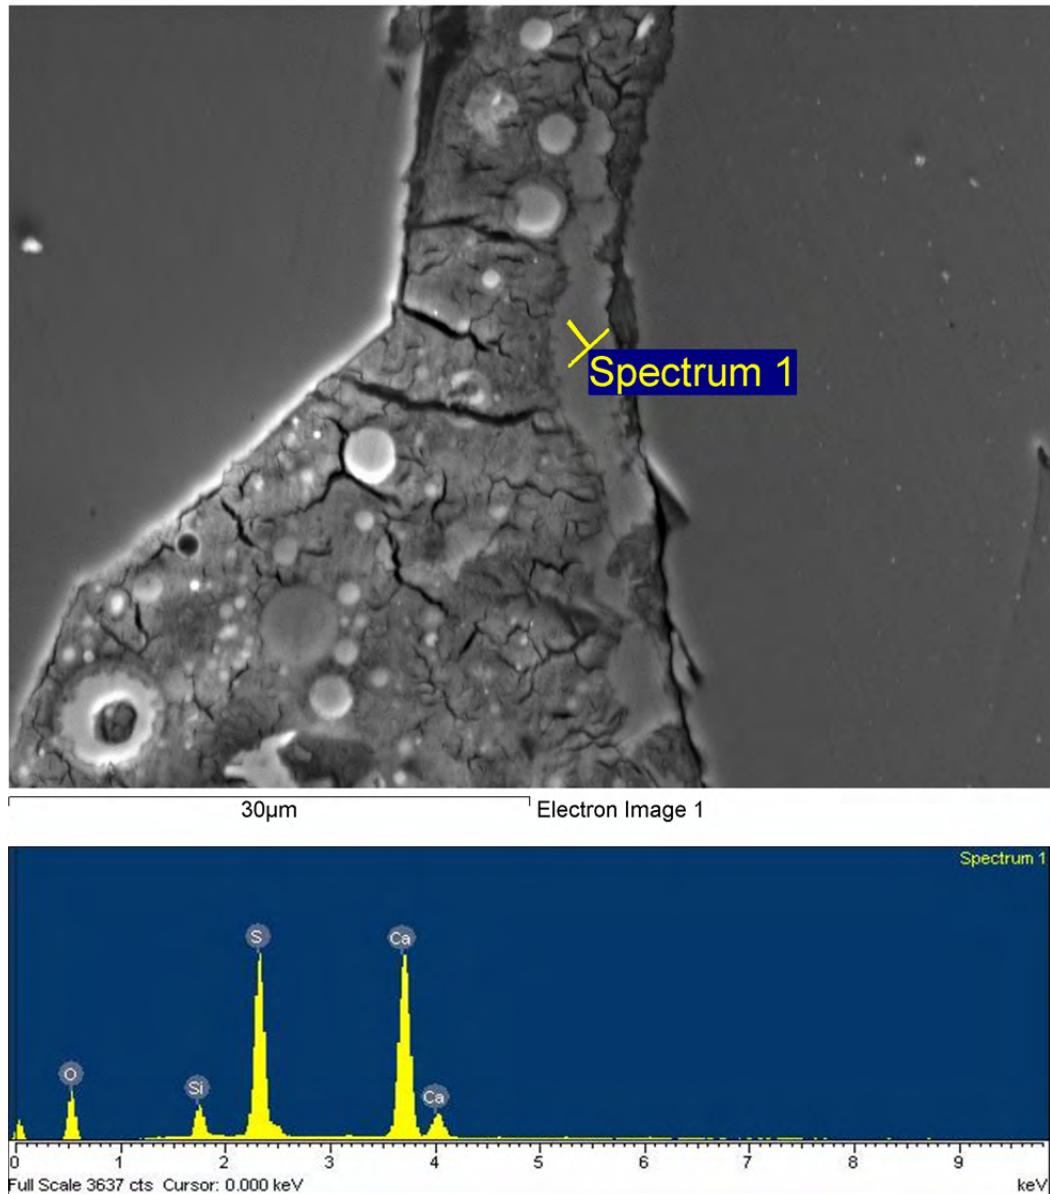
Figure 4.10: SEM and EDS analysis of 40% FA1 after 18 months in sodium sulfate solution

In addition, the FA2 may not present any reactive calcium aluminates that may react at later times to react with gypsum to form ettringite. There are a few small areas that have ettringite filled voids within the sample. The bulk chemistries of these two ashes were quite similar, but subsequent quantification of the glassy phases showed distinct differences in composition, as described later in this chapter.

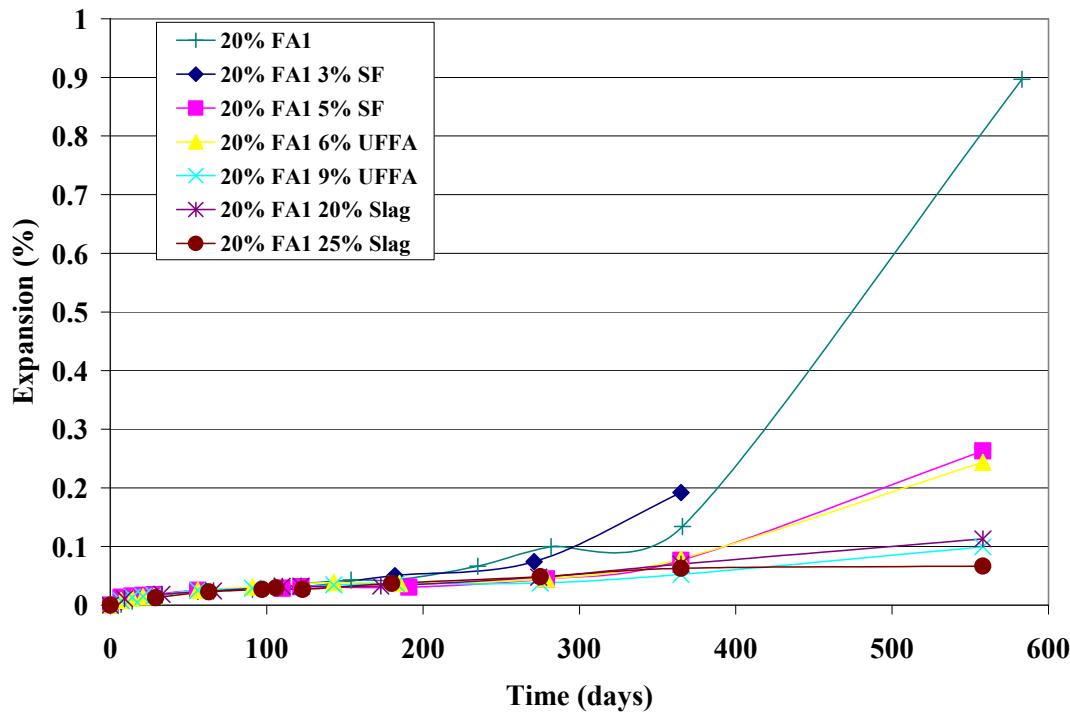
Figure 4.12: Mortar mixtures with 20% FA1 and ternary blends

When adding either silica fume or ultra-fine fly ash to mortar containing FA1, significant improvements in sulfate resistance were realized. All of these ternary blends reduced expansions at six months below 0.1% expansion criteria at 6 months, and the majority satisfied the aforementioned requirements for Class 2 equivalent sulfate resistance, as per ASTM C 1012. At 18 months, ternary blends at the lower replacement levels of Class C fly ash performed worse than those at higher replacement dosages. In almost all cases, ternary blends with 6 and 9% UFFA exhibited excellent sulfate resistance. A surprising trend noticed was an increase in protection of ternary blends as the replacement levels of FA1 increased, which was the opposite when FA1 was used separately (without silica fume or ultra-fine fly ash). Figure 4.12 and 4.13 provide the ternary blends for 20 and 40% FA1. The decrease in expansion with ternary blends at higher replacement dosages may be related to reductions in permeability, which slow down and reduce the ingress of sulfate solution into the bars. GGBFS performed well in a ternary blend with either 20 or 25% FA1 with 25% GGBFS. The performance of GGBFS is substantial as it usually takes at least a 50% replacement dosage to control sulfate attack. The addition of Class C fly ash and GGBFS may provide a combination that removes nearly 50% of the cement.

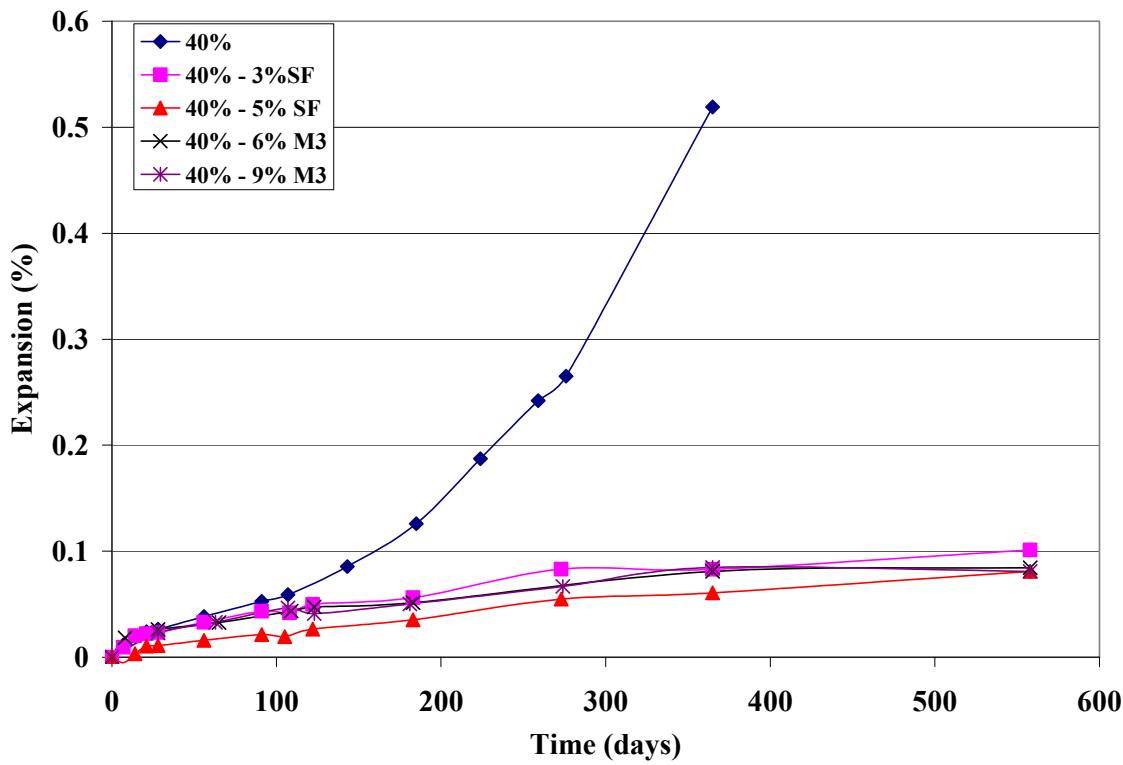
Figure 4.13: Mortar mixtures with 40% FA1 and ternary blends

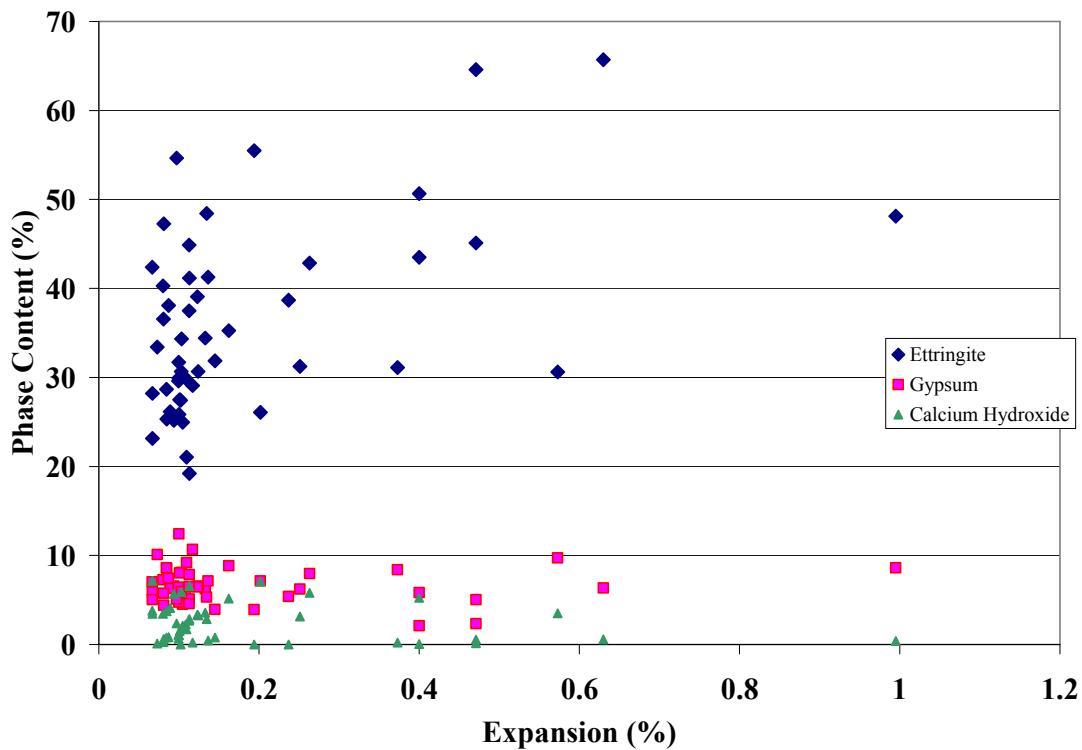
Figure 4.14: Relationship between ettringite, gypsum, and CH from mortars of ternary blends of FA1 and FA2

Figure 4.14 shows ettringite, gypsum, and CH contents from nearly 50 ternary blends with FA1 and FA2 related to expansion at 18 months. An increase of expansion relates primary to ettringite formation. There was little correlation between gypsum content and expansion. The concentration of CH did tend to decrease with increasing expansion. It should again be noted that the approach followed herein for quantifying the type and amount of hydration or reaction products was based on analyzing full cross sections of mortar bars, and as such, the results are averaged across a section that can be comprised of both damaged mortar (at surface exposed to sulfate solution) and undamaged mortar at the center of a given specimen. Nevertheless, this technique did allow for the identification of general trends in reaction products formed and their link to observed expansion and/or deterioration.

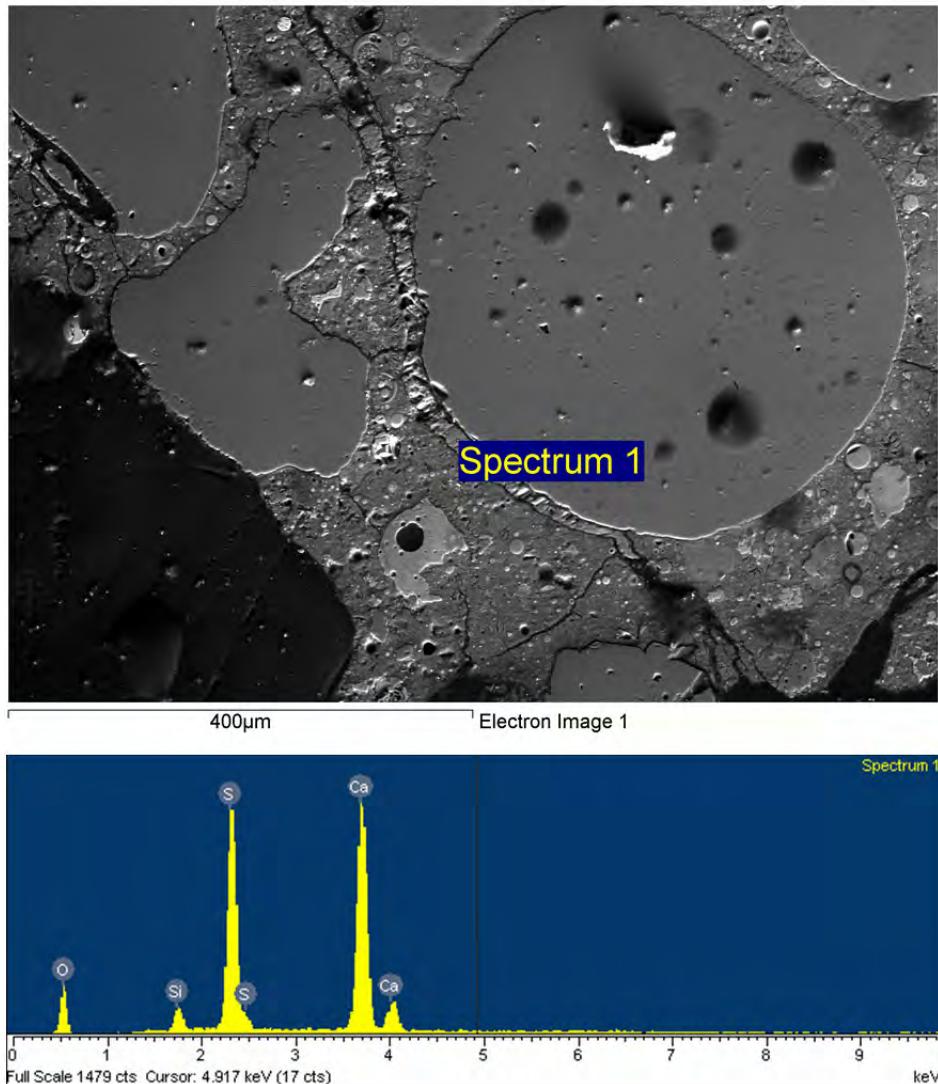
Figure 4.15: SEM Image and EDS spectrum of 40% FA1 with 5% SF after 18 months of storage in sodium sulfate storage. Gypsum band is found along the samples edge and around aggregates

Figure 4.15 shows an SEM image and EDS spectrum of 40% FA1 with 5% SF. In the image, a long band of gypsum runs along the samples edge. This band runs along the entire sample along the edge of the sample nearest to the sodium sulfate solution. The Ca and S in the EDS spectrum confirm the gypsum band in the image. In comparison with 40% FA1 in Figure 3.8, there is much less ettringite in the paste and around aggregates. Semi-quantitative XRD results show only 0.8% monosulfate in the 40% FA1 with 5% SF sample which suggests that gypsum has not converted to ettringite. Ternary blends with 6 and 9% UFFA also did well in suppressing expansion, even at 18 months. The use of these ternary blends significantly reduces the permeability of mortar, minimizing the ingress of sulfates and preventing chemical alterations of the matrix. This physical effect is also accompanied by the chemical effect of the pozzolanic reaction, resulting in lower CH contents and concomitant reductions in attack on this vulnerable phase.

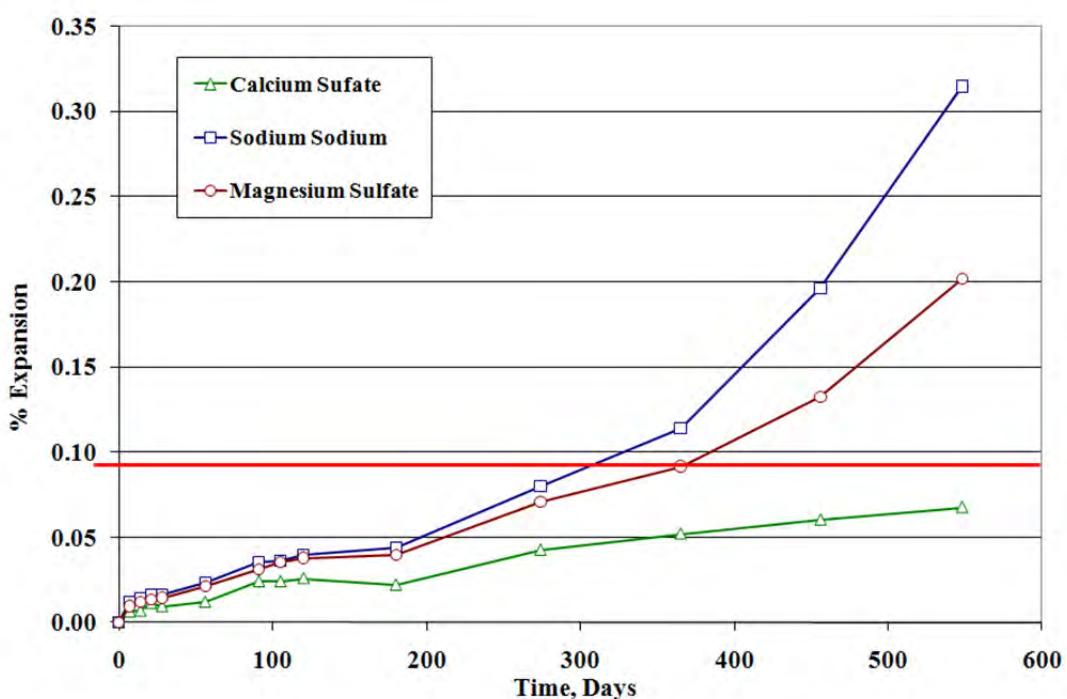
Figure 4.16: Mortar mixtures containing Type I/II Cement placed into three different soak solutions

Figure 4.16 and 4.17 provide the expansion values for the controls containing Type I/II and Type V cement. All three mixtures with Type V cement in the three soaking solutions pass the test at 18 months. The controls with Type II cement fail at 1 year with sodium sulfate and the mixture in magnesium sulfate fails the 0.1 % expansion criteria at 18 months. Type I/II placed in calcium sulfate passes at 18 months. According to ACI 318, the Type I/II cement would meet the S1 exposure class and the Type V cement would meet S3 exposure conditions.

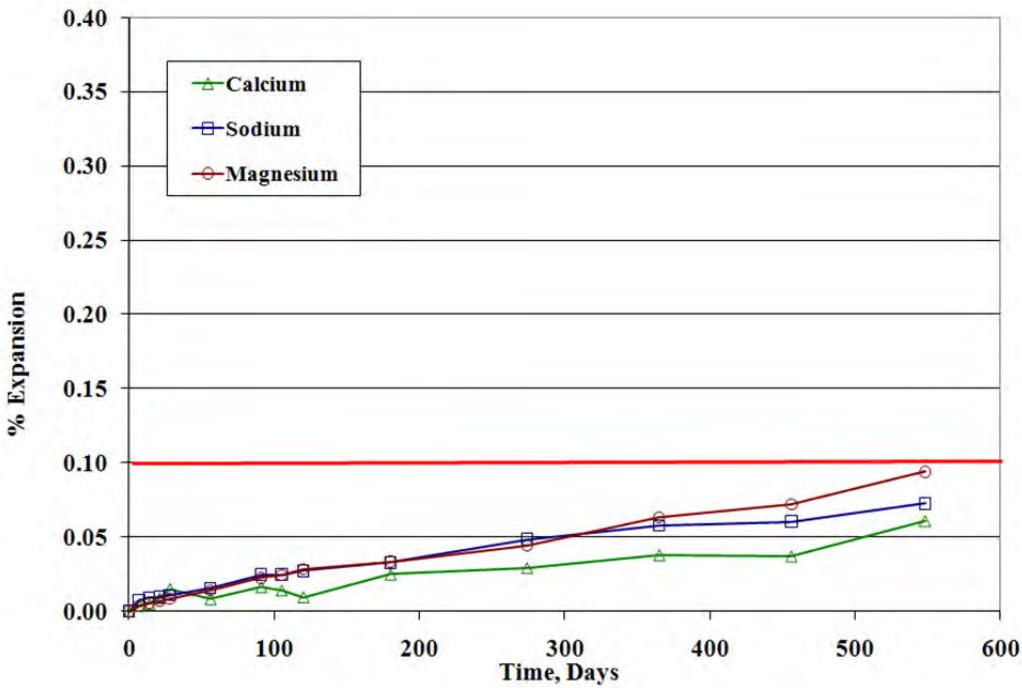
Figure 4.17: Mortar mixtures containing Type V Cement placed into three different soak solutions

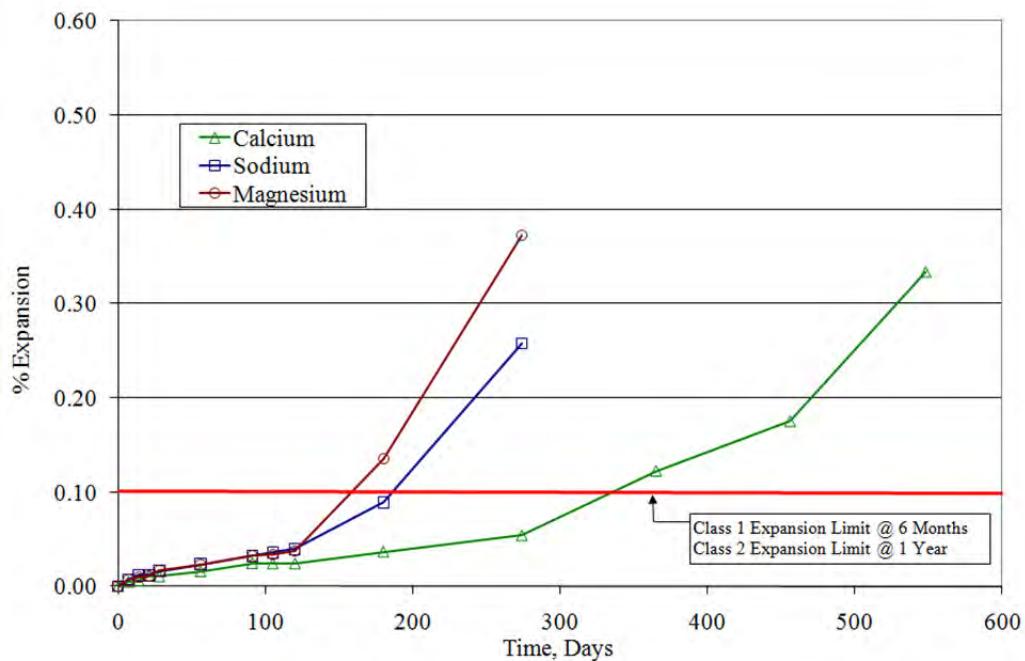
Figure 4.18: ASTM C 1012 mortar mixture with Type I/II cement and 20% FA8

Similar to section 4.2 the addition of Class C fly ash into mixtures increases the rate of expansion and fails the test at earlier times. The addition of Class C fly ashes increases the C3A content within the mixture of these mixtures which contain lower C3A content cements, and the addition of their reactive amorphous glassy phase increases the expansion values. Figure 4.18 and 4.19 show the effects of adding Class C fly ash into a mixture with either Type II or Type V cements. Figure 4.18 shows the addition of FA-8 with Type II cement. Mixtures in sodium and magnesium sulfate fail at 6 months while those in calcium sulfate fail the expansion limit at 1 year. Figure 4.19 shows the addition 40% FA-1 (lower reactive Class C fly ash) with Type cement. The mixtures placed into sodium and magnesium sulfate fail at 4 months and the mixture placed into calcium sulfate fails at 6 months. Overall, the calcium sulfate soak solution provides conditions with the least amount of expansion. The lower solubility of this solution may allow this soak solution to outperform the others. Sodium and magnesium sulfate solutions tend to provide the same rate of expansions.

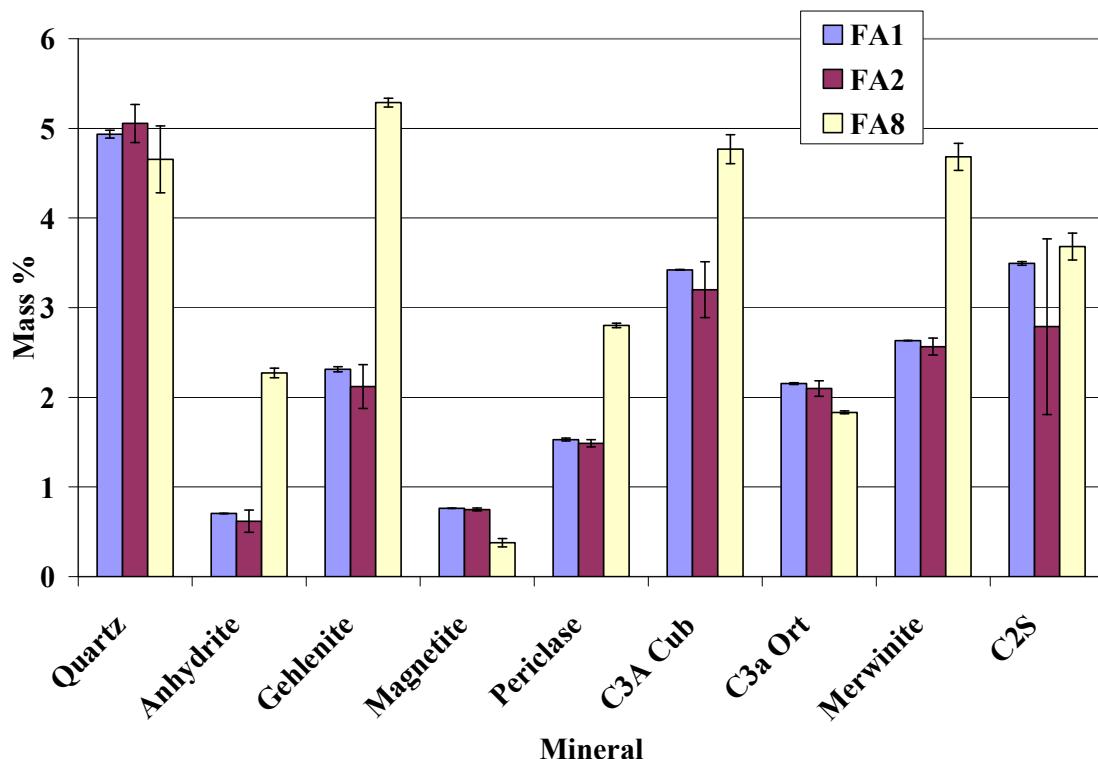
Figure 4.20: Quantitative XRD Rietveld analyses for FA1, FA2, and FA8. FA1 and FA2 have similar crystalline composition but perform drastically different in ASTM C 1012 Testing

The bulk chemical compositions of the Class C fly ashes used in this study were previously provided in Table 3.2. However, as previously described, fly ash with similar chemical compositions exhibits starkly different behavior when tested using ASTM C 1012. As such, it is necessary to go beyond chemical composition and to try to better quantify the mineralogy of fly ash, including both the crystalline and amorphous phases. Figure 4.20 shows the XRD Rietveld analyses for FA1, FA2, and FA8. FA1 and FA2 showed similar crystalline phase compositions, and these were quite different from the crystalline composition of FA8.

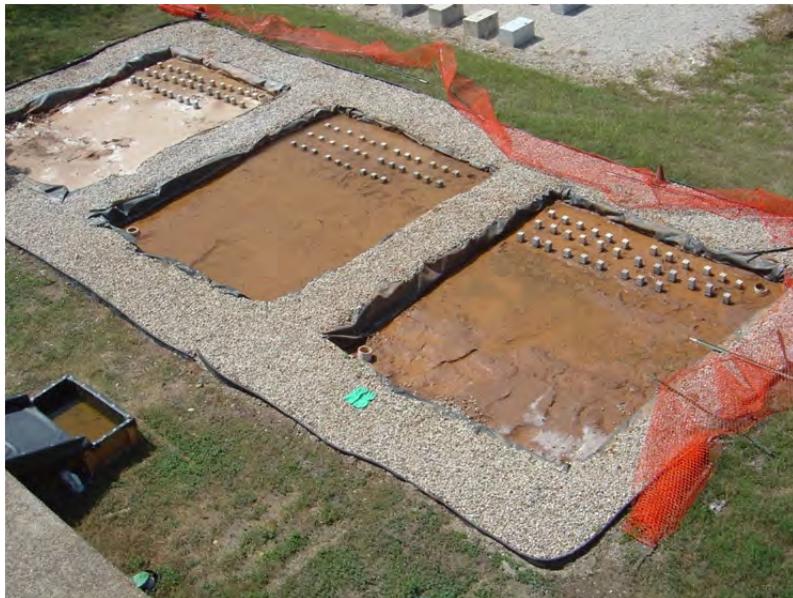
Figure 5.1: Outdoor sulfate exposure site located in Austin, TX. From left to right, the trenches contain calcium sulfate, sodium sulfate, and magnesium sulfate.

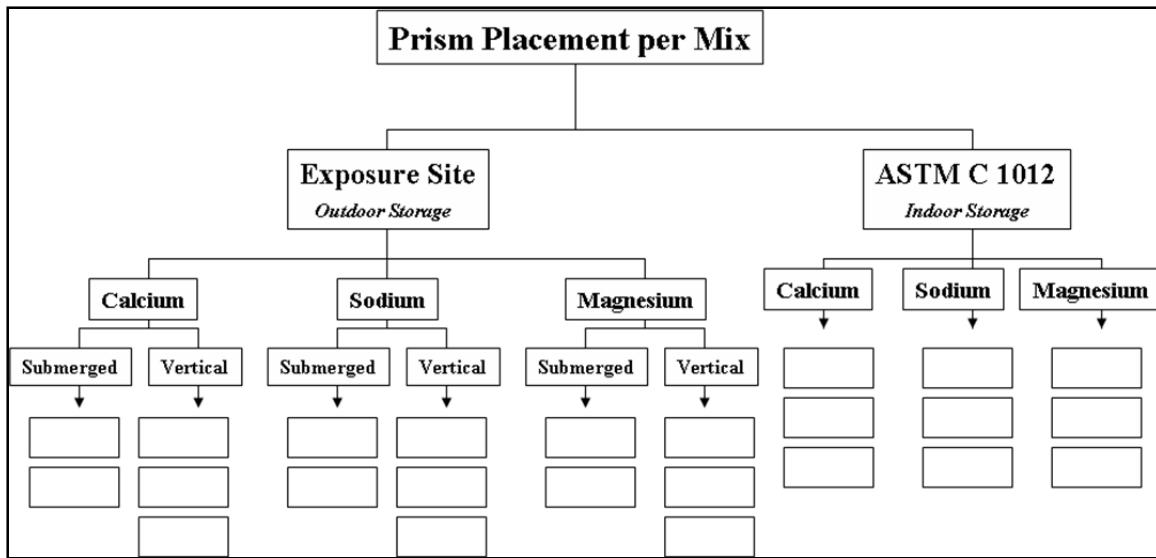
Figure 5.2: The placement of prisms from each mixture into the outdoor exposure site or in the modified ASTM C 1012 testing

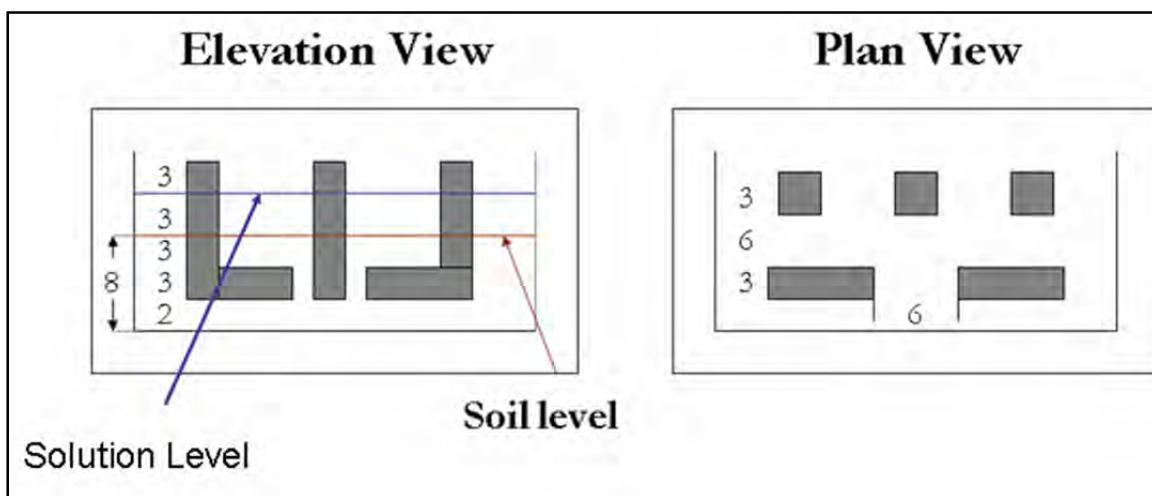
Figure 5.3: Placement of prisms in each outdoor exposure trench. The units are in terms of inches.

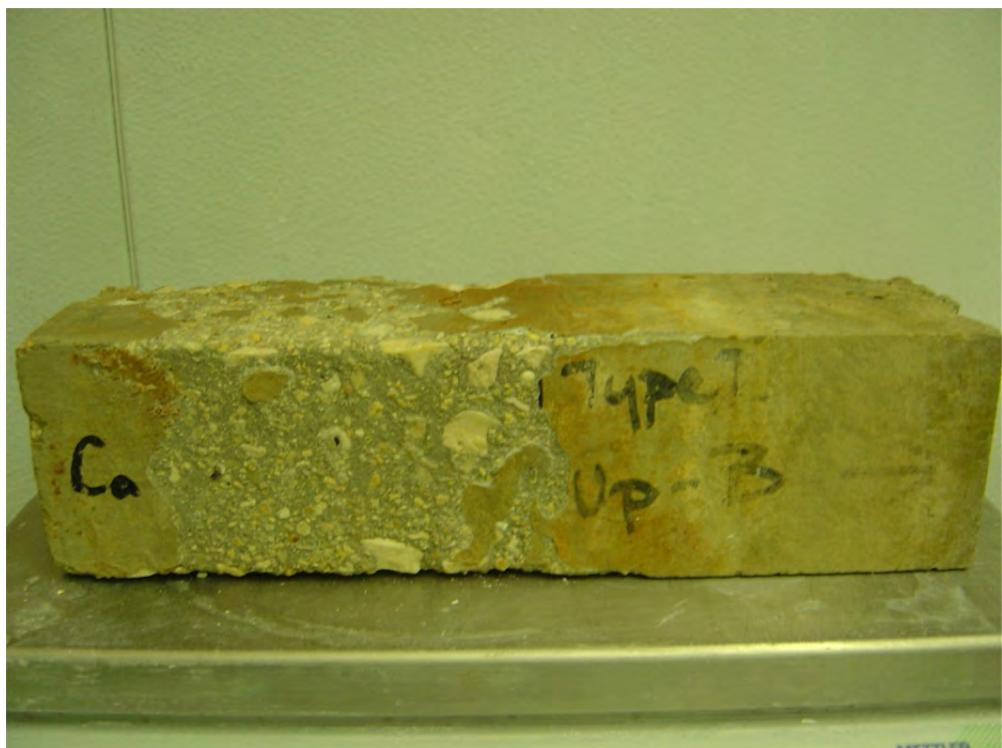
Figure 5.7: Concrete prism with a 0.4 w/cm placed vertically in the outdoor calcium sulfate exposure site. In this photograph, the left side shows the portion of the prism that was below the soil level.

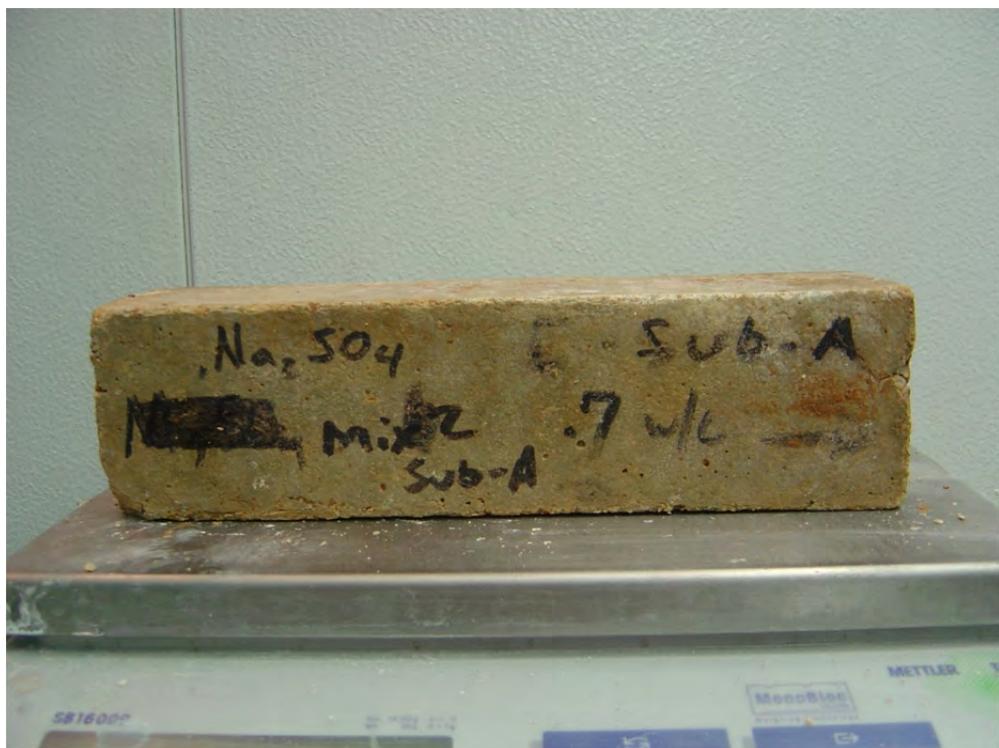
Figure 5.15: C1-7 Prism submerged in the outdoor sodium sulfate exposure site after 18 months
