1. Report No. FHWA/TX-11/0-4889-1	2. Government Accession No.	3. Recipient's Catalog No.	
4. Title and Subtitle Laboratory and Field Evaluations of External Sulfate Attack in Concrete		5. Report Date February 2010, Rev. January 2011

Laboratory and Field Evaluations of External Sulfate Attack in Concrete

Chapter 7 summarizes the findings of various field investigations of transportation structures in the state of Texas exposed to sulfate-rich conditions.

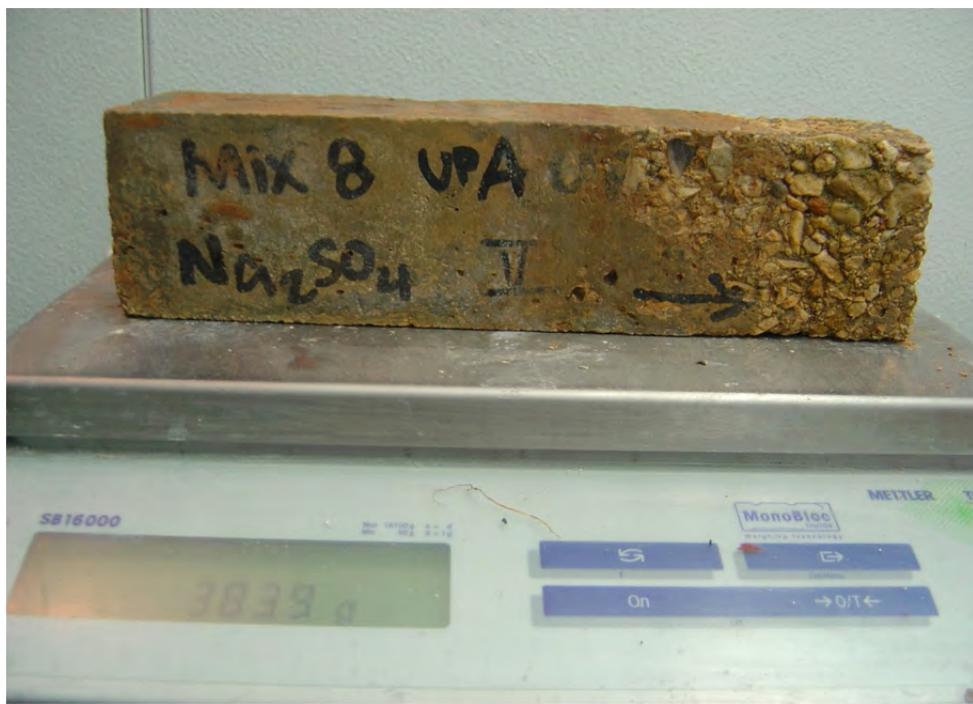
Figure 5.16: Mixture C5-7 after 18 months of outdoor exposure to sodium sulfate. This prism was placed vertically, with the section on the left fully submerged below sulfate-saturated soil.

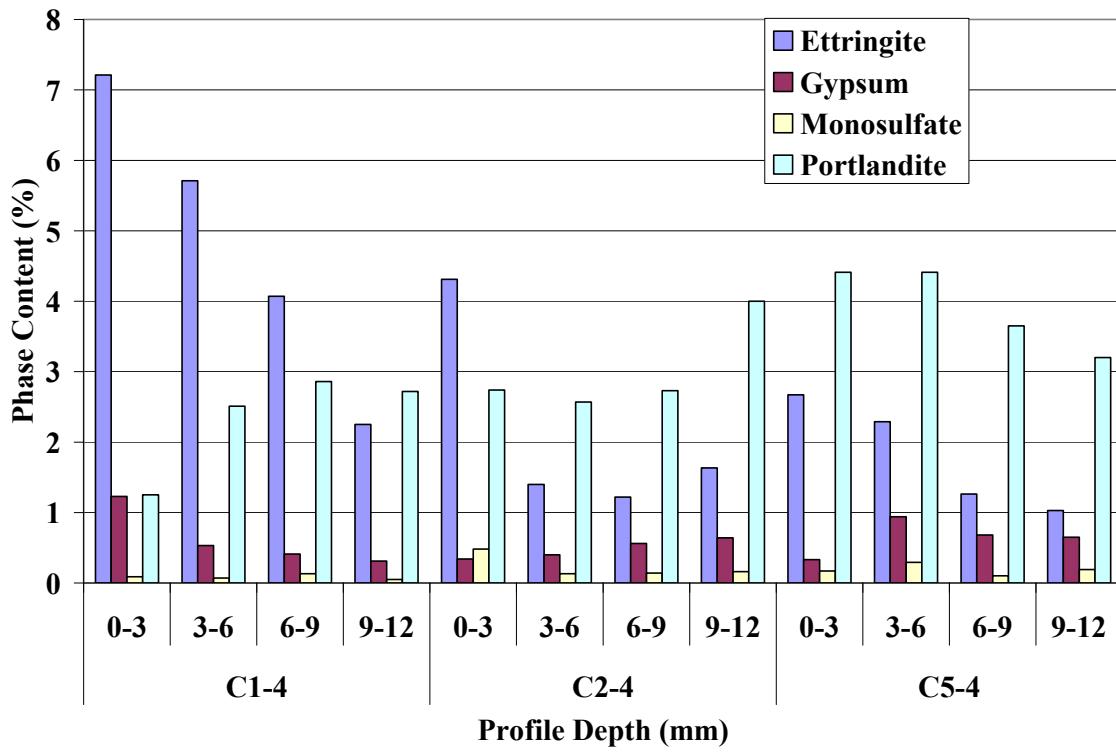
Figure 5.17: Quantitative XRD Rietveld analyses of concrete prisms at 0.4 w/cm, placed indoors in sodium sulfate solutions after 18 months

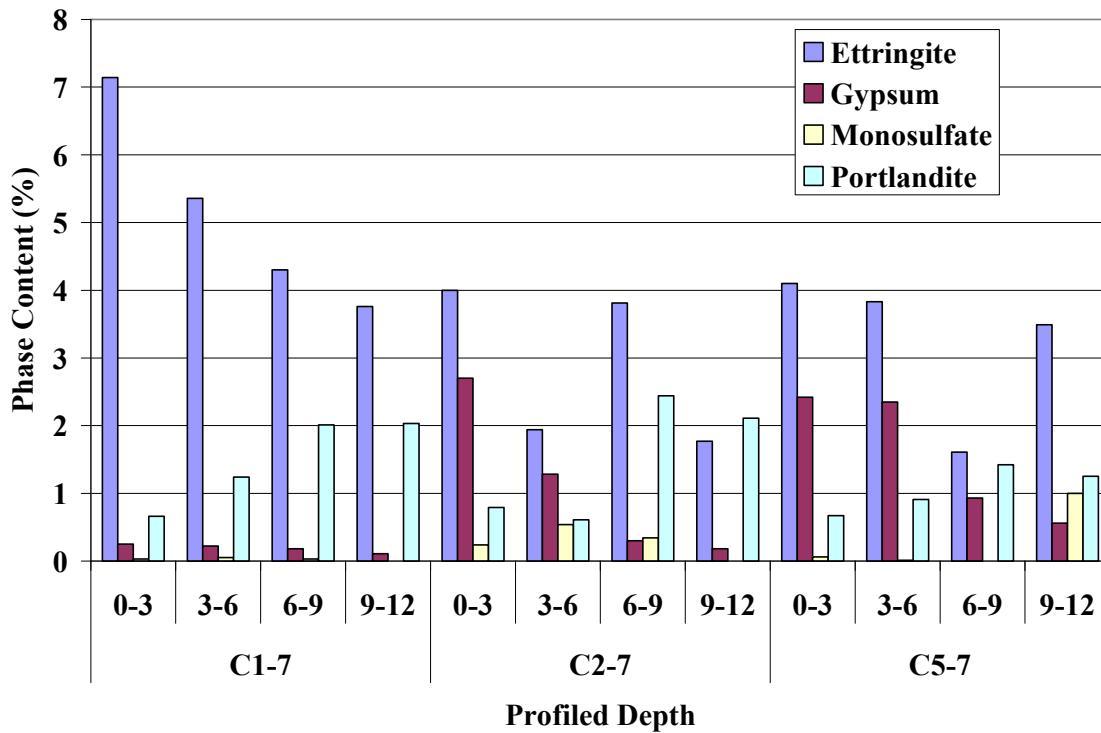
Figure 5.18: Semi-quantitative XRD Rietveld analysis of concrete prisms at 0.7 w/cm, placed indoors in sodium sulfate solutions after 18 months

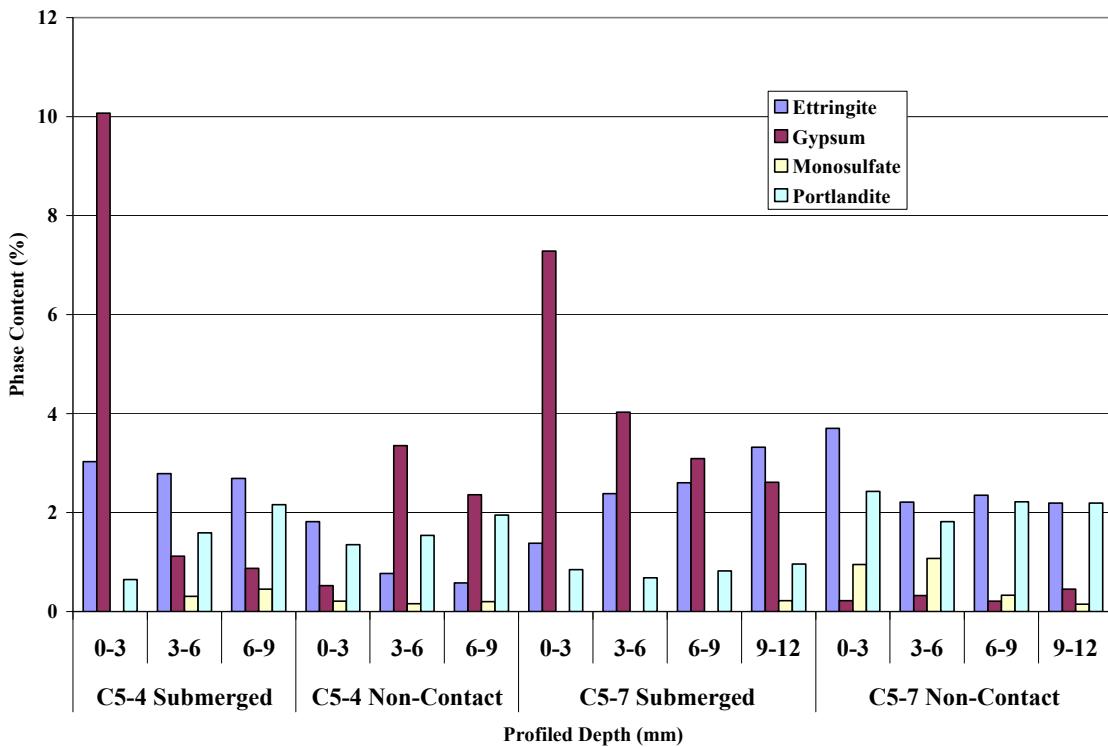
Figure 5.19: Semi-quantitative XRD analysis from mixtures containing sulfate resistant cement at in the outdoor sulfate exposure site

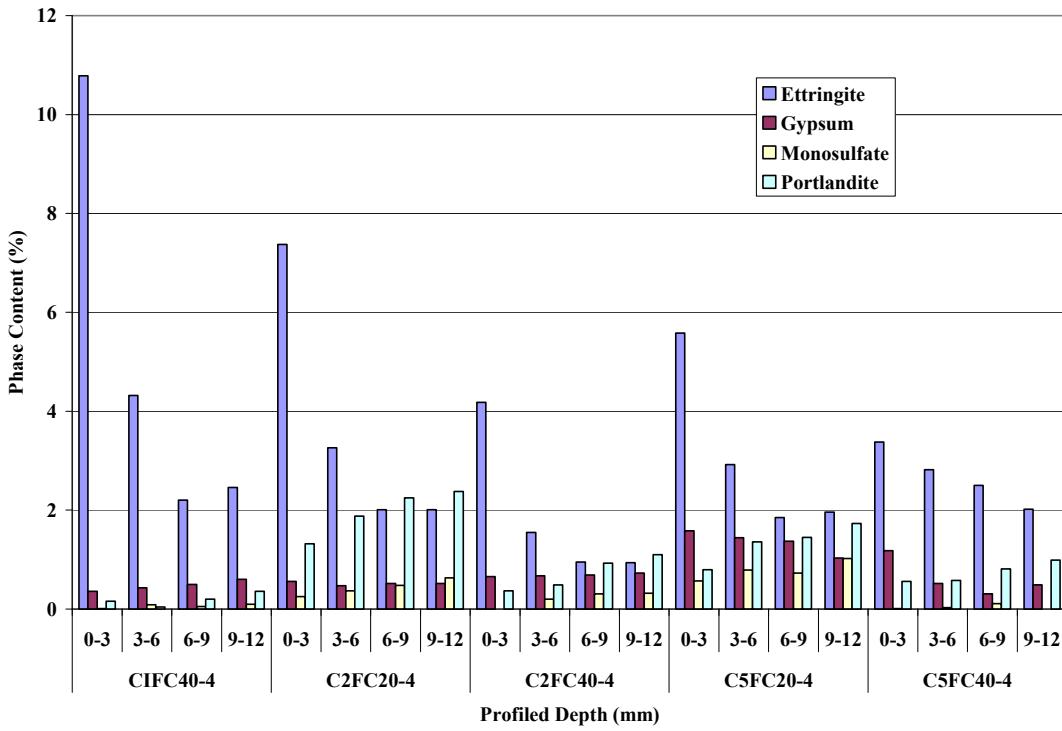
Figure 5.20: Quantitative XRD Analysis of Concrete prisms at 0.4 w/cm placed in sodium sulfate solutions for 18 months

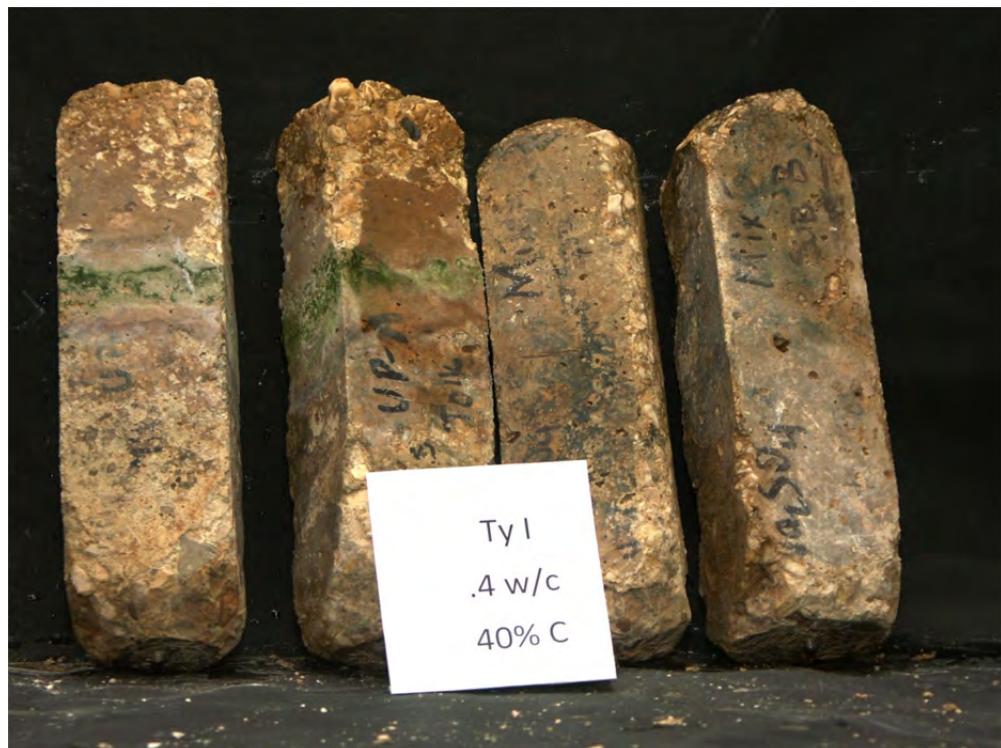
Figure 5.22: Damage to prisms exposed to 33000 ppm sodium sulfate

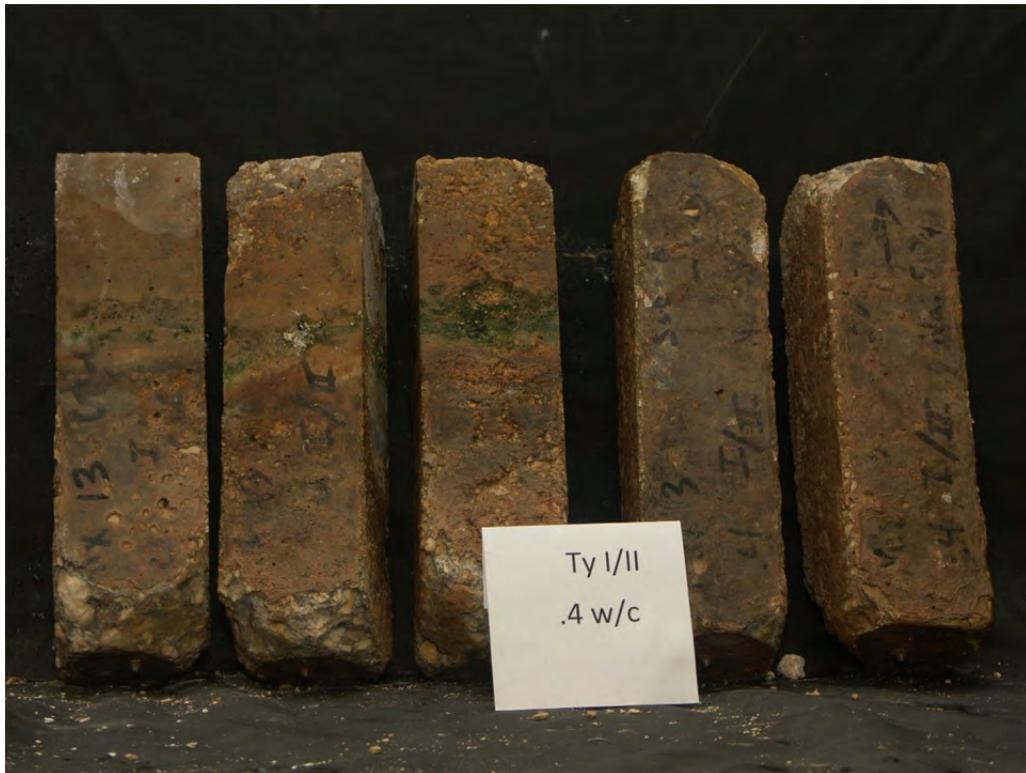
Figure 5.23: Damage to mixtures with Type I/II binders at a 0.4 w/cm in sodium sulfate exposure

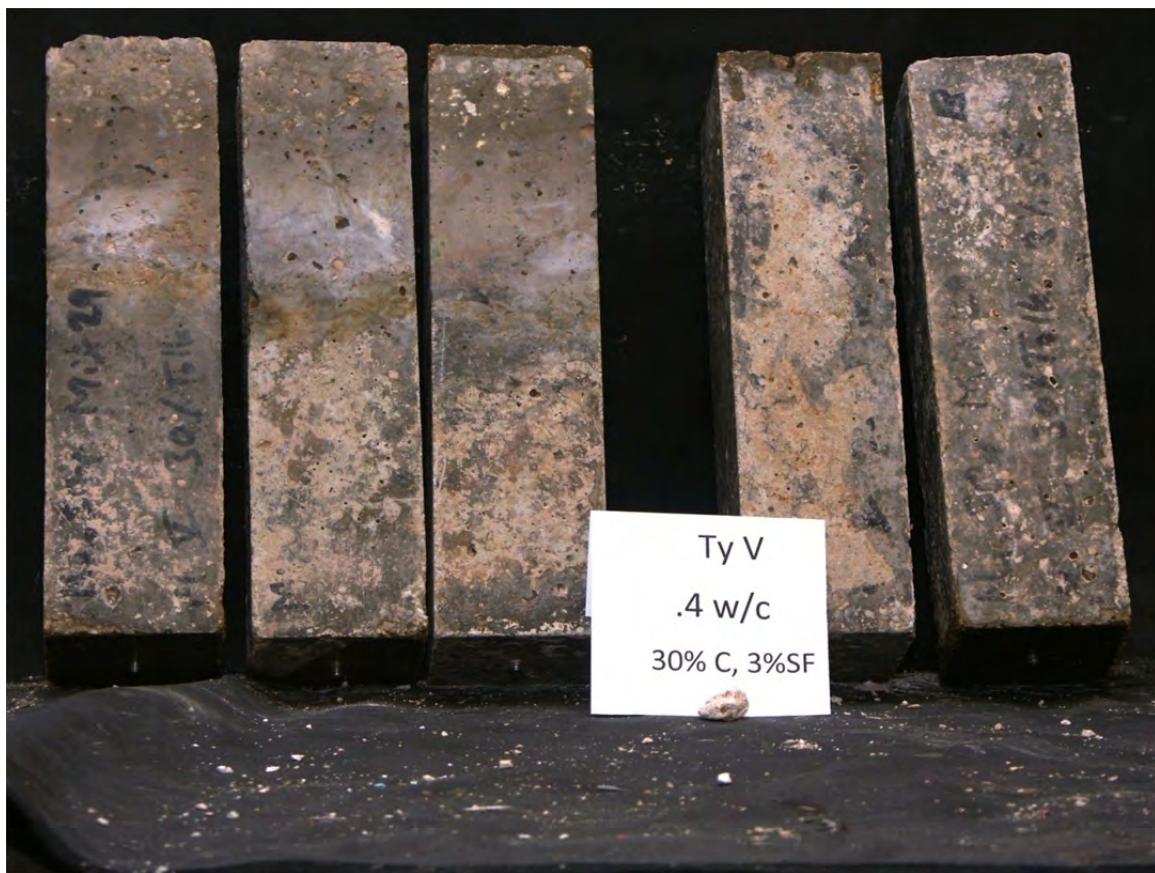
Figure 5.24: Concrete Prisms Exposed to 33000 ppm Sodium Sulfate exhibiting excellent performance

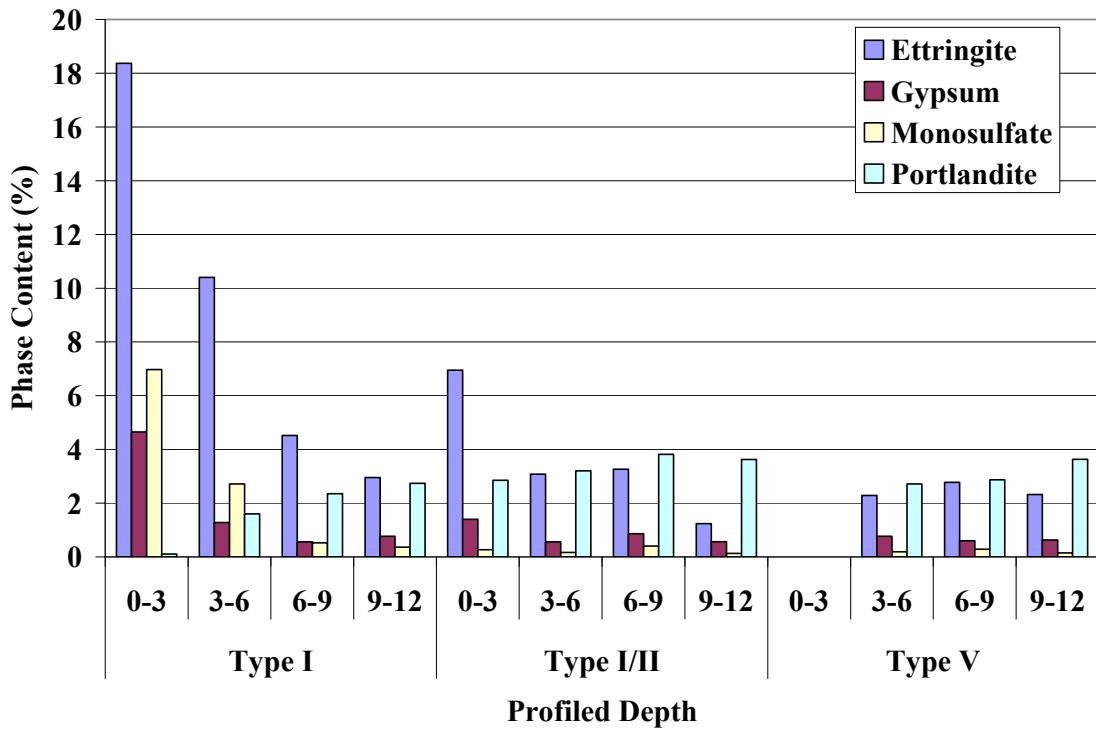
Figure 5.25: Semi-quantitative XRD Analysis of concrete prisms at 0.4 w/cm placed in indoor magnesium sulfate conditions

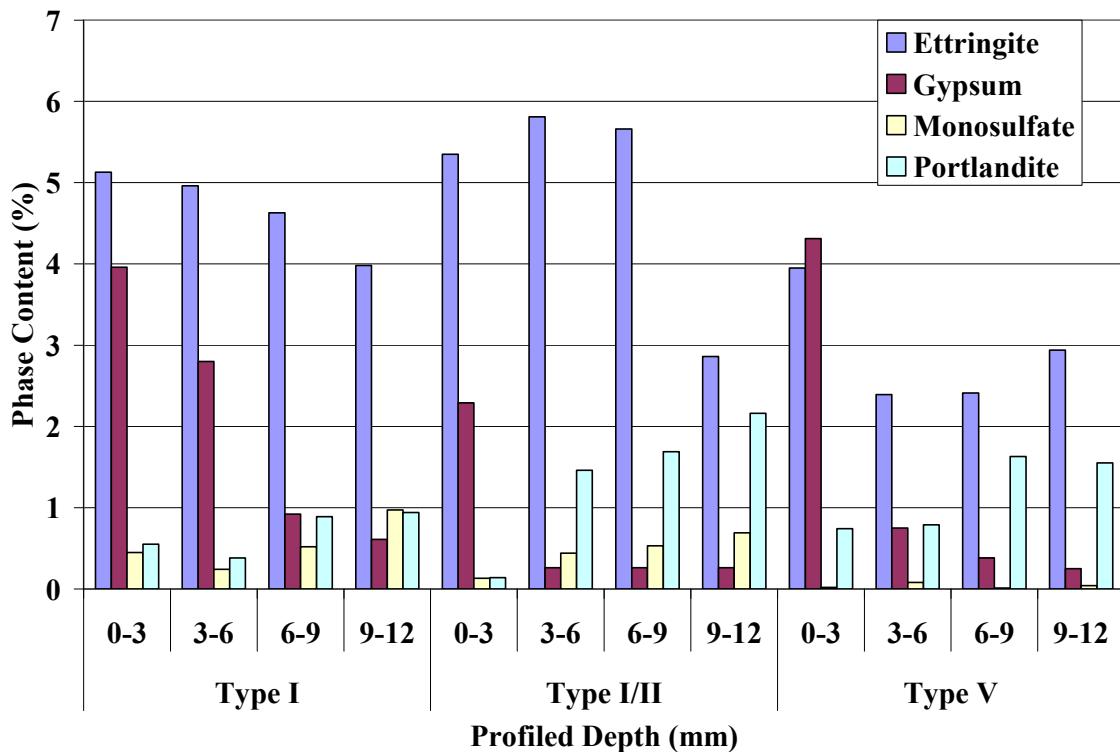
Figure 5.26: Semi-quantitative XRD Rietveld analysis of prisms placed in magnesium sulfate conditions

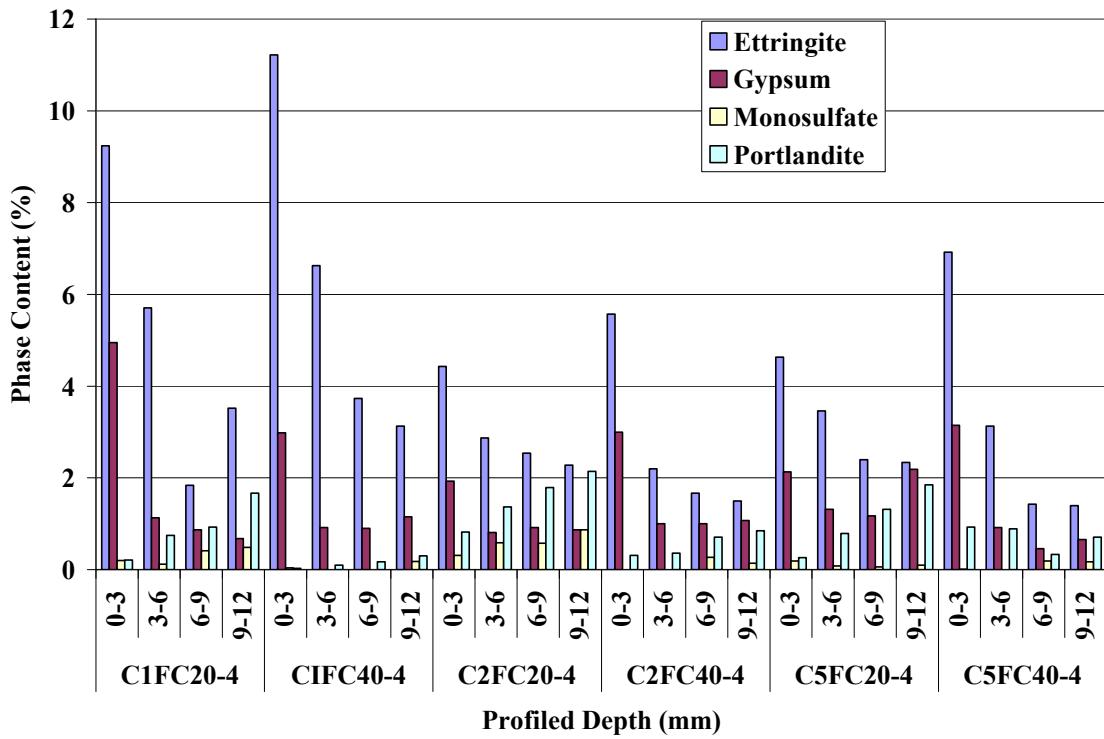
Figure 5.27: Semi-quantitative XRD Rietveld analysis of prisms containing SCMs in indoor magnesium sulfate conditions

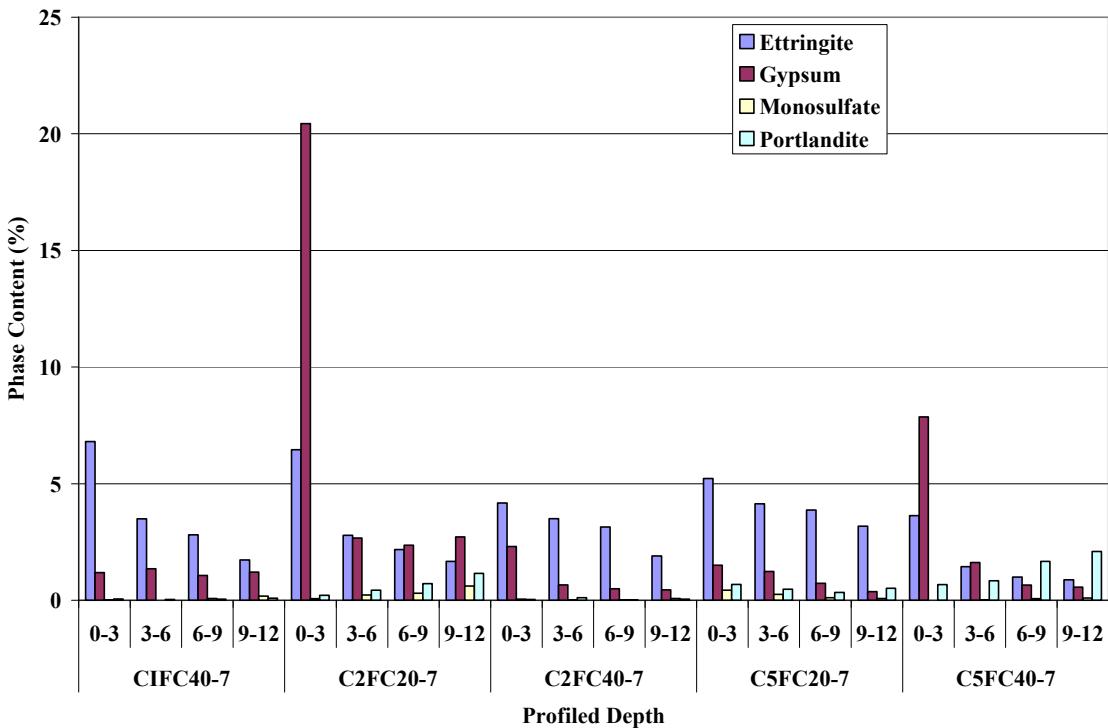
Figure 5.28: Semi-quantitative XRD Rietveld Analysis of prisms with SCMs placed indoors in magnesium sulfate solution

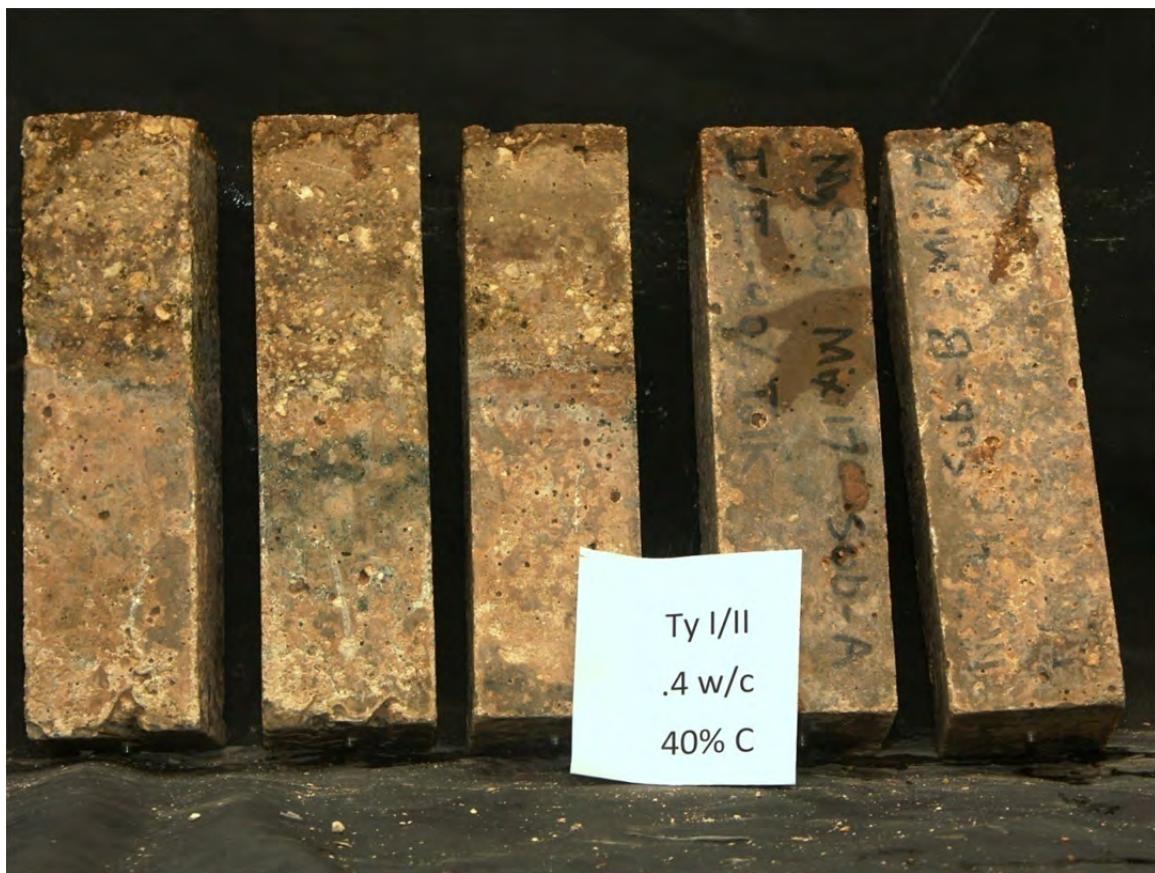
Figure 5.29: Damage to Prisms Exposed to 33000 ppm Magnesium Sulfate

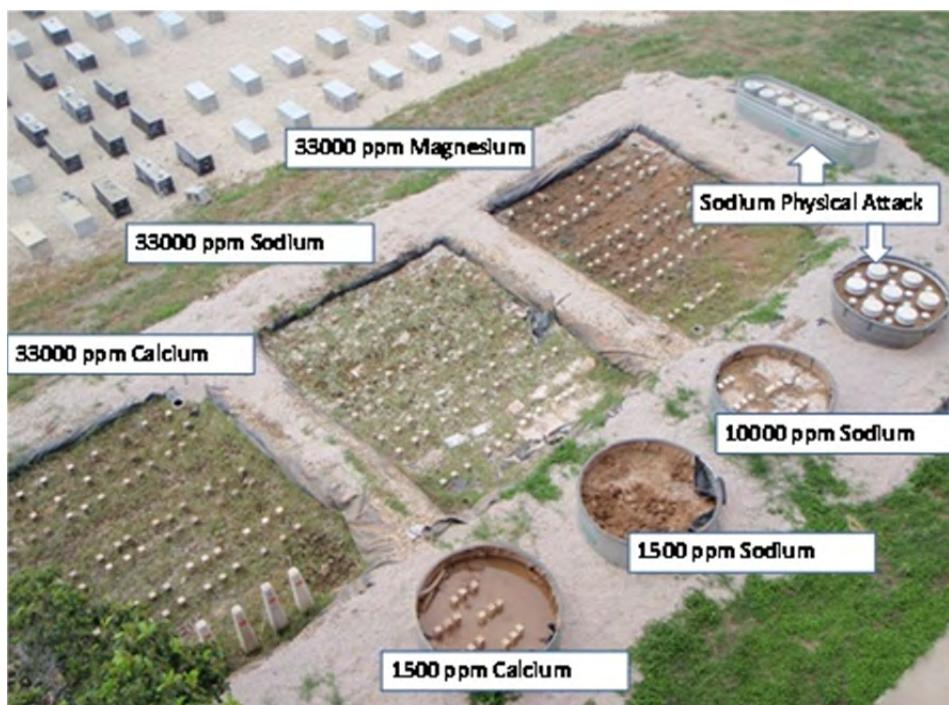
Figure 5.30: Updated Outdoor Sulfate Exposure Site

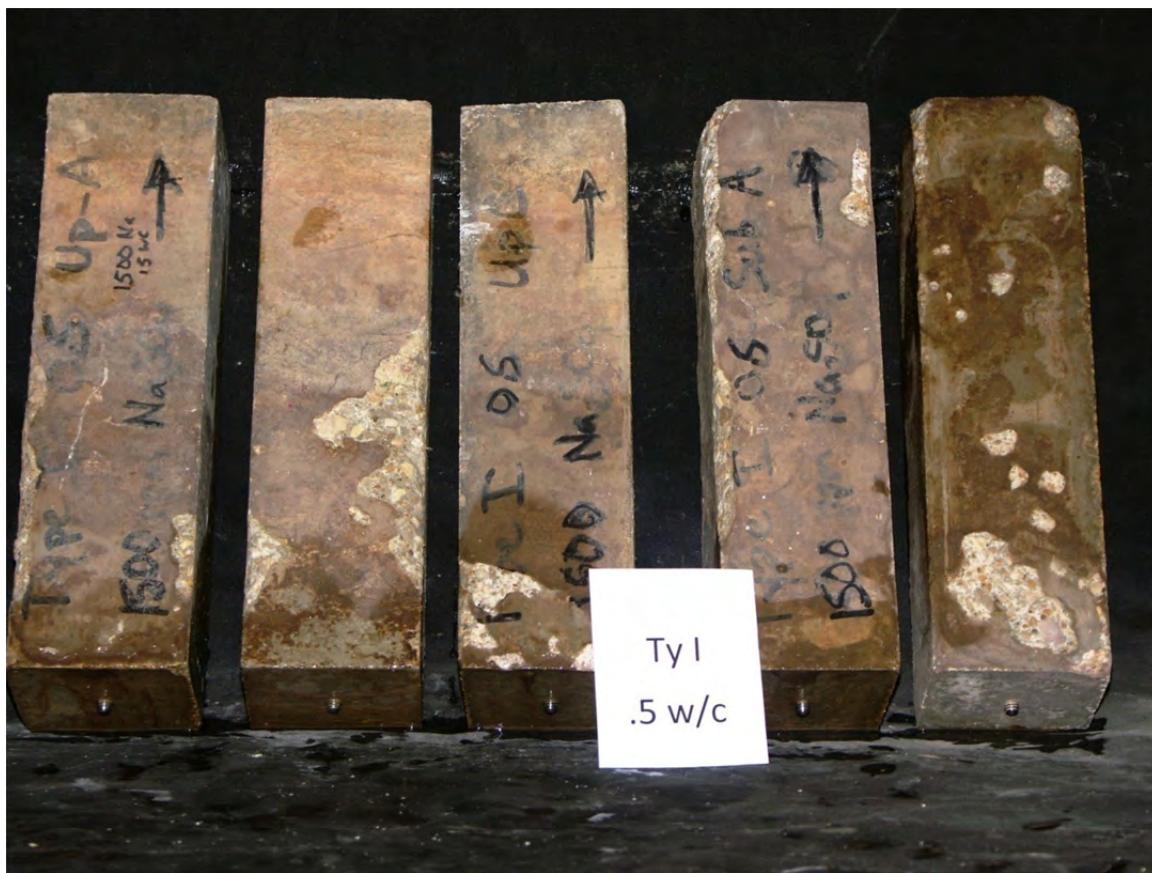
Figure 5.31: Surface Scaling in 1500 ppm Sodium Sulfate in Soil Contact Zone

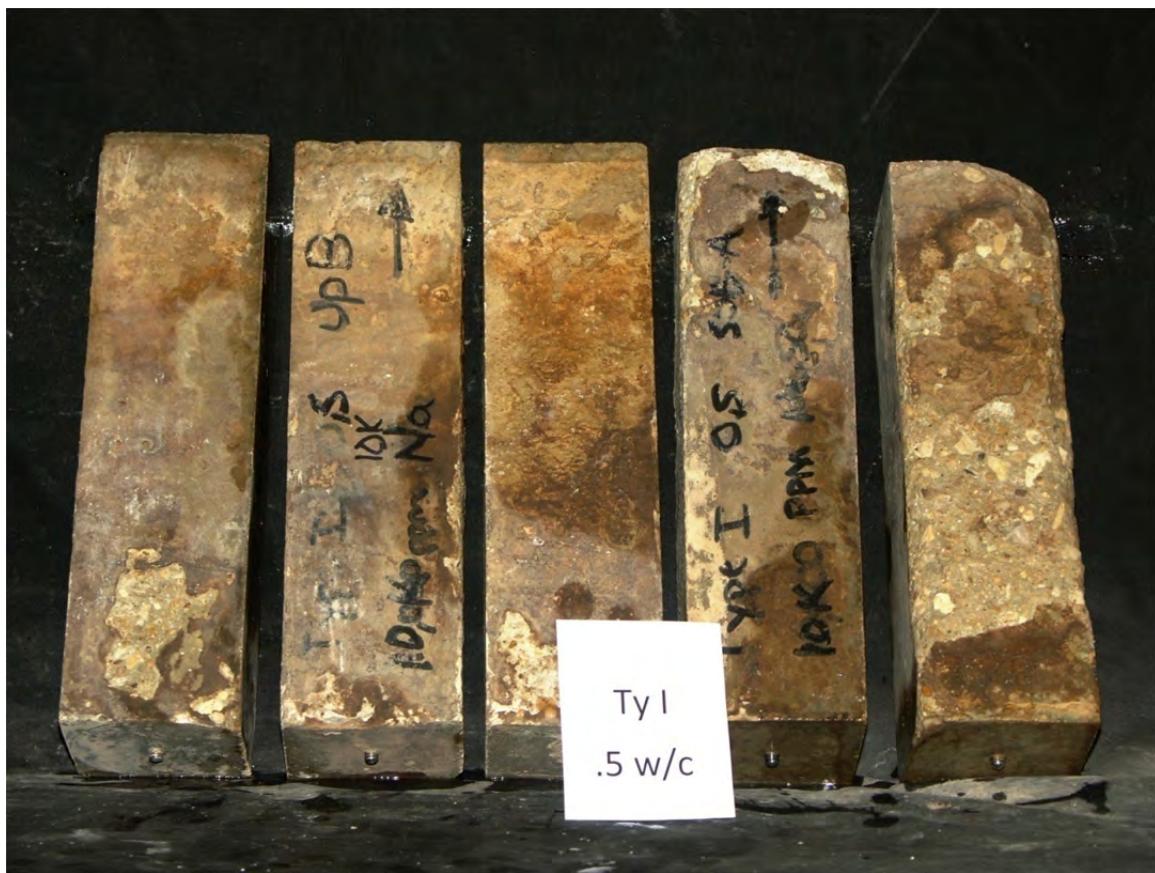
Figure 5.32: Surface Scaling in 10000 ppm Sodium Sulfate in Soil Contact Zone

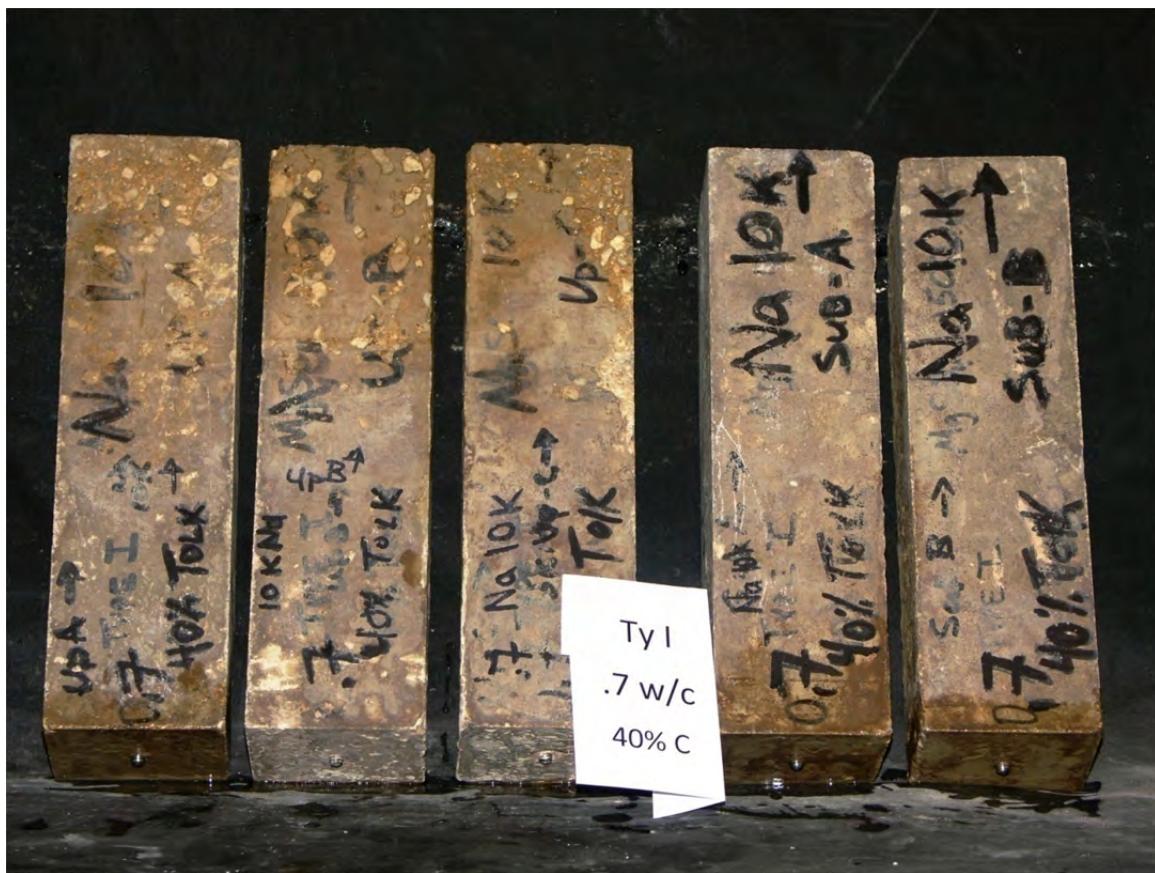
Figure 5.33: Physical Sulfate Attack in 10000 ppm Sodium Sulfate Above Soil Contact Zone

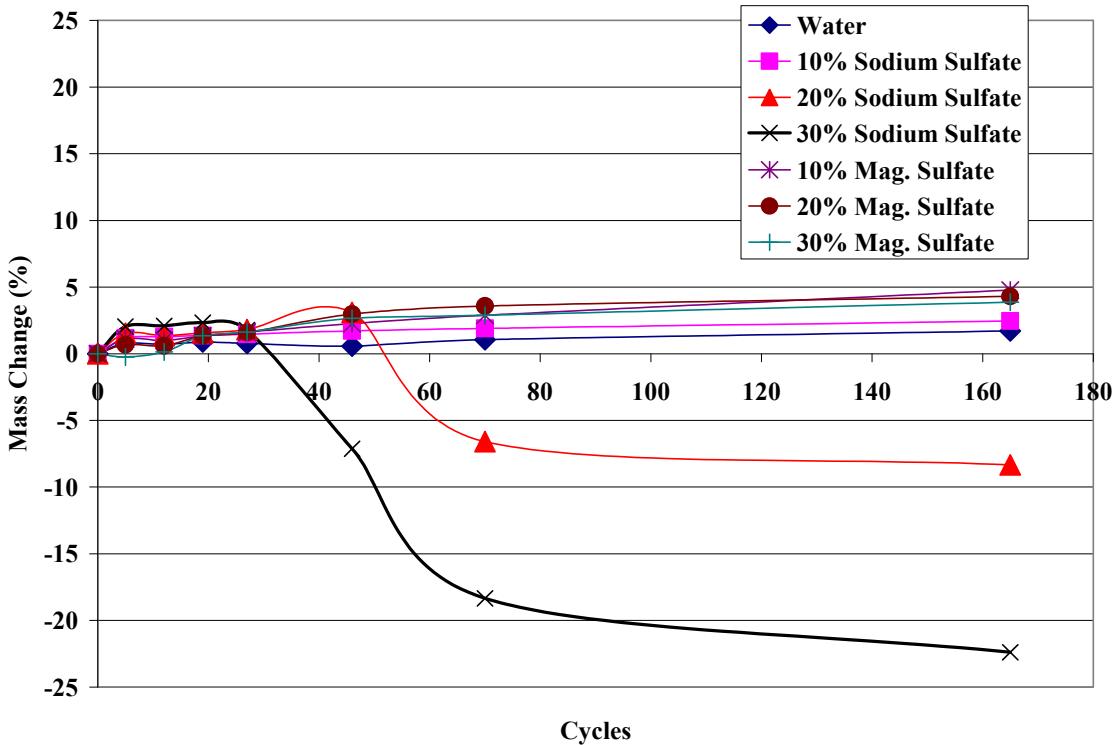
Figure 5.34: Physical sulfate testing of non-air-entrained mortars containing Type V cement ($w/cm=0.7$)

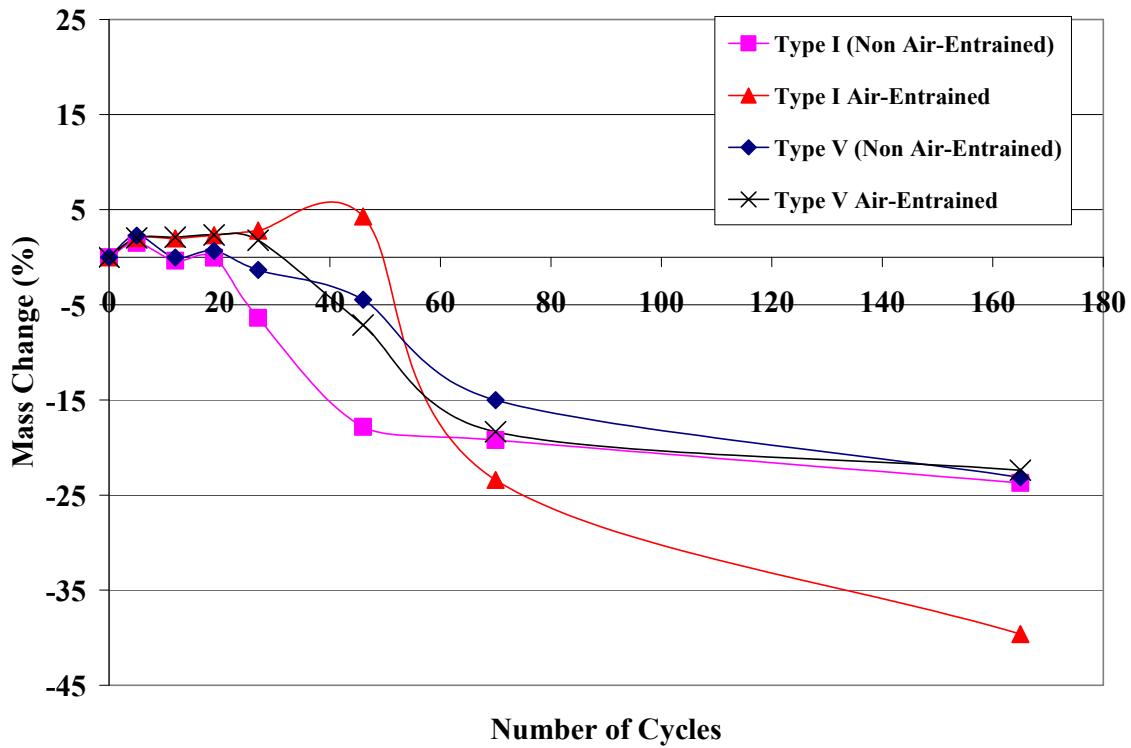
Figure 5.35: Physical sulfate testing of air-entrained and non-air-entrained mortars ($w/cm=0.7$) immersed in 30% sodium sulfate solution and subjected to temperature changes.

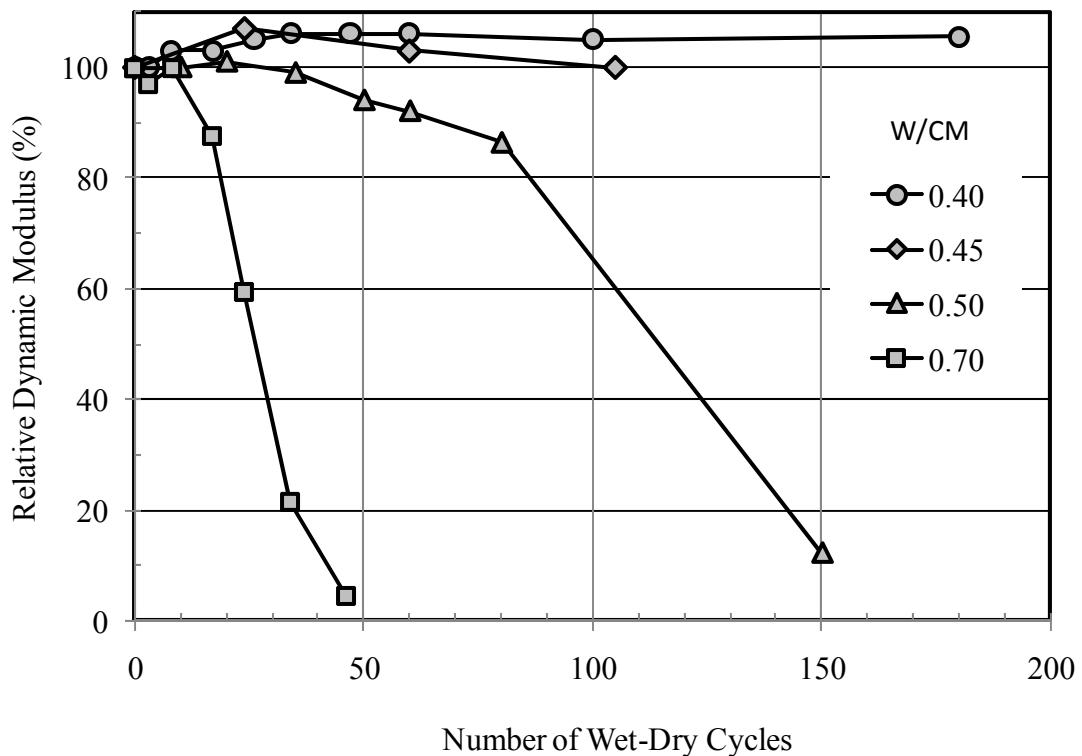
Figure 6.1: Effect of w/cm on the Change in Relative Dynamic Modulus of Control Mixes Exposed to Wet-dry Cycling in 5% Na_2SO_4 Solution (NSD)

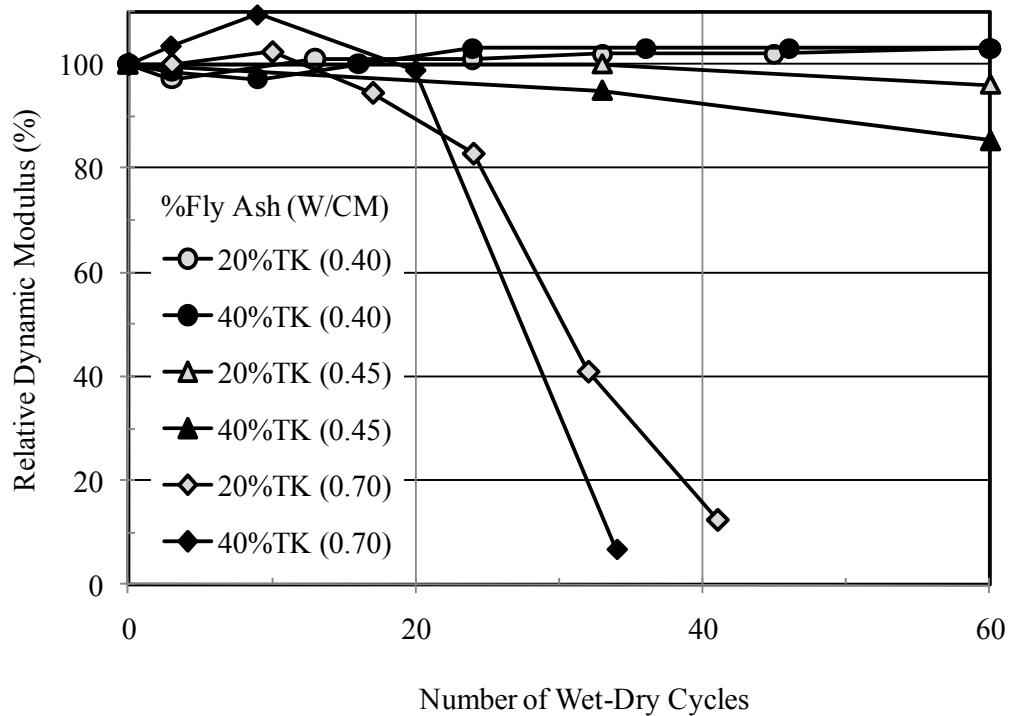
Figure 6.7: Change in Relative Dynamic Modulus of Concrete with TK Fly Ash (23.54% CaO) Exposed to Wet-Dry Cycling in 5% Na_2SO_4 Solution (NSD)

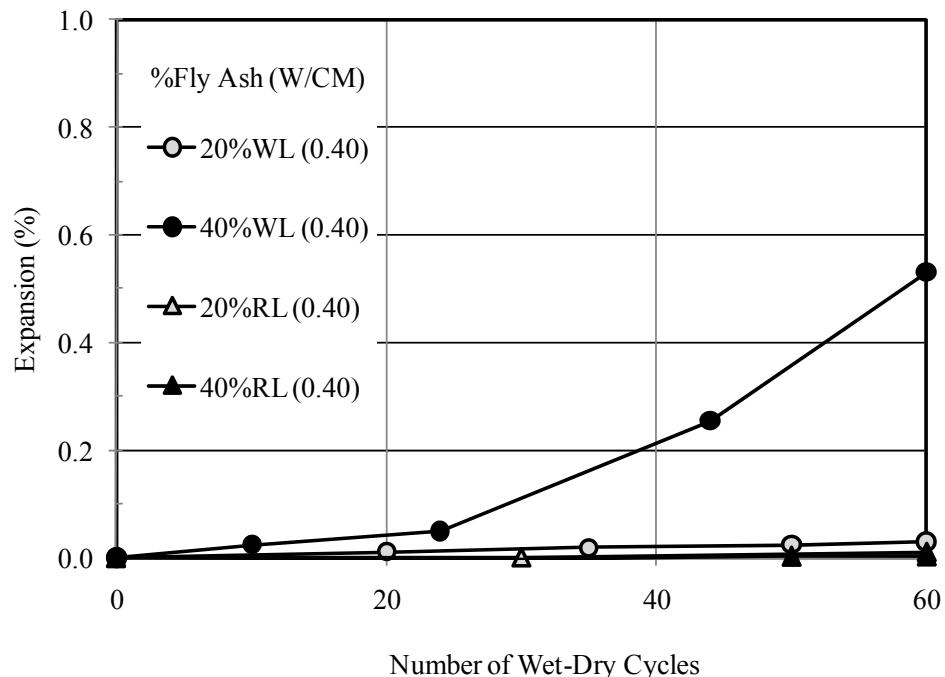
Figure 6.10: Expansion of Concrete with Fly Ash WL (28.98% CaO) and RL (12.76% CaO) Exposed to Wet-Dry Cycling in 5% Na_2SO_4 Solution (NSD)

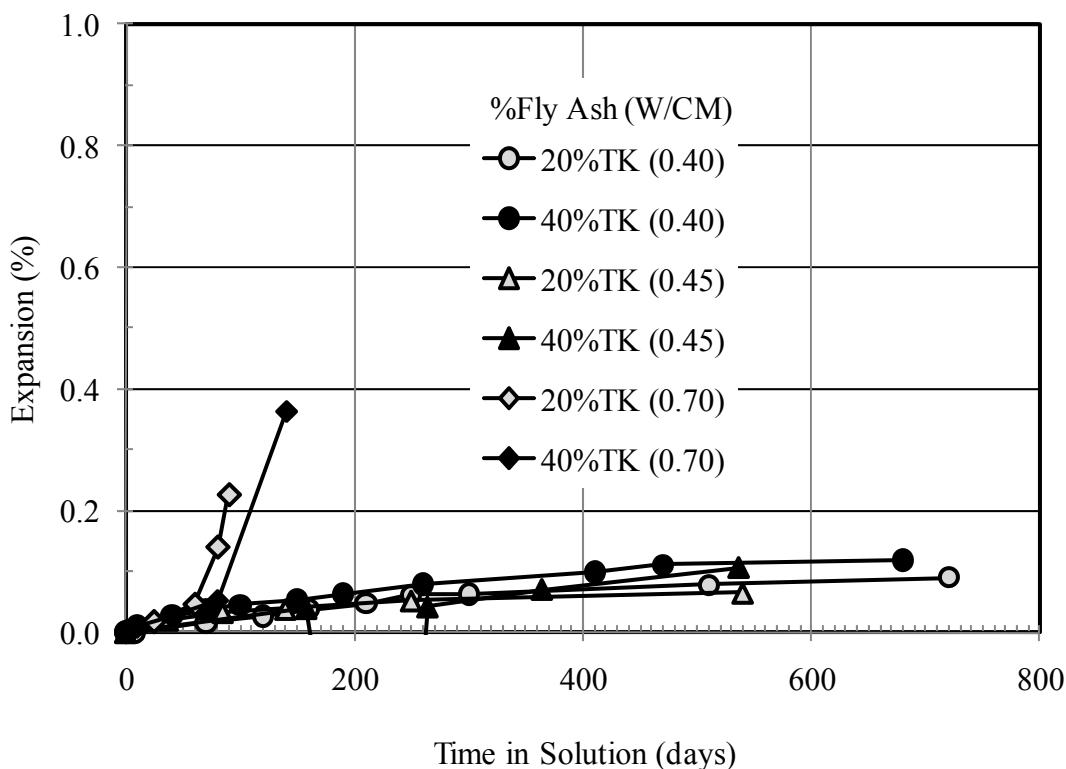
Figure 6.11: Expansion of Concrete with Fly Ash TK (23.54% CaO) Immersed in 5% Na_2SO_4 Solution (NSS)

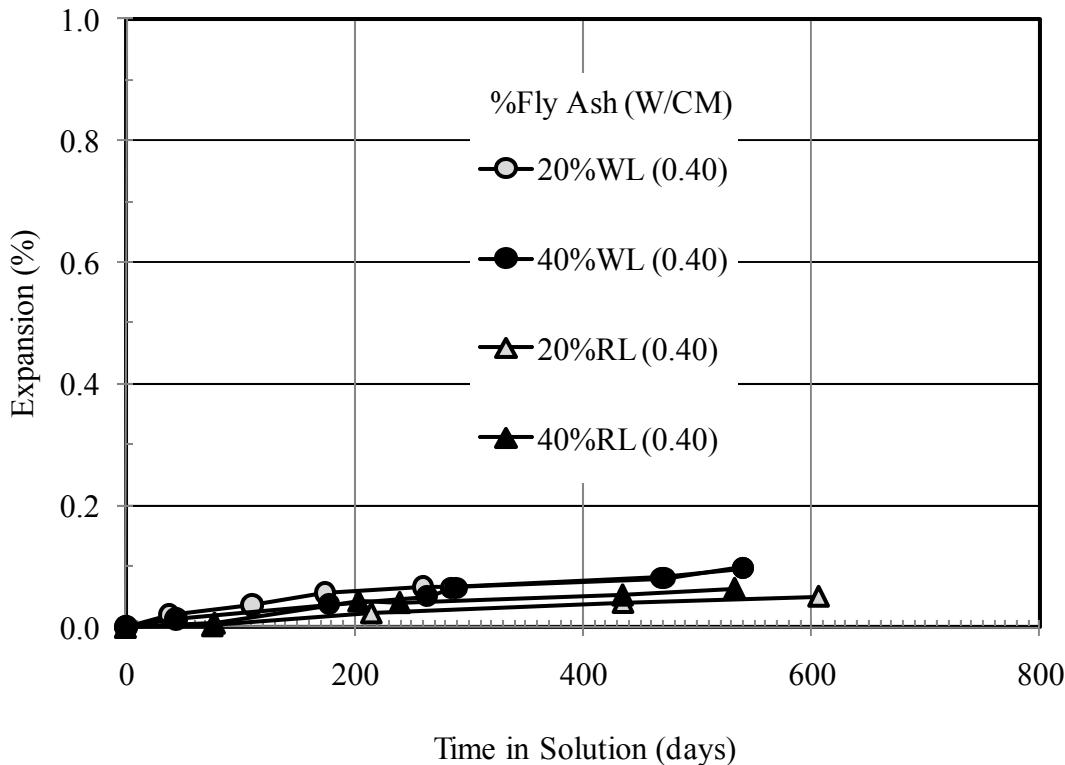
Figure 6.12: Expansion of Concrete with Fly Ash WL (28.98 CaO) and RL (12.76% CaO) Immersed in 5% Na_2SO_4 Solution (NSS)

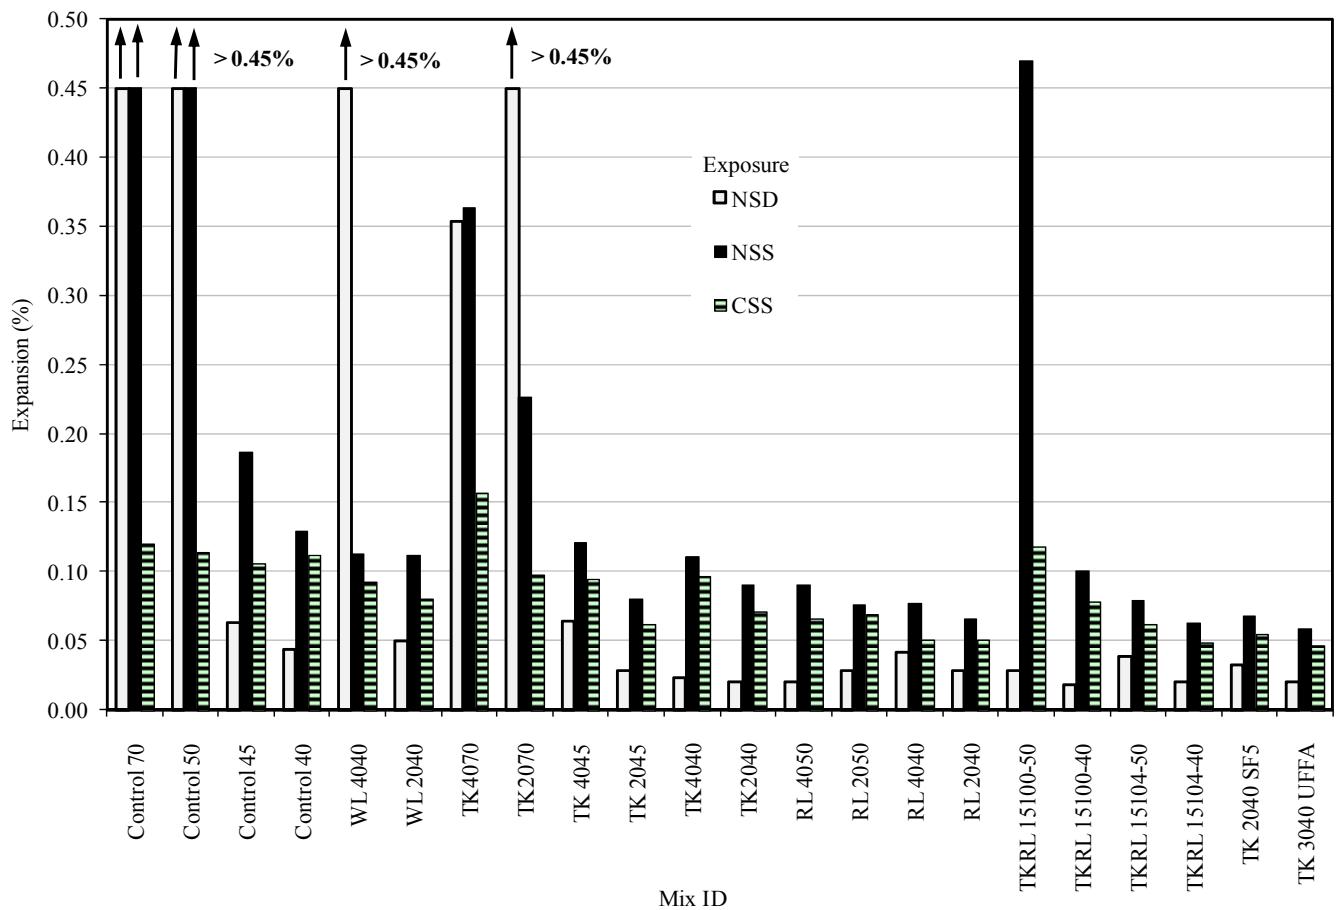
Figure 6.13: Summary of Expansion Data for Concrete Mixes

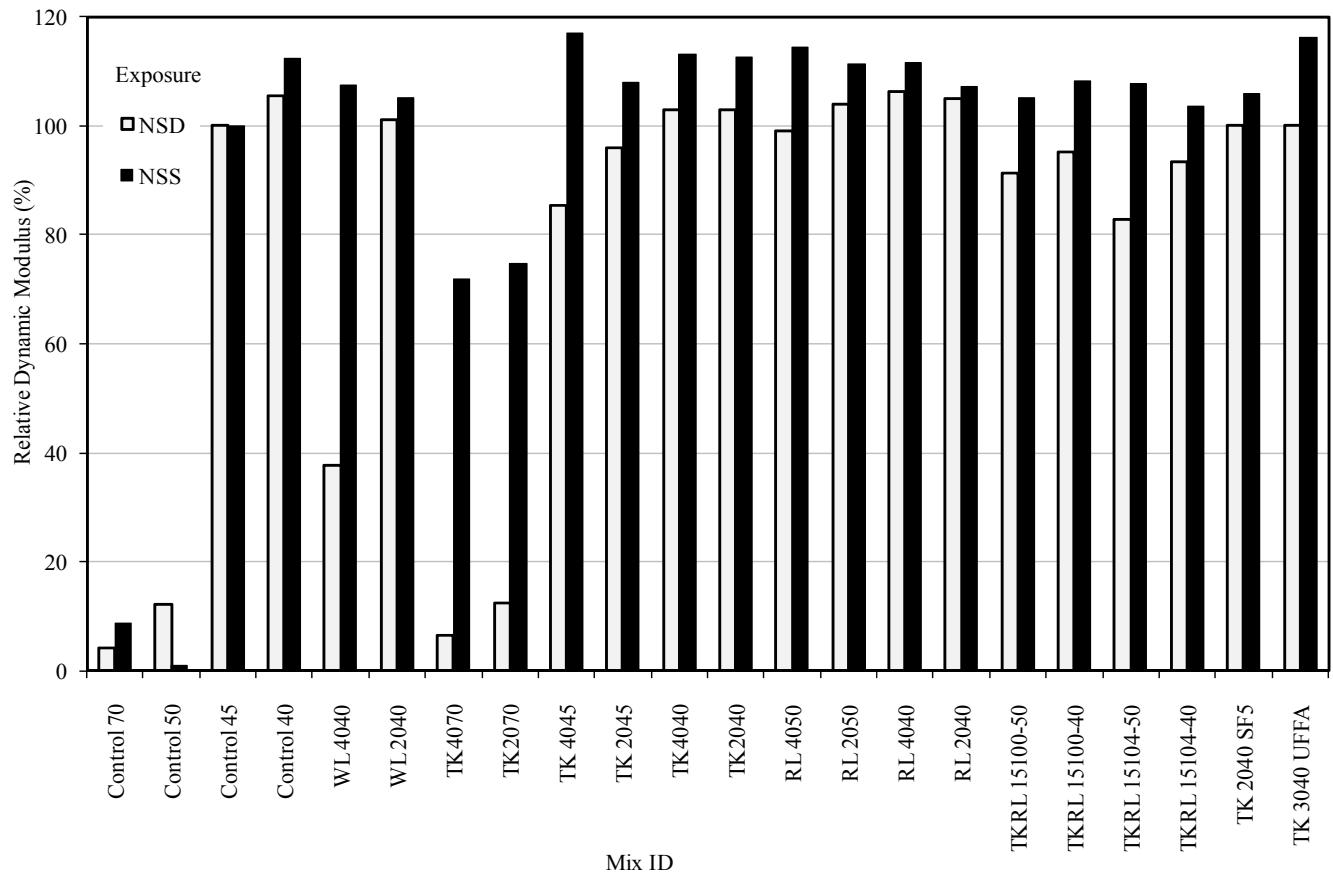
Figure 6.14: Summary of Relative Dynamic Modulus Data for Concrete Mixes
