1. Report No. FHWA/TX-11/0-4889-1	2. Government Accession No.	3. Recipient's Catalog No.	
4. Title and Subtitle Laboratory and Field Evaluations of External Sulfate Attack in Concrete		5. Report Date February 2010, Rev. January 2011

Laboratory and Field Evaluations of External Sulfate Attack in Concrete

Chapter 7 summarizes the findings of various field investigations of transportation structures in the state of Texas exposed to sulfate-rich conditions.

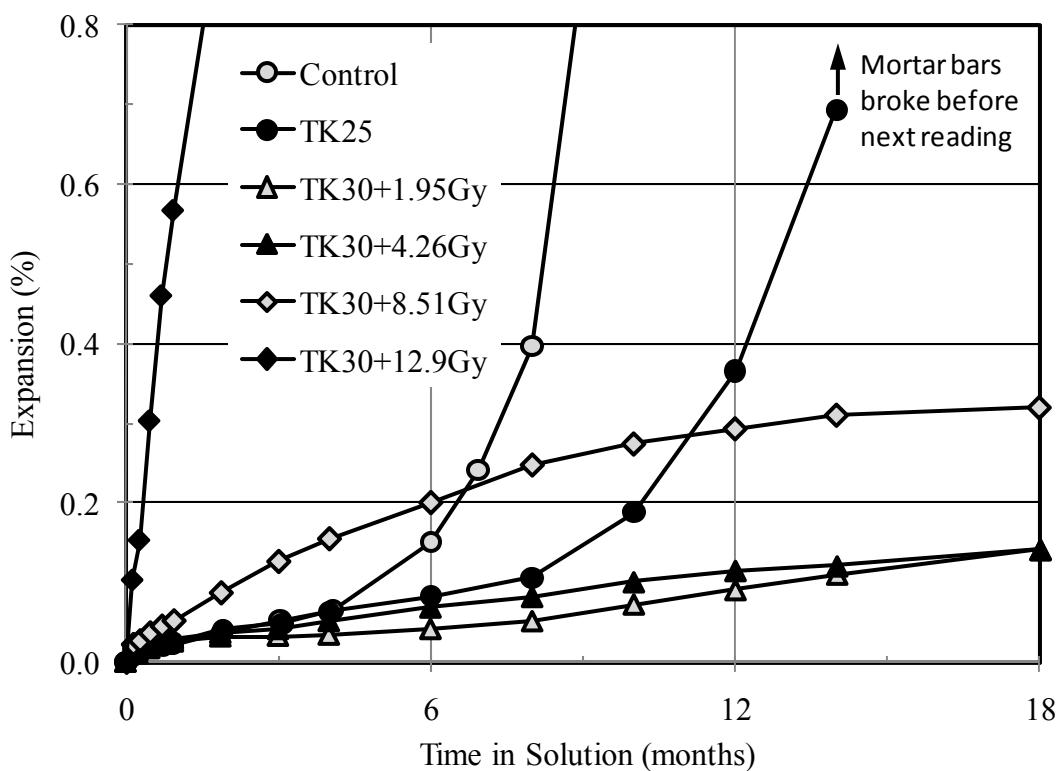
Figure 6.20: Expansion of Mortar Bars with TK Fly Ash and Added Gypsum (ASTM C 1012 – 5% Na_2SO_4 Solution)

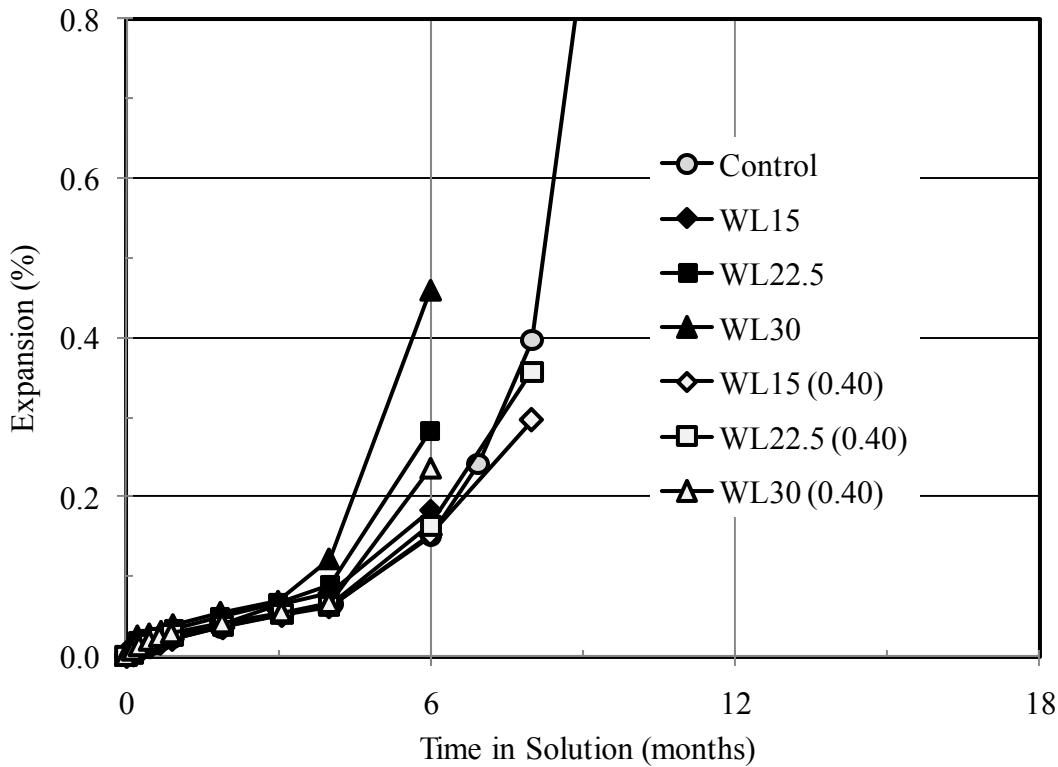
Figure 6.22: Effect of w/cm on the Expansion of Mortar Bars with WL Fly Ash (ASTM C 1012 – 5% Na_2SO_4 Solution)

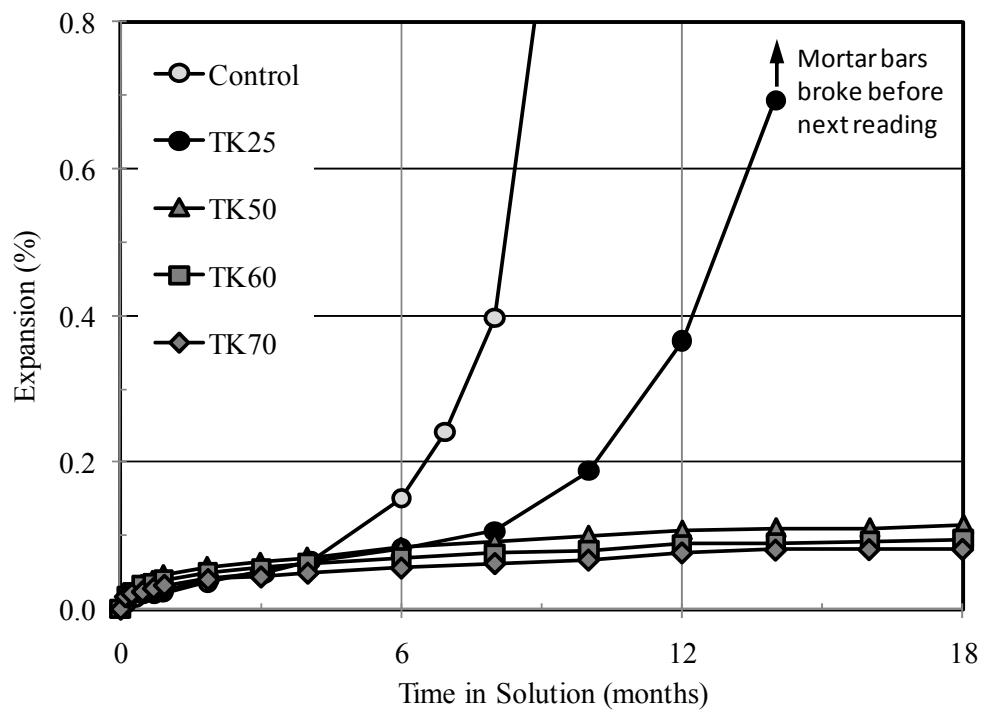
Figure 6.23: Expansion of HVFA Mortar Bars with TK Fly Ash (ASTM C 1012 – 5% Na₂SO₄ Solution)

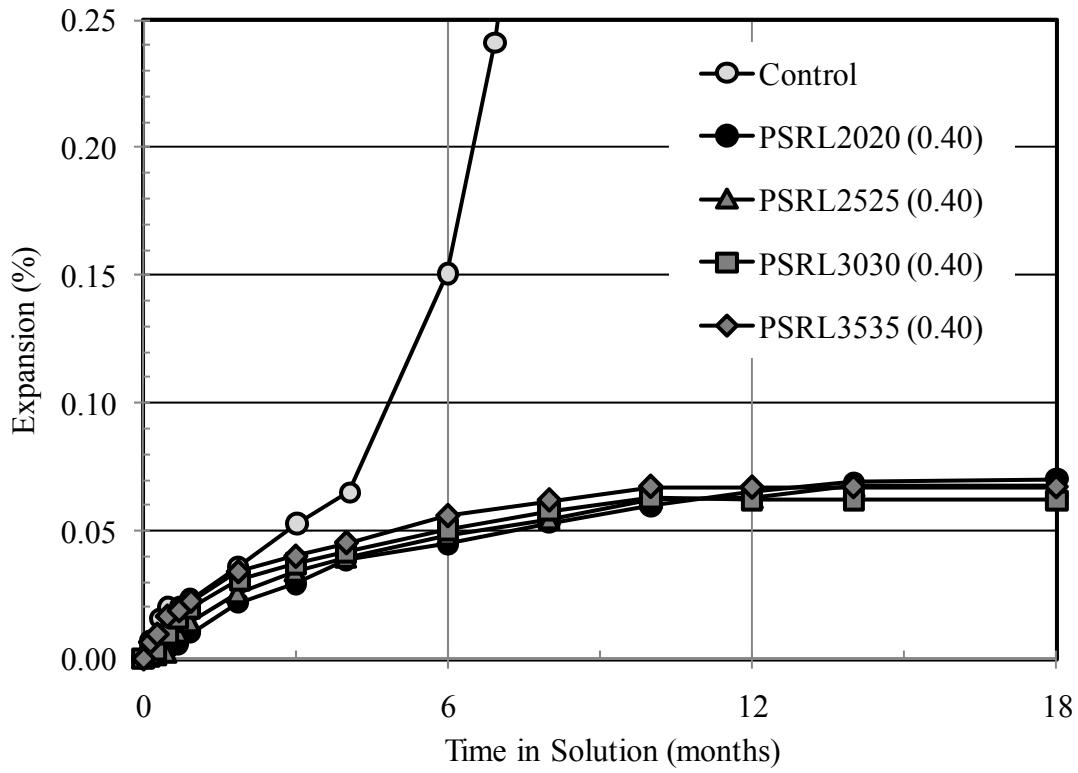
Figure 6.27: Expansion of HVFA Mortar Bars with Blends of PS and RL Fly Ash and Reduced $w/cm = 0.40$ (ASTM C 1012 – 5% Na_2SO_4 Solution)

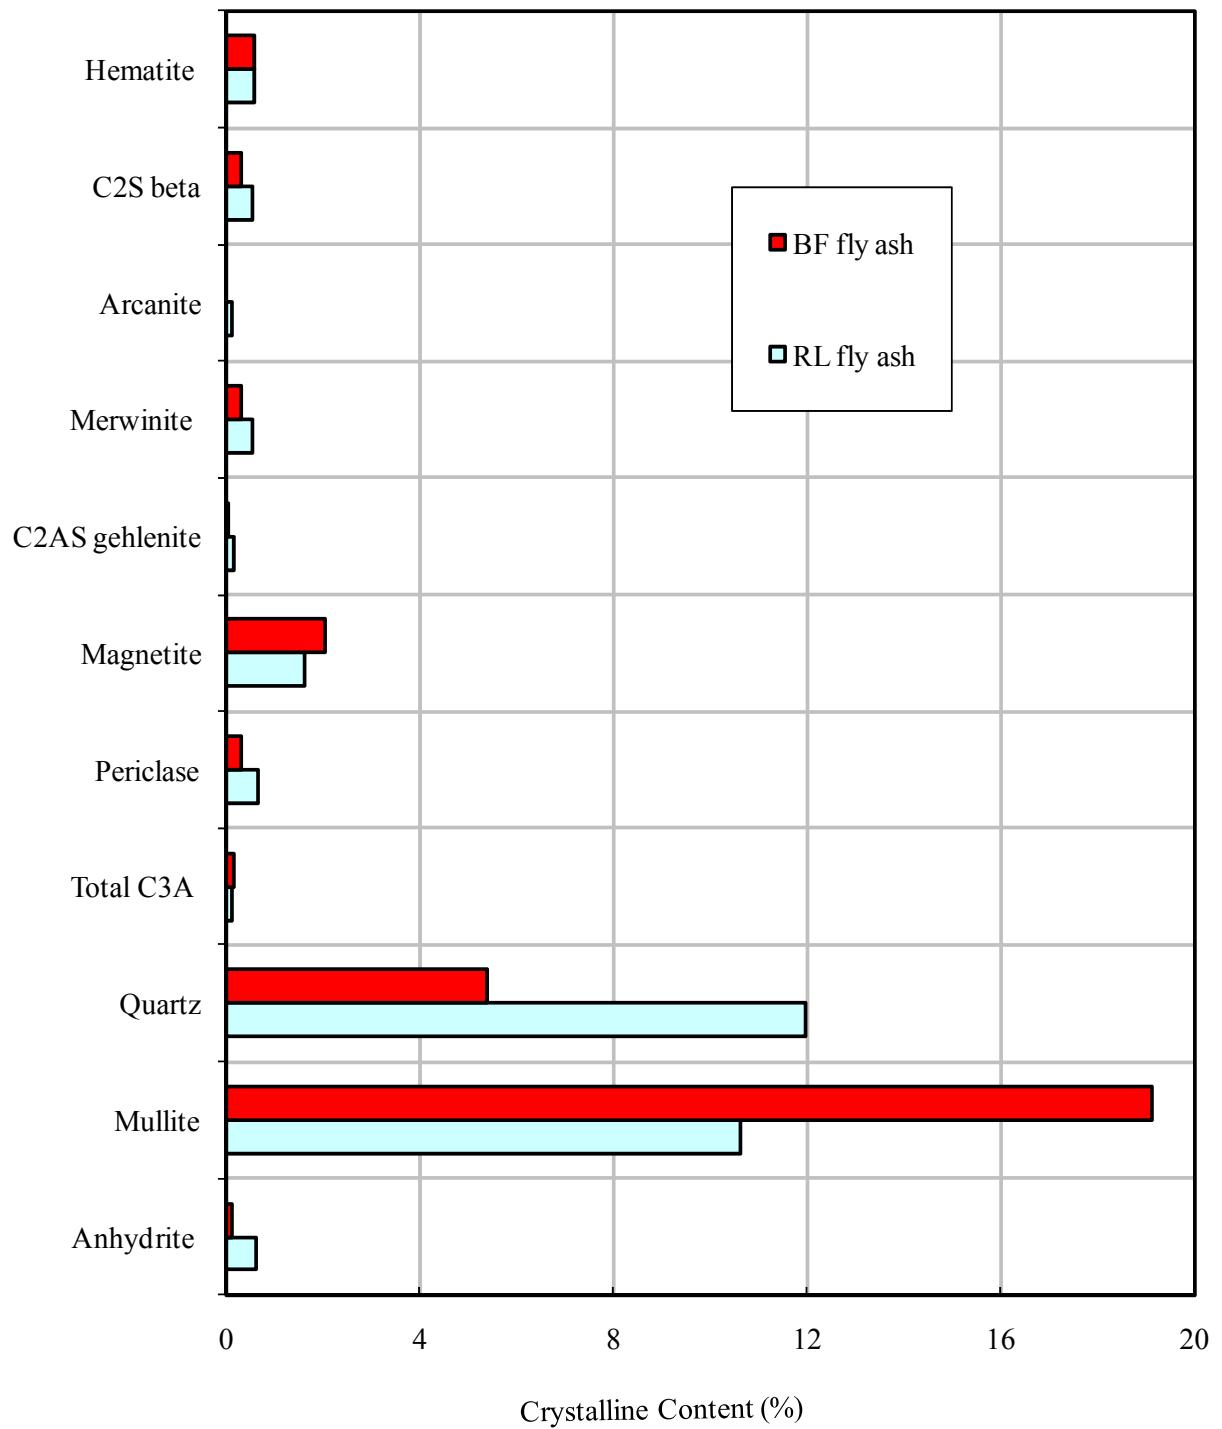
Figure 6.28: Crystalline Composition of Class F Fly Ashes Determined by XRD Rietveld Method

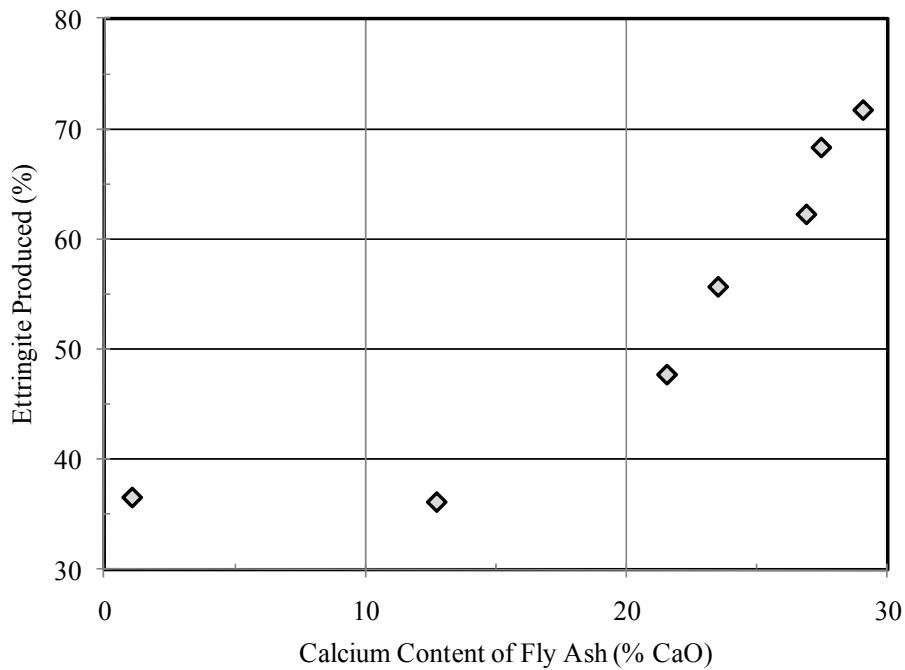
Figure 6.35: Relationship between the CaO Content of Fly Ash and the Quantity of Ettringite produced in Lime-Fly Ash Pastes exposed to 5% Na₂SO₄

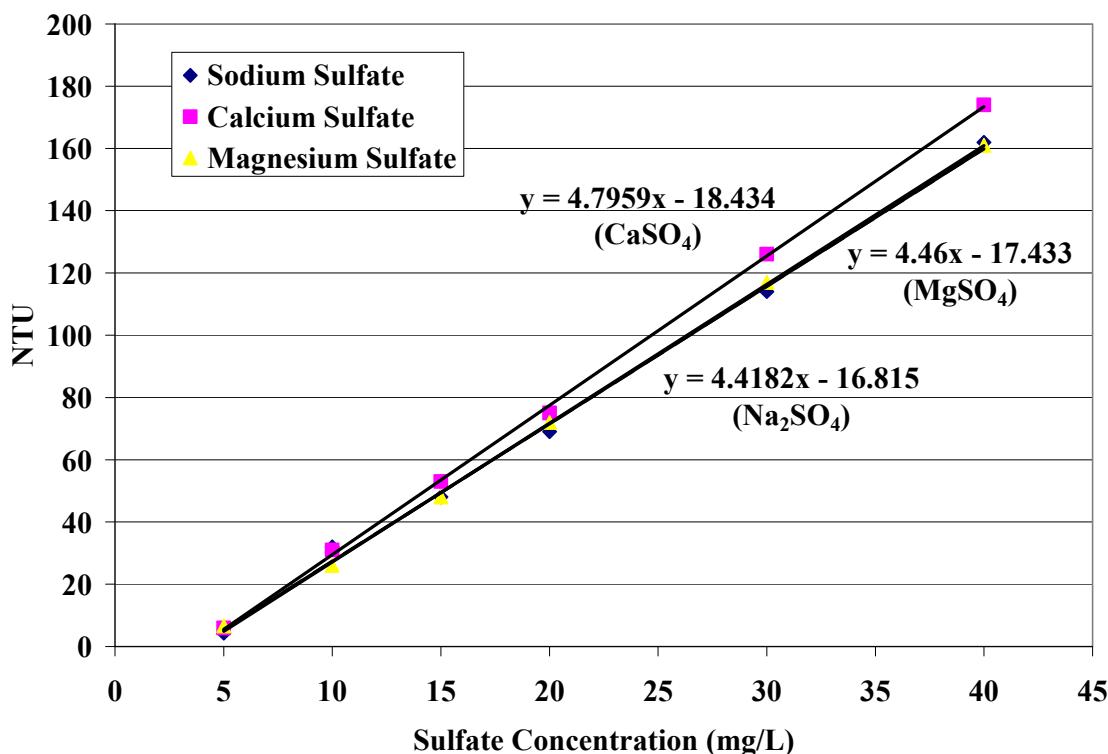
Figure 7.2: Calibration curve for sulfate using the turbidimeter

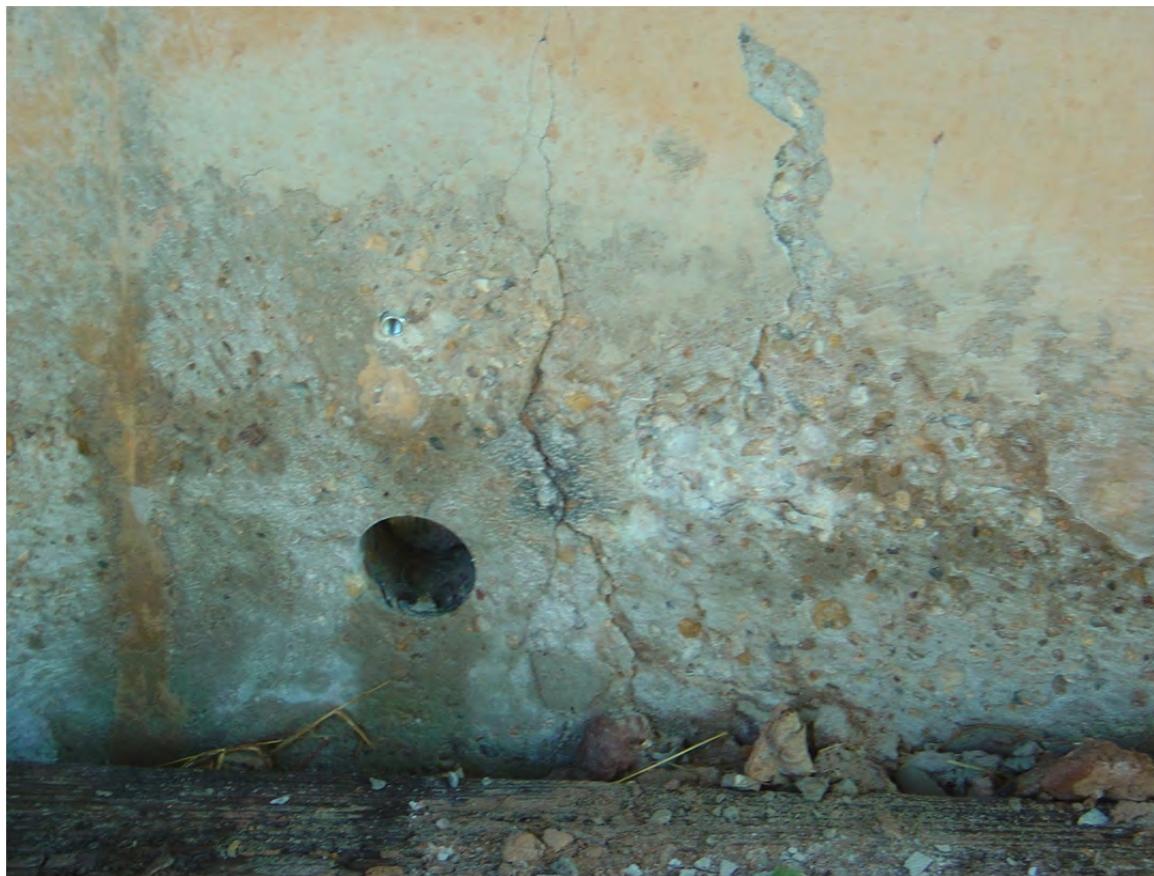
Figure 7.3: Damage to the lower part of a wall below US 83 in Childress District

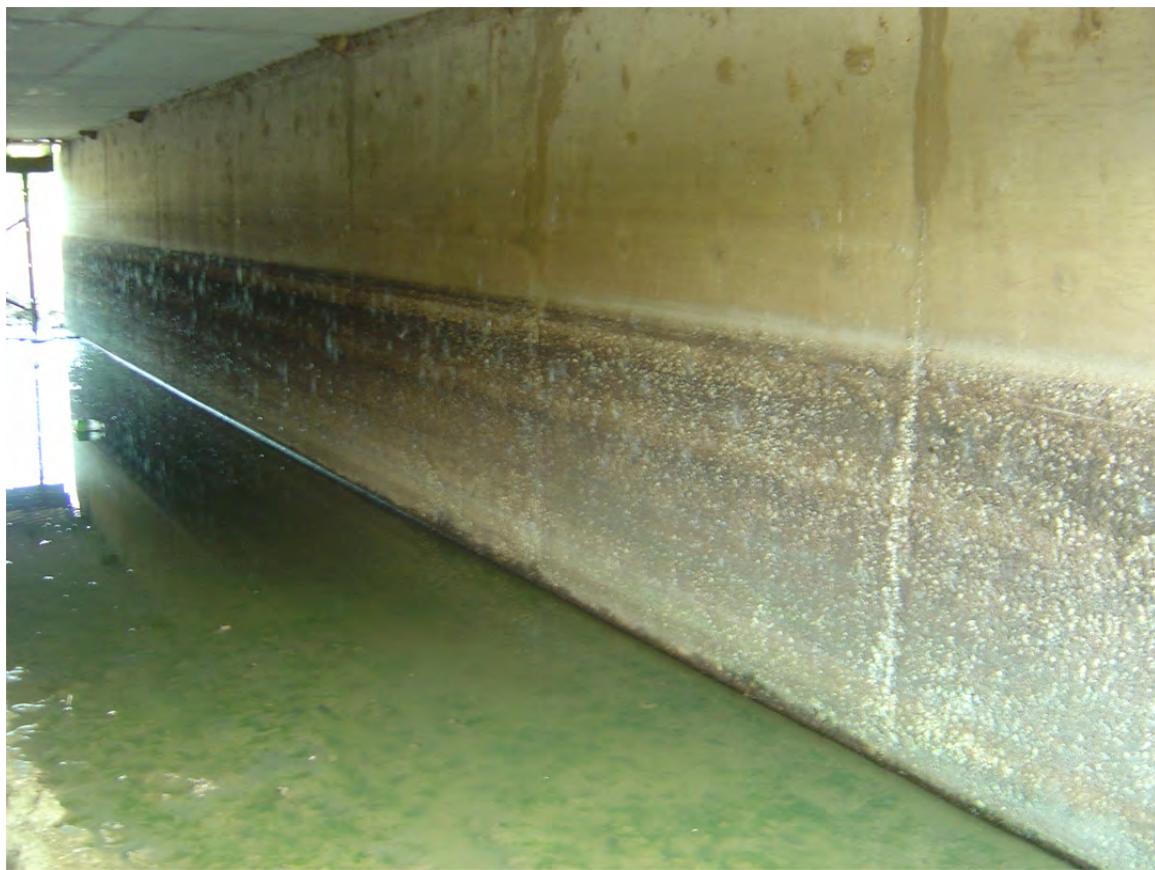
Figure 7.5: Deterioration commonly found in culverts in the Paris District. The distress begins near the base of the culvert and continues up the side, likely in line with the highest level of water.

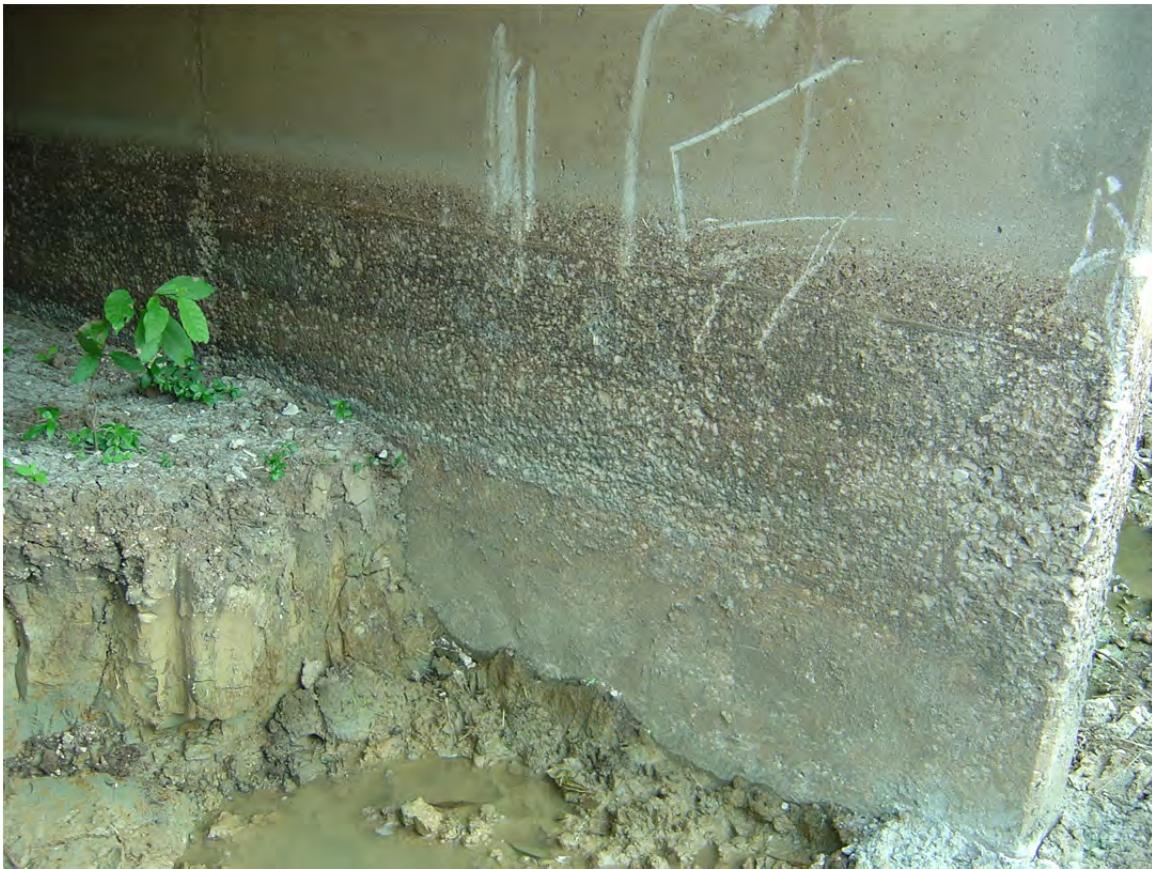
Figure 7.6: Deterioration of a culvert above the soil level, with no deterioration visible below the level of the soil (after excavation)

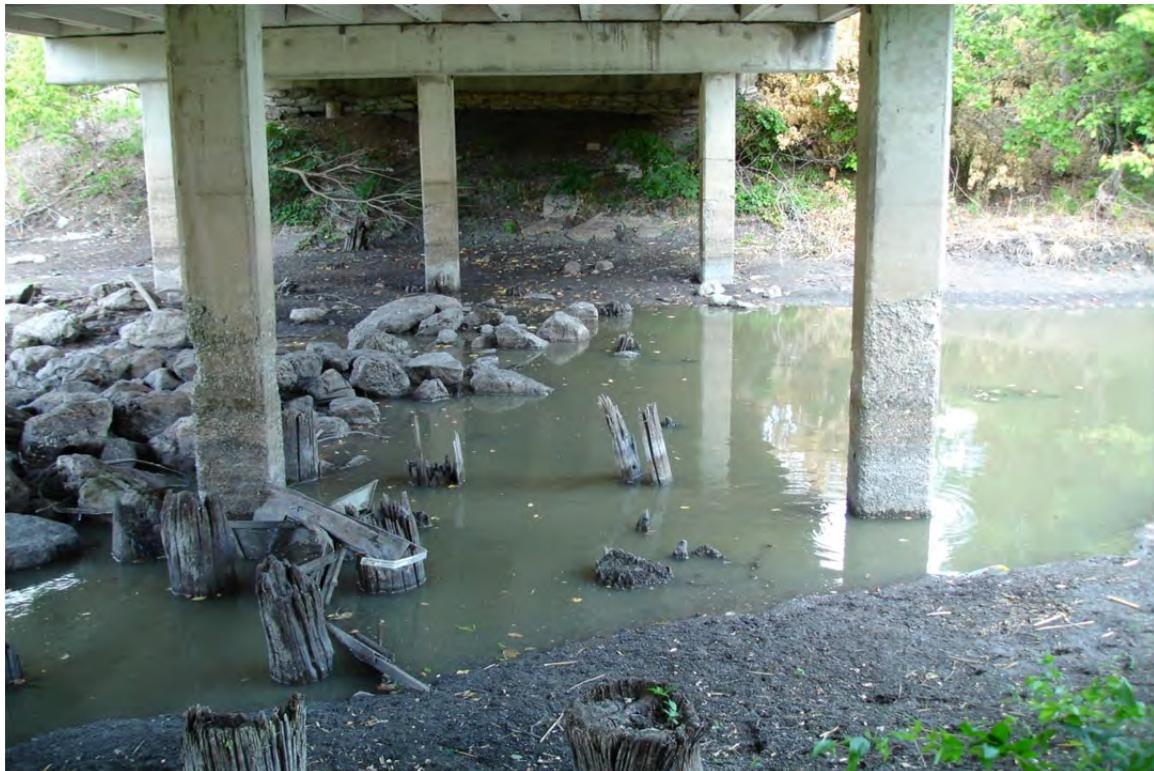
Figure 7.7: Deteriorated concrete columns from a bridge in the Paris District

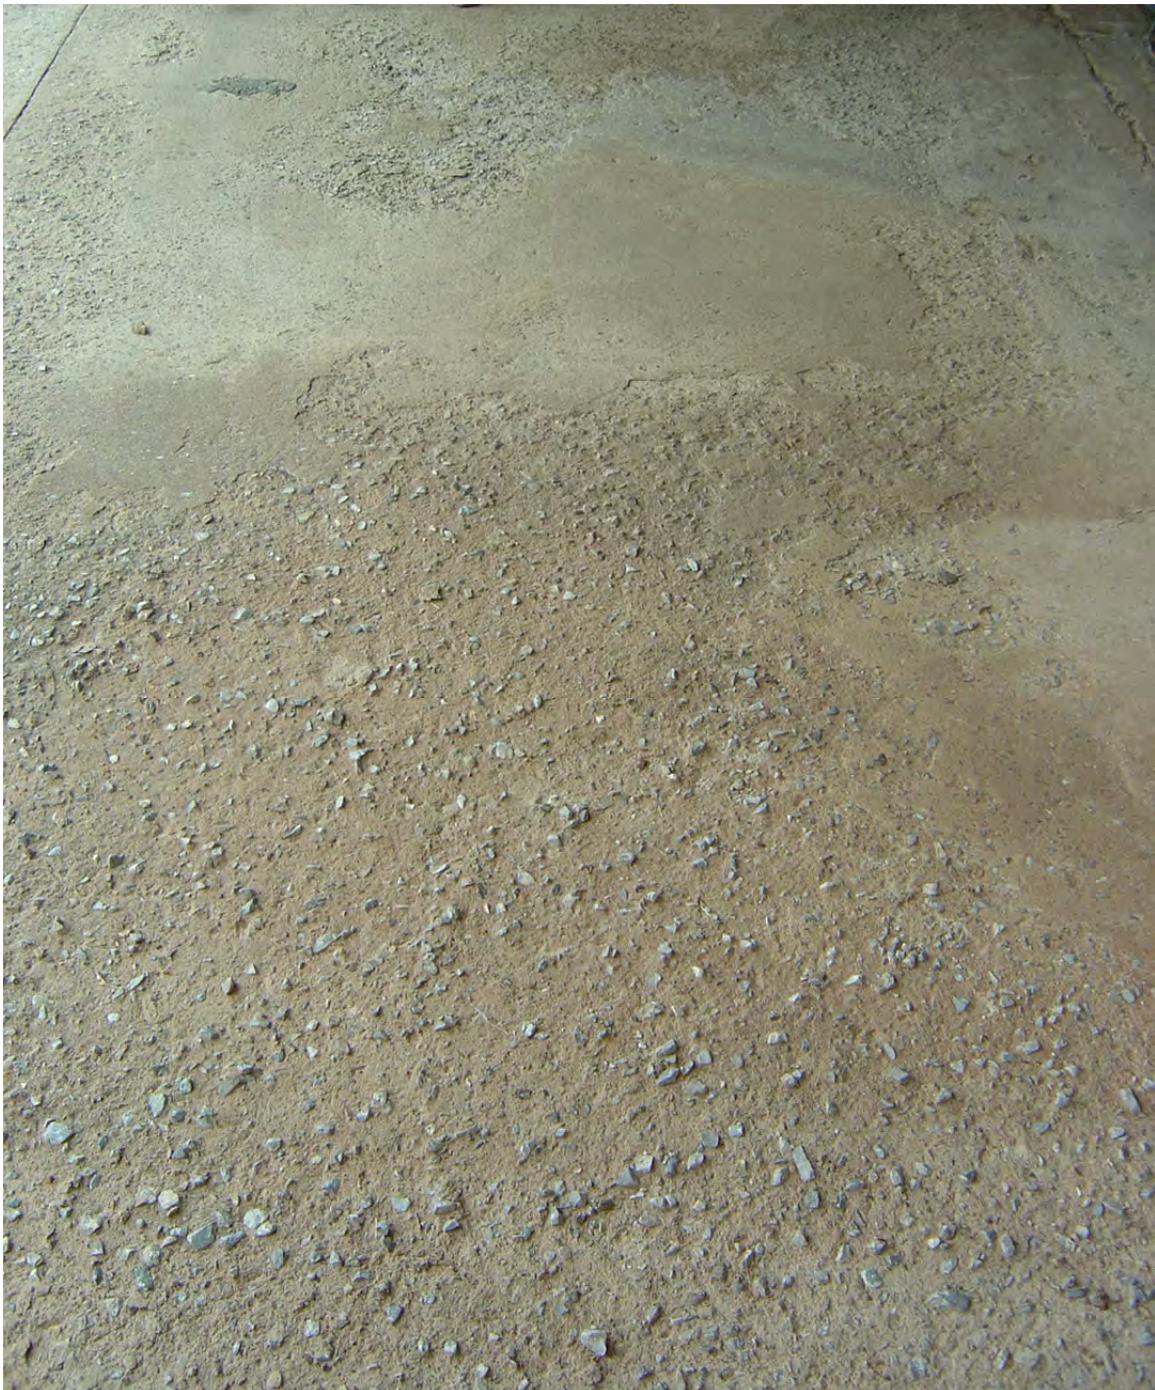
Figure 7.8: Riprap deterioration occurring on the embankment below a bridge

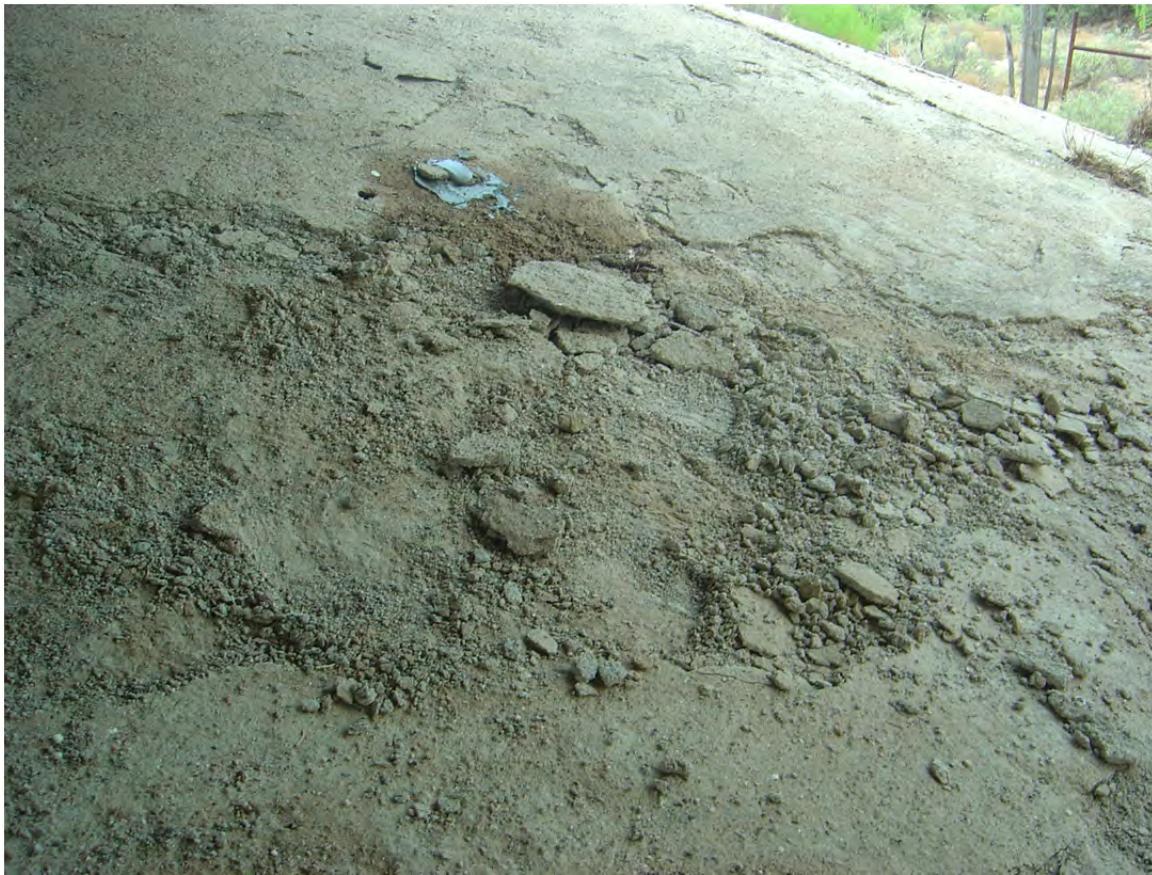
Figure 7.9: Riprap deterioration at Site 31 in the El Paso District

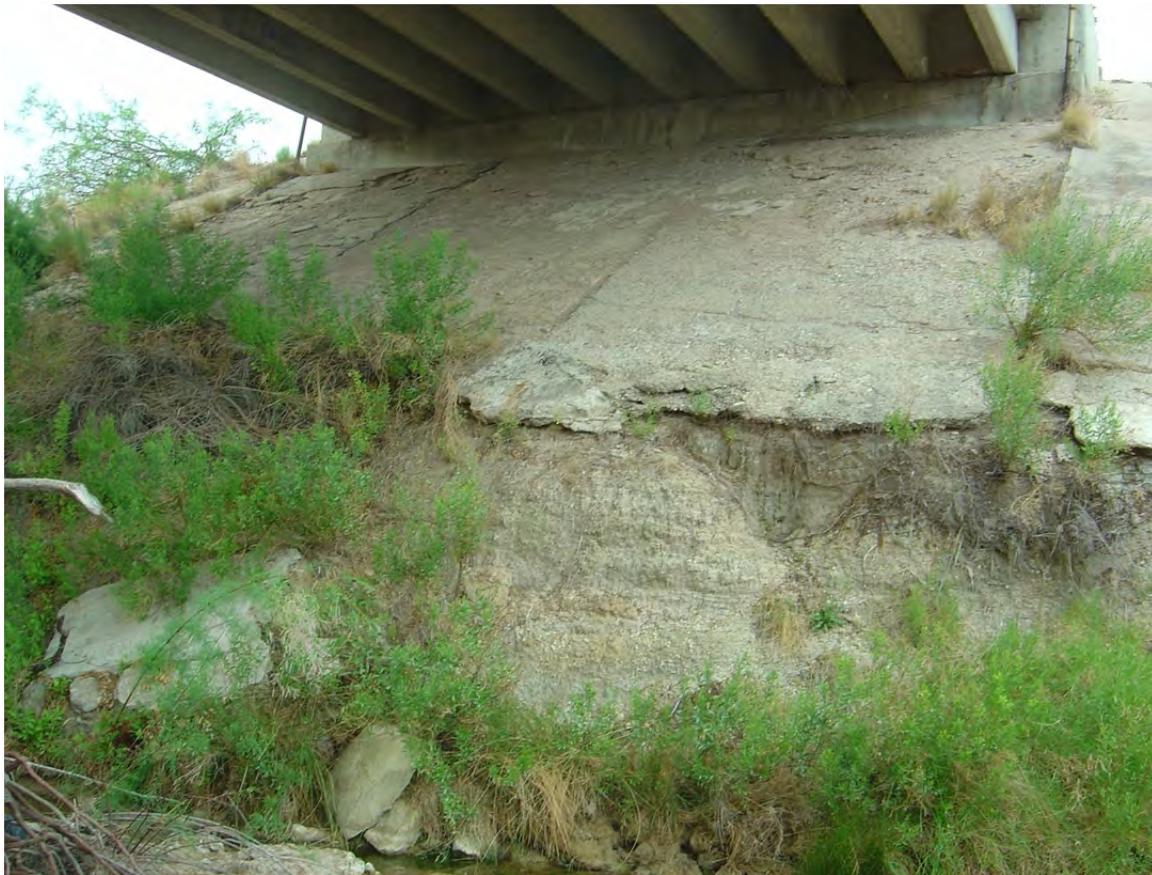
Figure 7.10: Deteriorated Riprap at Site 32 located on FM 652 in the El Paso District

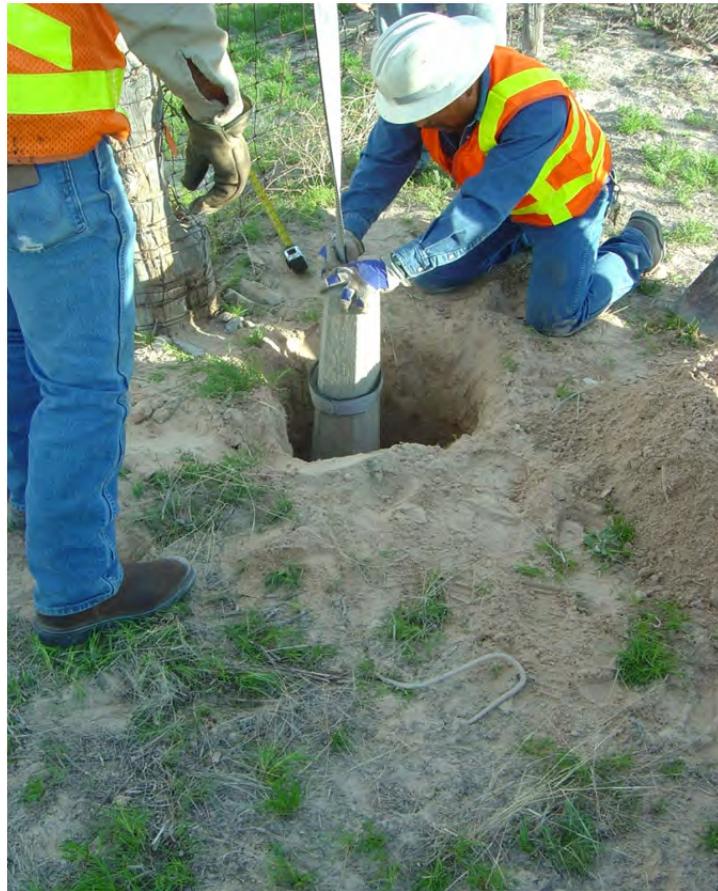
Figure 7.13: Placement of new ROW marker in the existing location of the deteriorated ROW marker

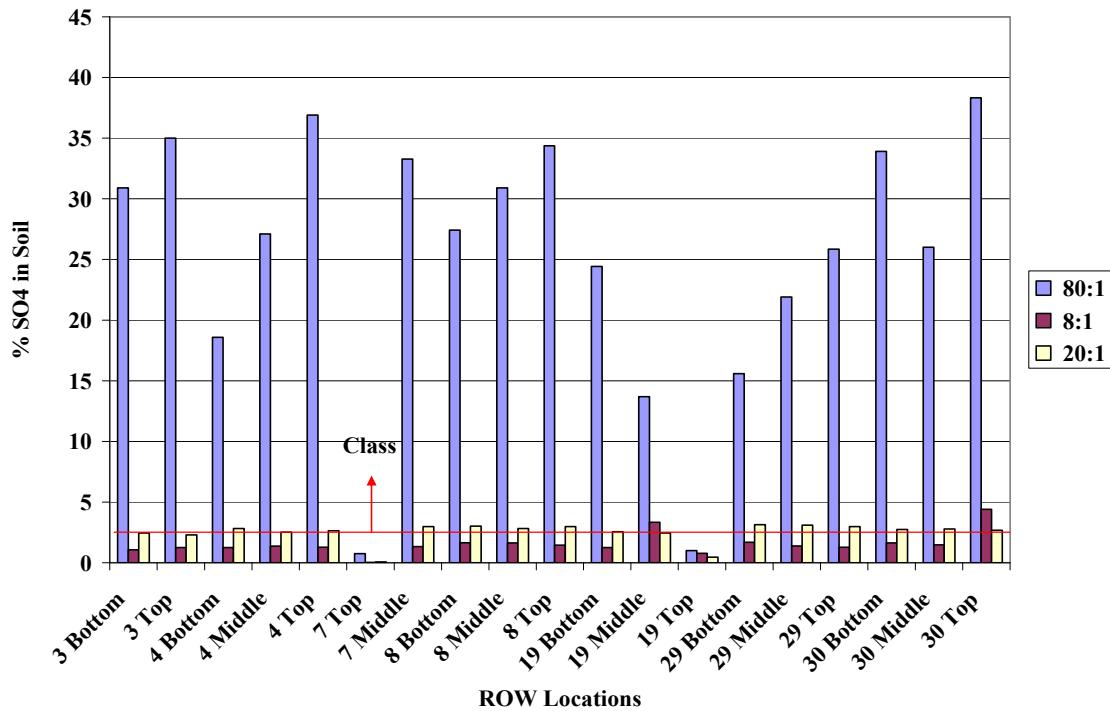
Figure 7.14: The sulfate content of soils taken from each of the ROW locations using ASTM C 1580 and TEX-135-E Test Methods

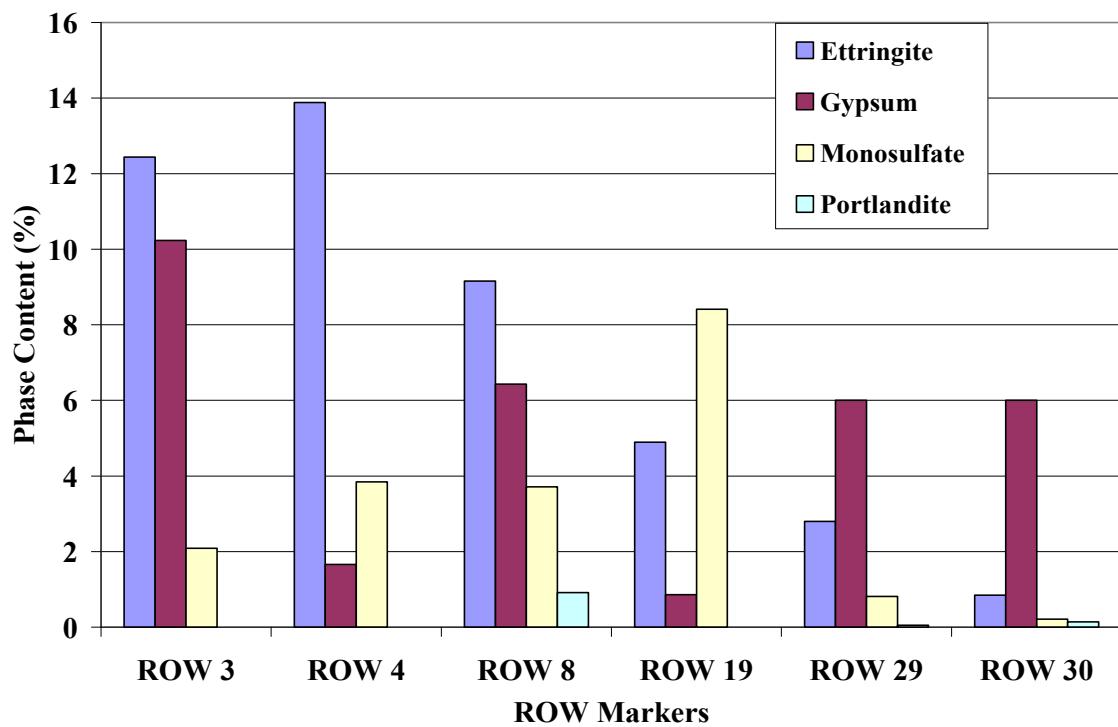
Figure 7.15: Rietveld Analyses from ROW markers in the El Paso District

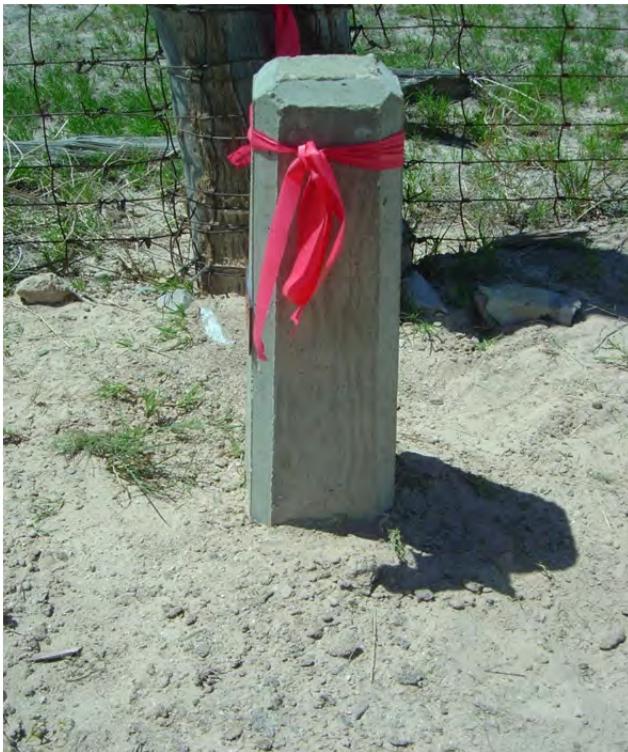
Figure 7.16: New ROW marker with Class C fly ash at 0.4 w/cm after 3 months of exposure in gypsiferous soils
