Evaluation of MEPDG with TxDOT Rigid Pavement Database

CTR Technical Report:	0-5445-3
Report Date:	July 2009
Project:	0-5445
Project Title:	Project Level Performance Database for Rigid Pavements in Texas
Sponsoring Agency:	Texas Department of Transportation
Performing Agency:	Center for Transportation Research at The University of Texas at Austin

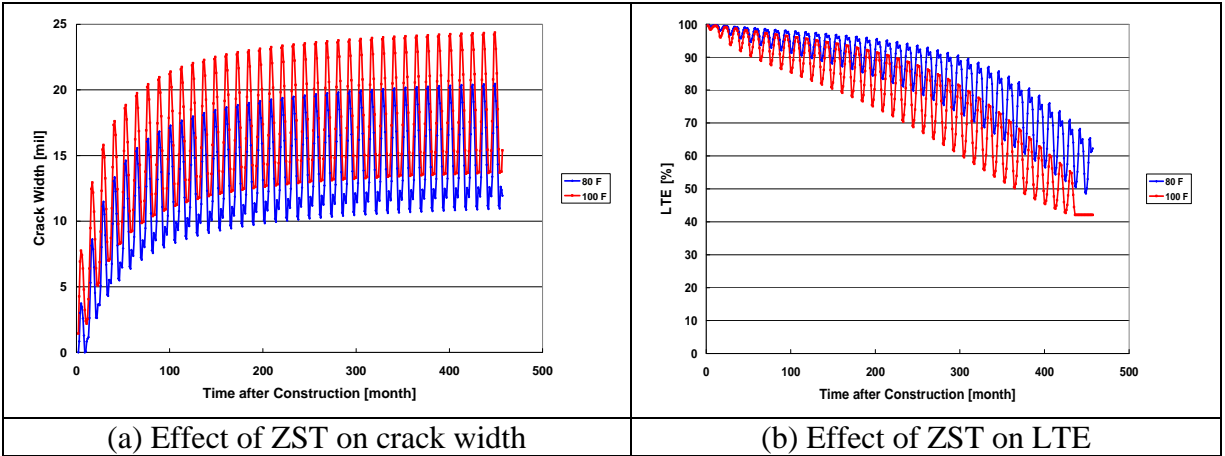
Figure 2.2: Effect of ZST on crack width and LTE

The mechanism discussed illustrates that the degradation of LTE, along with an increase in crack width and loss of support in the subbase, plays a major role in the punchout model. In this model, large crack width and loss of support are the causes of low LTE, which facilitates the development of punchout. Estimating loss of support is quite complicated, and until now, the loss of support has not been a direct pavement design input consideration, except for including its effect on the reduction of modulus of subgrade reaction. In the punchout model, however, loss of support is a direct consideration for punchout development as will be discussed later. In short, a fixed value of LTE considering loss of potential is assigned to each subbase type. Accordingly, for a subbase type considered in the pavement design, LTE becomes a function of crack width, with a minor effect exerted by longitudinal reinforcement. It is important to evaluate the correlation between crack width and LTE. Preliminary sensitivity analysis conducted on MEPDG by the research team indicated a strong correlation between zero-stress temperature and transverse crack width as shown in Figure 2.2-(a). The input values for all the MEPDG analyses presented in this chapter were obtained from the test section in the database project, Section 3US287-1 in the Wichita Falls District, except for the values noted. Figure 2.2-(a) compares predicted crack widths of the sections built in two different zero-stress temperatures (ZST); one is at 80 F and the other at 100 F. It is observed that crack width changes with time, and also fluctuates within a year following seasonal temperature variations. The section built at 100 F ZST has greater crack widths than those built at 80 F ZST. Figure 2.2-(b) shows the variations in LTE of the two sections. The section with 100 F ZST experiences more rapid decrease in LTE than the section with 80 F ZST. It follows that larger crack widths with 100 F ZST shown in Figure 2.2-(a) resulted in lower LTE compared with those at 80 F ZST.

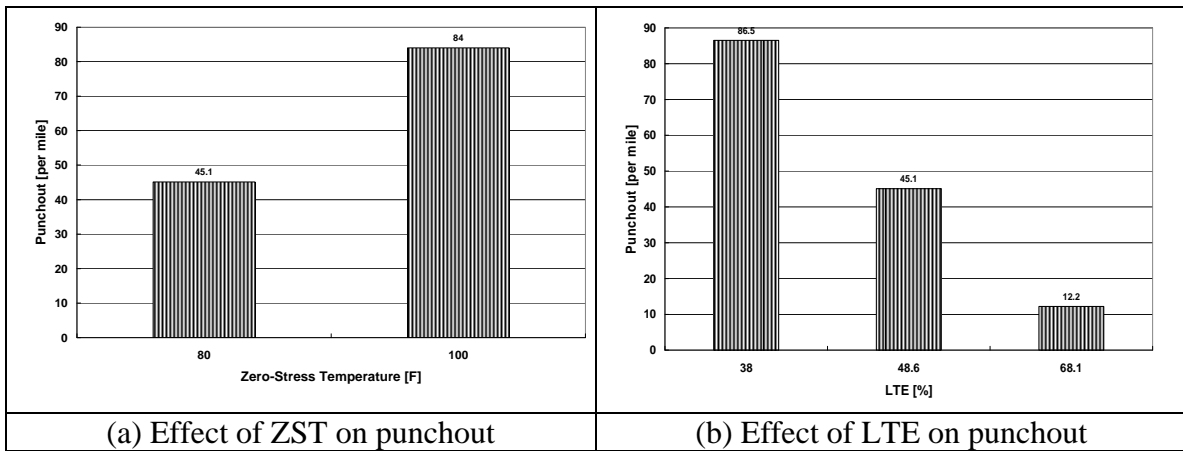
Figure 2.3: Effect of ZST and LTE on punchout

The effect of ZST on punchout is shown in Figure 2.3-(a). It is observed that the number of punchouts in the section constructed at 100 F ZST was almost double of the number of the section with 80 F ZST. Larger crack width and resulting lower LTE in the section built with 100 F ZST are responsible for this large increase in punchouts compared with the section built with 80 F ZST. This result indicates high sensitivity of the punchout predictions of MEPDG to ZST, which has significant implications in pavement design as will be discussed later in this chapter. To further investigate the effect of LTE on punchout, various LTE values were generated by using different longitudinal steel amounts. Quite strong correlation was obtained between LTE and number of punchouts as shown in Figure 2.3-(b). In this analysis, all the other variables were kept constant except for longitudinal reinforcement, which varied from 0.5% to 0.6% and 0.7%. A larger amount of reinforcement resulted in decreased crack spacing and smaller crack width, with larger LTE and fewer punchouts. Because a number of variables are involved in CRCP structural behavior and punchout development, and their relationship is quite complicated, it was decided that an expanded sensitivity analysis of the punchout development model would be beneficial in understanding how much sensitivity each variable has on punchout. The results of the sensitivity analyses are discussed next.

As shown in Figure 2.3, a strong correlation appears to exist between LTE and punchouts. Considering the punchout mechanism in MEPDG, it's not surprising that LTE has such a substantial effect on punchouts, which necessitates the need for accurate evaluation of LTE in the field for the calibration of the punchout model. In the database research study, however, it was discovered that there is a serious discrepancy between LTE values predicted by MEPDG and measured values. LTE values evaluated in the field were maintained at quite high levels in all test sections—above 95% except for one crack in the winter—regardless of pavement age (from 4 to 38 years), slab thickness (from 8 to 15 inches), crack spacing (small, medium, and large) and the season (summer and winter). On the other hand, LTE values predicted by MEPDG as shown in Figure 2.2-(b) are decreasing rather constantly, leading to quite a low value just after 20 years.

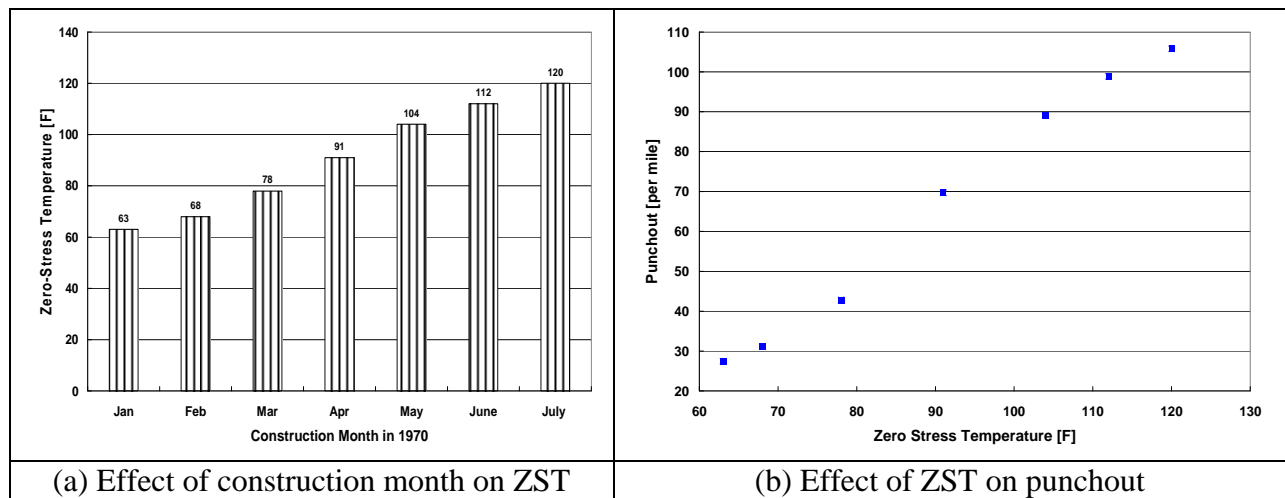
Figure 2.4: ZST effects

Figure 2.4-(a) shows the effect of construction month on zero stress temperatures. The ZST values in this figure are computed within MEPDG for months from January through July 1970, for the Wichita Falls environment. The ZST of the concrete placed in January 1970 was estimated at 63 F, while the value was 120 F for concrete placed in July 1970. This information clearly indicates the effect on ZST of the concrete placement season. Figure 2.4-(b) illustrates the effect of ZST on punchouts. The ZST values in the x-axis are those from January (the lowest) to July (the highest) placed concretes. This indicates substantial effects of ZST on punchouts. The effect of ZST on punchout is also substantial, even though subsequent environmental conditions after concrete placements at different months will be different and have some effect on structural responses of CRCP. ZST almost doubled from January placement to July placement and resulting punchout almost quadrupled.

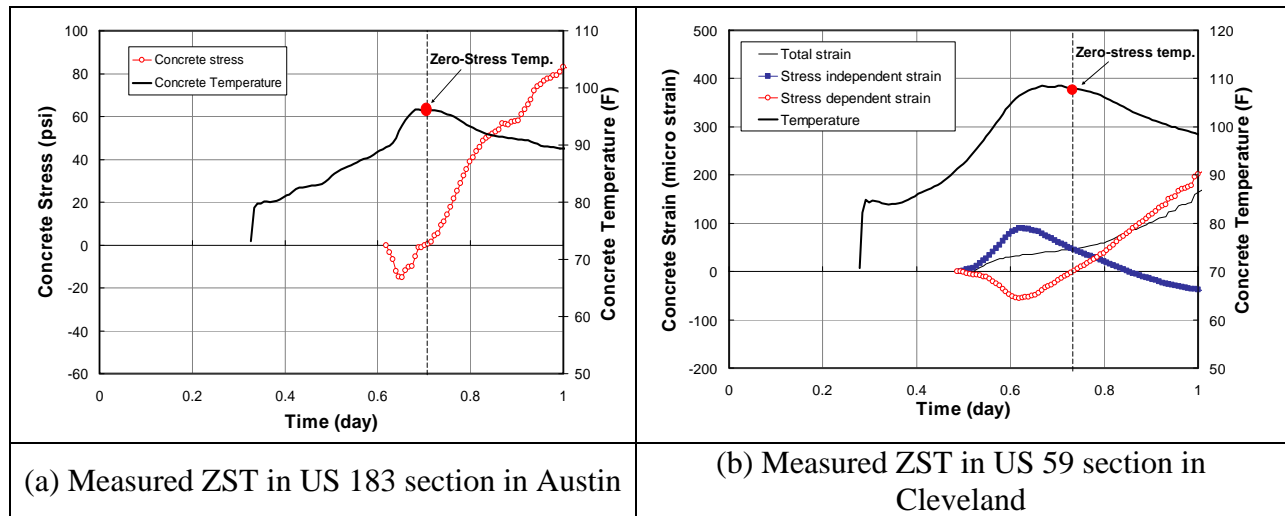
Figure 2.5: Measured ZST

Equation (2.1) shows that the mean monthly temperature for month of construction has a direct effect on ZST. The term H increases until MMT reaches 117 F. Because mean monthly temperature in Texas does not exceed 117 F, equation (2.1) implies ZST is almost proportional to mean monthly temperature. It appears that the way ZST is estimated in MEPDG is overly simplified. Actual ZST was measured under TxDOT 0-1700 research study. Figures 2.5-(a) and 2.5-(b) show actually measured ZST in Austin and Cleveland sections, respectively. In these experiments, concrete total strains were measured, along with stress-independent strains (temperature and moisture-induced strains). The stress-independent strains were subtracted from the total strains to obtain stress-dependent strains. The results show that ZST is quite close to the maximum concrete temperature during hydration. This finding corroborates the findings from Springenschmid and Breitenbucher (1995) (3). They suggested that average zero-stress temperature is about 95.5% of the concrete maximum temperature.

The preceding discussion indicates that, for all practical purposes, the maximum concrete temperature due to heat of hydration after concrete placement can be assumed as ZST. Field measurements of concrete setting temperature and ZST obtained in TxDOT research project 0-1700 indicate a large variability within a single day. Figure 2.6 shows concrete temperature

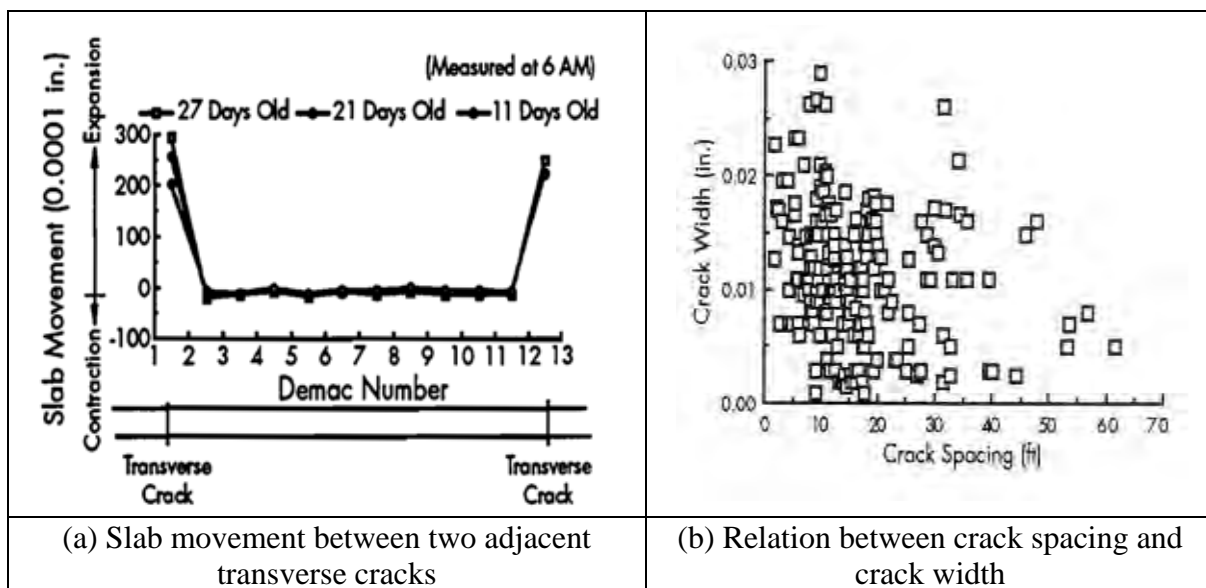
Figure 2.8: Crack data

This finding explains what has been observed in TxDOT research study 0-1244 (4). In that study, DEMEC gages were installed continuously for over 10 ft in a longitudinal direction. When two cracks developed within this area, the movements of concrete were measured between DEMEC gages.

Figure 2.8-(a) shows that the slab movement is confined near the transverse crack area, which confirms the findings shown in Figure 2.7-(b). In other words, as long as crack spacing is larger than 2 ft, the effect of crack spacing on crack width will be negligible. This could explain a poor correlation between crack spacing and crack width as shown in Figure 2.8-(b). Recall that the equation (2.2) implies approximate linear relation between crack spacing and crack width, while Figure 2.8-(b) shows otherwise.

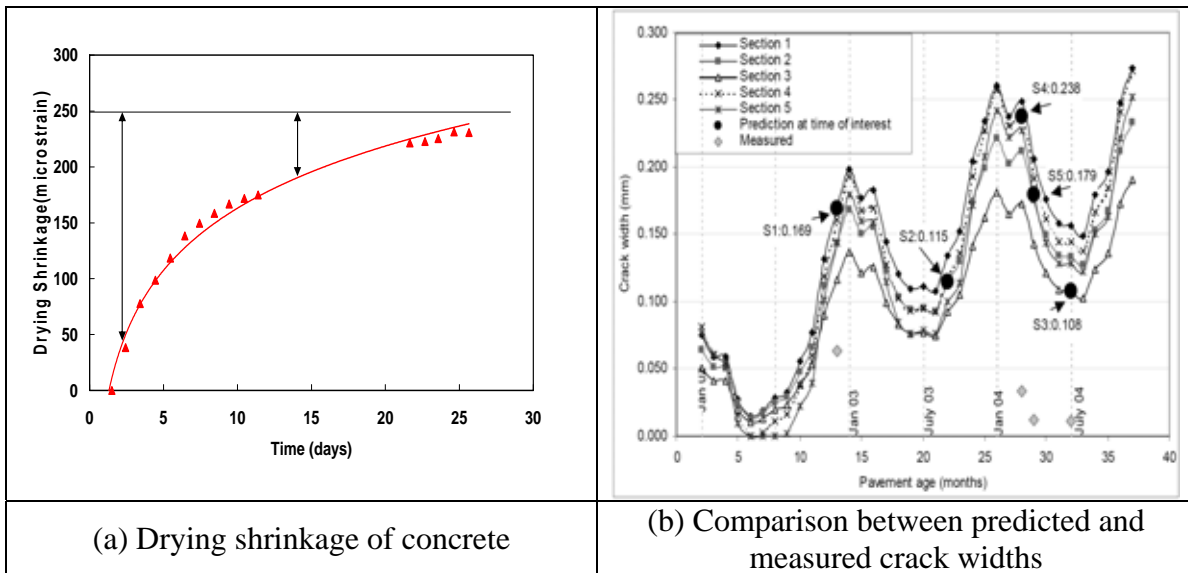
Figure 2.9: Shrinkage and crack widths

The second discussion item on equation (2.2) is the way the drying shrinkage effect is incorporated. In equation (2.2), the accumulated drying shrinkage value from the concrete setting is used. In other words, equation (2.2) assumes that all the cracks occur right after setting, and no more cracks will develop in CRCP, which is not the case. Depending on the environmental condition and the effectiveness of curing operations, some cracks could form quite late. To illustrate the effect of the timing of crack development on crack width, assume that cracks form at early ages. Then, subsequent drying shrinkage will make the crack widths larger compared with cracks that form much later, when drying shrinkage is almost complete. Figure 2.9-(a) shows the actual drying shrinkage measured in the field (5). For a crack that occurred at 2 days after concrete placement, there will be additional 200 micro-strains of drying shrinkage at 30 days. On the other hand, if a crack occurred at 14 days after concrete placement, additional drying shrinkage at 30 days will be about 70 micro-strains, and the drying shrinkage up to the 14th day (in this case, about 180 micro-strains) was absorbed by the creep of concrete. The resulting width of the crack that occurred at 14 days will be smaller compared with the width of crack that occurred at 2 days, if the crack spacing is comparable. As discussed earlier, equation (2.2) implies an approximate linear relationship between crack spacing and crack width; however, field-measured values show otherwise, as shown in Figure 2.9-(b). This discrepancy could be a result of not including the time of crack-forming effect of drying shrinkage in the equation (2.2). Because equation (2.2) uses drying shrinkage value from the setting of the concrete, it over-predicts actual crack widths as explained above.

A research study at by Kohler et al. at the University of Illinois (6) compared crack widths predicted by MEPDG with actual measurements. Figure 2.9-(b) illustrates the comparison. It shows a large discrepancy between actual measurements and predicted values, as much as more than 10 times. The over-prediction of crack width by MEPDG could be due to the combined effects of two factors explained earlier.

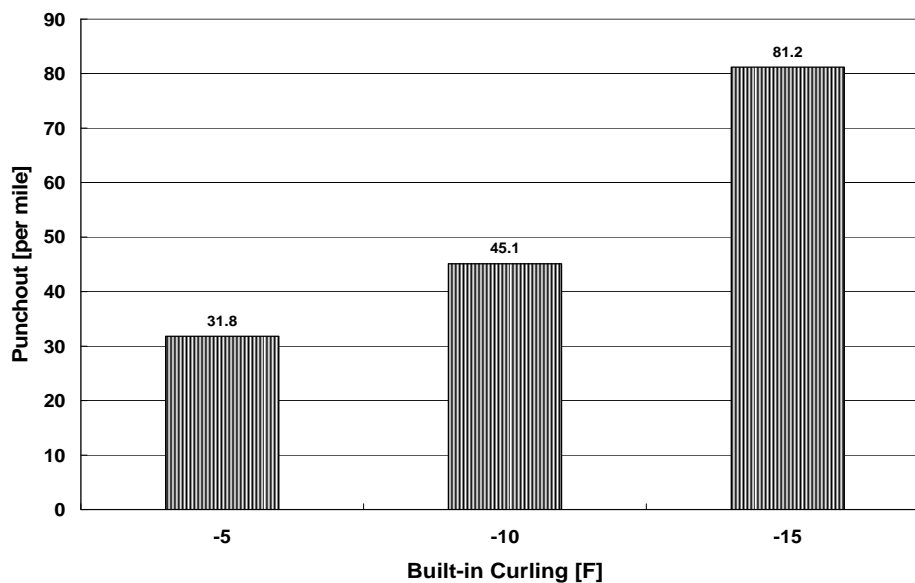
Figure 2.10: Effect of built-in curling on punchouts

When plastic concrete sets, the concrete temperature distribution through the slab depth is not uniform. There will be temperature gradient at setting and subsequent stress development will be based on the temperature variations from the temperature gradient at setting. This temperature gradient is defined as built-in curling (BIC). BIC is different from ZST distribution through the slab depth, because there are differences between setting temperatures and ZST. The introduction of zero-stress temperatures and built-in curling to CRCP research is rather recent, and no published data from actual CRCP is available. As discussed earlier, efforts are currently under way in TxDOT research study 0-5832 to measure zero stress temperatures and built-in curling in CRCP projects. In MEPDG, BIC is set at -10 F, which is the value derived from curling measurements in LTPP database. As in ZST, Figure 2.10 illustrates the effect of BIC on punchouts, which shows that BIC's effect on punchout is not small.

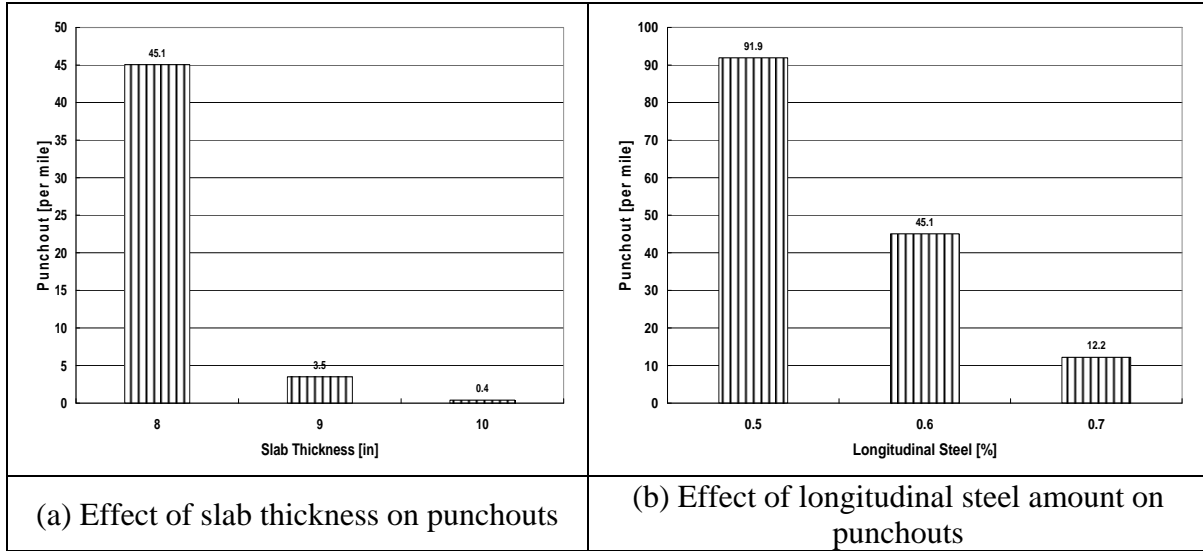
Figure 2.11: Effects on punchouts

punchouts. The effect of slab thickness is quite substantial, potentially even more than observed in the field. The effect of longitudinal steel is not as significant as slab thickness is. Increasing longitudinal steel amount from 0.6% to 0.7% reduces punchout from 91.9 to 45.1 per mile.

The marked effect of slab thickness on punchout in MEPDG is explained by the direct and substantial effect of slab thickness on LTE. On the other hand, the longitudinal steel amount does not have as much effect as thickness has on LTE. This difference is due to the fact that the contribution of longitudinal steel to LTE and crack stiffness is not direct, as slab thickness is. Longitudinal steel has indirect effect on LTE through its effect on crack width control. LTE estimation in MEPDG is through transverse crack stiffness, which is estimated by equation (2.3):

The equation (2.4) indicates that slab thickness is a direct input for shear capacity loss estimation, while longitudinal steel is not a direct input; rather, its effect is included through crack widths. Whether slab thickness has such a substantial effect on punchout, as shown in Figure 2.11-(a) needs to be verified.

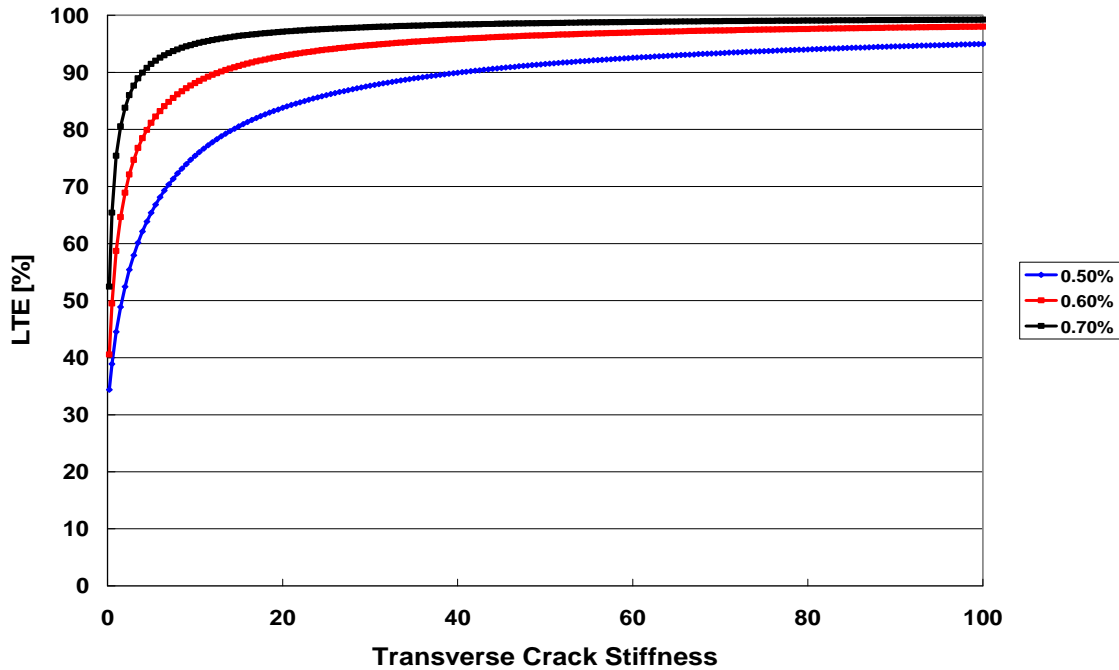
Figure 2.13: Effect of transverse crack stiffness on LTE

LTE_{Base} is 20% for aggregate base, 30% for asphalt or cement treated subbase, and 40% for lean concrete subbase. In Equation (2.5), radius of loaded area, radius of relative stiffness, and load transfer efficiency contributed by the base layer remain almost constant throughout the analysis period. Therefore, the only variable responsible for the deterioration of LTE over time in this equation is the changes in transverse crack stiffness. Figure 2.13 illustrates the variations in LTE for a wide range of transverse crack stiffness values. It shows relatively little effect of crack stiffness on LTE when it is larger than 20. On the other hand, once transverse crack stiffness is reduced below 20, LTE decreases rather quickly, and this could explain rather rapid increase in the frequency of punchout in MEPDG results as CRCP reaches its terminal condition. This implies that once transverse crack stiffness has deteriorated, longitudinal steel does not provide adequate LTE. This could be possible only if longitudinal steel is ruptured or the concrete around longitudinal steel at transverse cracks is much deteriorated. In Texas, neither longitudinal steel rupture nor concrete deterioration around longitudinal steel at cracks was observed often. As a matter of fact, it's extremely rare to see either situation. Even when either condition is observed, it's quite localized and often due to locally deficient subbase support condition. It wouldn't be prudent to develop pavement designs to address isolated issues related to construction quality that is not likely to happen often. Otherwise, the pavement design will be more conservative than is needed. As long as longitudinal steel is not ruptured, LTE would be maintained at quite a high level.

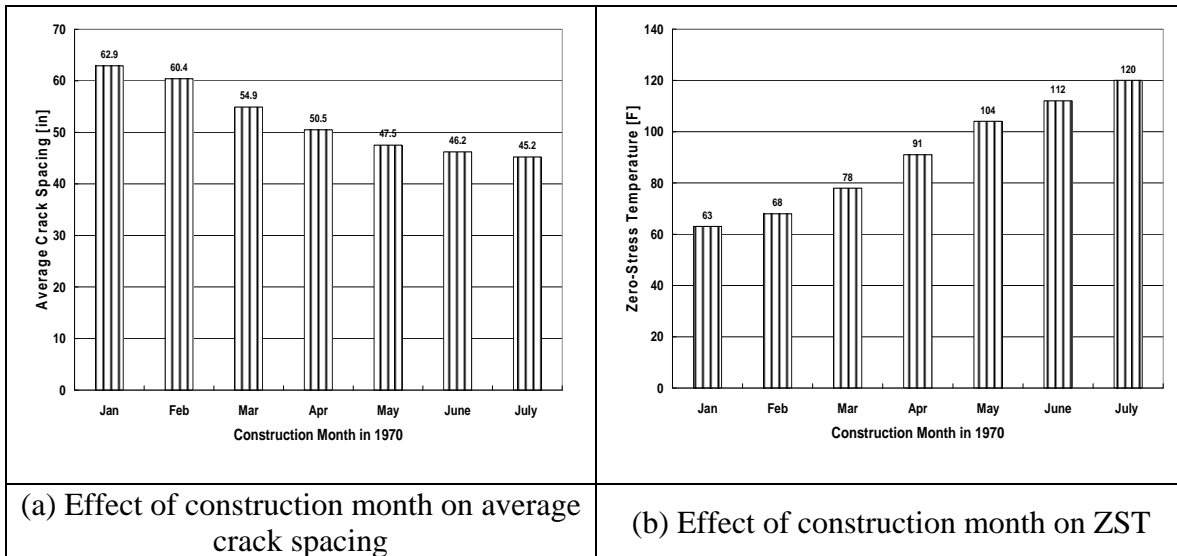
Figure 3.2: Effect of construction month

(3) climate, and (4) pavement structures. The information needed for the first category is not used in the actual pavement analysis, except for the construction and “open to traffic” months. The best information available for the construction of this section is September, 1970. This date could quite possibly be the month the project was accepted by TxDOT, and the actual construction could have been a few months prior to the acceptance. Because the construction month has substantial effect on ZST and punchout, as shown in the sensitivity analysis described in Chapter 2, it was necessary to determine the most probable construction month. With the information on construction month not available, attempts were made to estimate the construction month by comparing actual crack spacing with the predictions from MEPDG. Figure 3.2-(a) shows the average crack spacing predicted by MEPDG for different months of construction. The actual average crack spacing is 56.4 inches, and it is assumed that this section was constructed in March 1970. Figure 3.2-(b) shows zero stress temperatures of the section predicted from MEPDG if it had been constructed in different months. The ZST for March 1970 construction in Wichita Falls was estimated at 78 F.

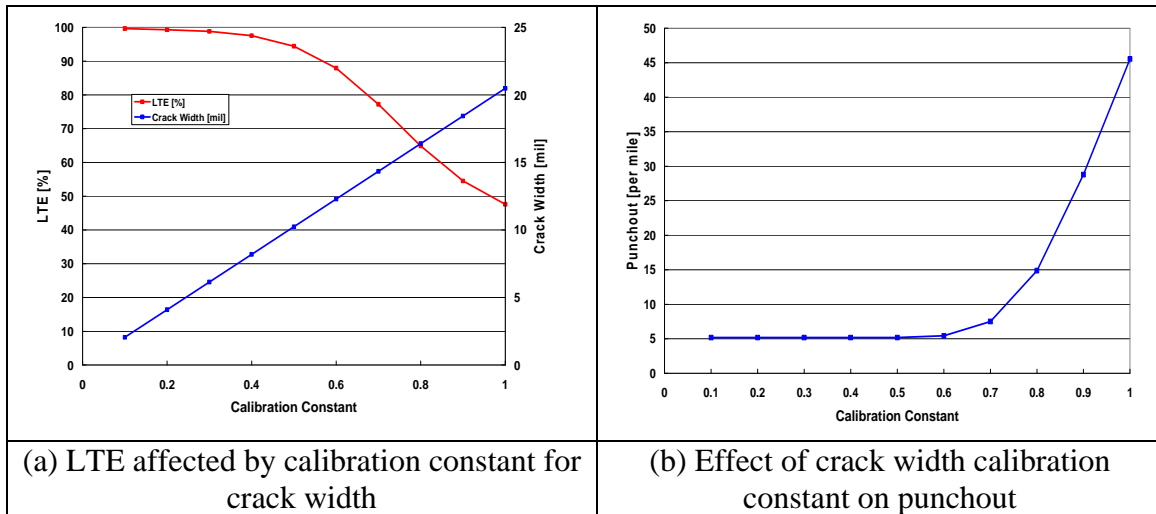
Figure 3.4: Effect of calibration constants

Figure 3.4-(a) shows predicted crack width and LTE in 2008 as affected by the changes in calibration constant for crack width. MEPDG algorithm appears to work properly, because the crack width increases linearly with the calibration constant. It shows that, in this case, LTE is maintained at quite high levels with a crack width calibration constant up to 0.5. Once the crack width calibration constant gets larger than 0.5, LTE decreases rather quickly.

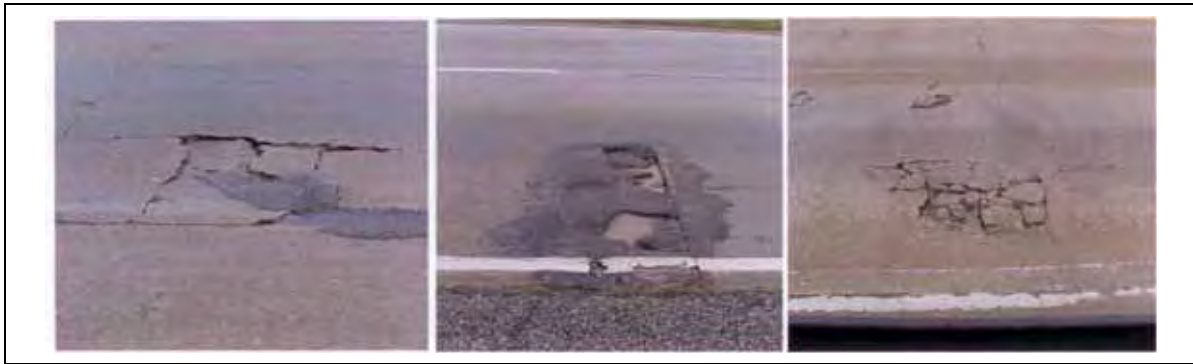
Figure 4.1: Examples of punchout in TxDOT PMIS Rater's Manual

TxDOT's current "Pavement Management Information System—Rater's Manual" (PMIS) (9) identifies five distress types in CRCP: spalled cracks, punchouts, asphalt patches, concrete patches, and average crack spacing. In this classification system, punchout is the only un-repaired structural distress and both asphalt and concrete patches are assumed to have been done to repair punchouts. In other words, except for spalled cracks and average crack spacing, all the other distresses and repairs are related to "punchouts." The Manual provides three example pictures for punchouts as shown in Figure 4.1. Even though all the three distresses shown in Figure 4.1 may meet the definition of punchouts, their development mechanisms may not be the same, and as a matter of fact, their mechanisms could be quite different as will be discussed later. For example, the second and third pictures shown in Figure 4.1 have to do with concrete material quality and design/construction quality than structural deficiency in CRCP. In CRCP, punchout is considered as a distress caused by deficiencies in the structural capacity of the pavement system. Therefore, when distresses identified as punchouts are excessive in CRCP, it is assumed that the pavement system, or more often, the slab thickness was deficient for the given truck traffic. The consequence of this kind of logic is that, if misdiagnosis is made in identifying punchout, pavement design could become more conservative than needed. Considering the current fiscal constraints each state DOT, including TxDOT, is experiencing, improper or incorrect identification of punchout in CRCP has significant consequences in DOT operations. In this section, detailed discussions are presented along with actual distresses observed in Texas on the potential mechanisms and what could be done to prevent or minimize those distresses. It is expected that understanding correct distress mechanisms would help enhance the accuracy of TxDOT's pavement design procedures, which will ultimately result in more efficient use of financial resources to better address the needs of pavement system in TxDOT. In this section, distresses observed in Texas that are currently identified as punchouts are discussed in detail. Possible distress mechanisms are presented. Because CRCP has not been used in other states as extensively as in Texas, most of the national research efforts in Portland cement concrete (PCC) have been devoted to jointed concrete pavement (JCP). Consequently, not much national research effort has been made in CRCP. Fortunately, over the years TxDOT has sponsored a number of research projects on CRCP, including this rigid pavement database project, and a substantial amount of information has been gathered on CRCP structural responses and performance. This section discusses distresses observed in CRCP in Texas, and their potential mechanisms are presented based on the information obtained and knowledge gained through the research projects sponsored by TxDOT.

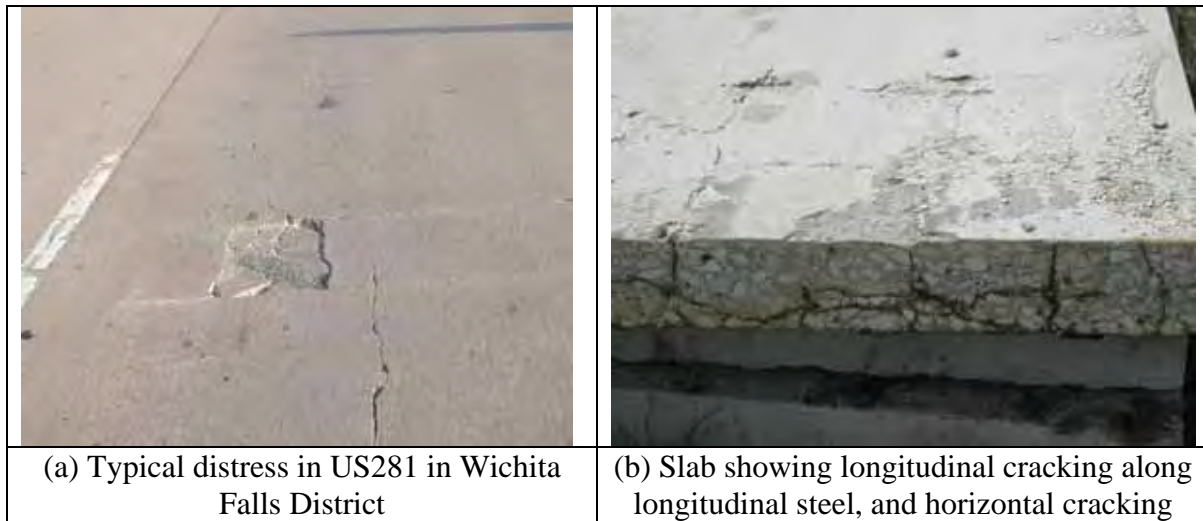
Figure 4.7: Distresses in US 281

A 3-mile section of US 281 in the Wichita Falls District, which was built in early 1960s, experienced severe distresses as shown in Figure 4.7-(a). The slab is 8 in. on top of prepared subgrade. The section was rehabilitated with 4-in. bonded overlay in June 2002, and prior to the overlay, full-depth repairs were conducted. Figure 4.7-(b) shows the slab taken out during the full-depth repair.

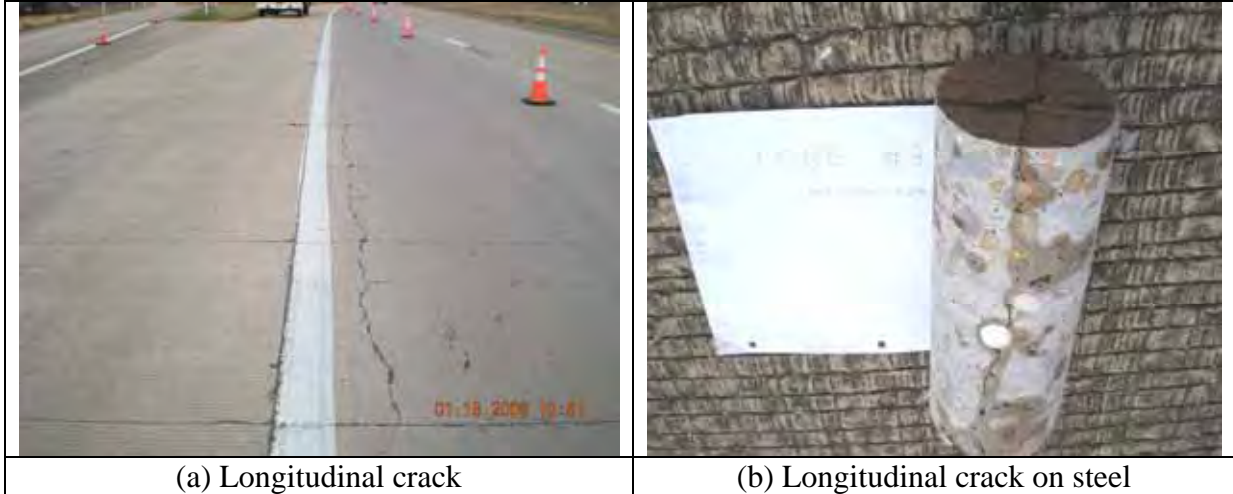
Figure 4.9: Longitudinal cracking on steel

Longitudinal cracking was observed on US 290 eastbound just south of Hempstead. This section was constructed in 1995, and the pavement structure consists of 10-in. concrete slab+1-in. asphalt bondbreaker+6-in. cement stabilized subbase+6-in. lime treated subgrade. Figure 4.9-(a) shows a longitudinal crack, which was 14-in. from the intended longitudinal warping joint. The saw-cut depth at the warping joint was insufficient and no crack was developed under the saw-cut as of January 2009. Instead, longitudinal cracks formed near the warping joint. Figure 4.9-(b) shows a core taken at the longitudinal crack. It is shown that the longitudinal crack was along the longitudinal steel. However, horizontal cracking is not noted. Based on the observations on the distresses in CRCP in Texas, it is postulated that horizontal cracking might eventually form in this section once additional transverse cracks form due to fatigue, which will be discussed in the next section. Figure 4.10-(a) shows a quite fine longitudinal crack formed on the same US 290 section. Compared with the transverse crack shown in the picture, the longitudinal crack is so tight that it looks as though it just started forming. A core was taken at the location marked, and Figure 4.10-(b) shows that longitudinal crack was along longitudinal steel, as in the previous cases, and actually quite wide within the slab, even though the crack was so tight on the surface. This implies that the longitudinal crack might not be due to the mechanism of top-down or bottom-up cracking; rather, it could be that the interactions between concrete and longitudinal steel during wheel loading applications could have caused this longitudinal crack.

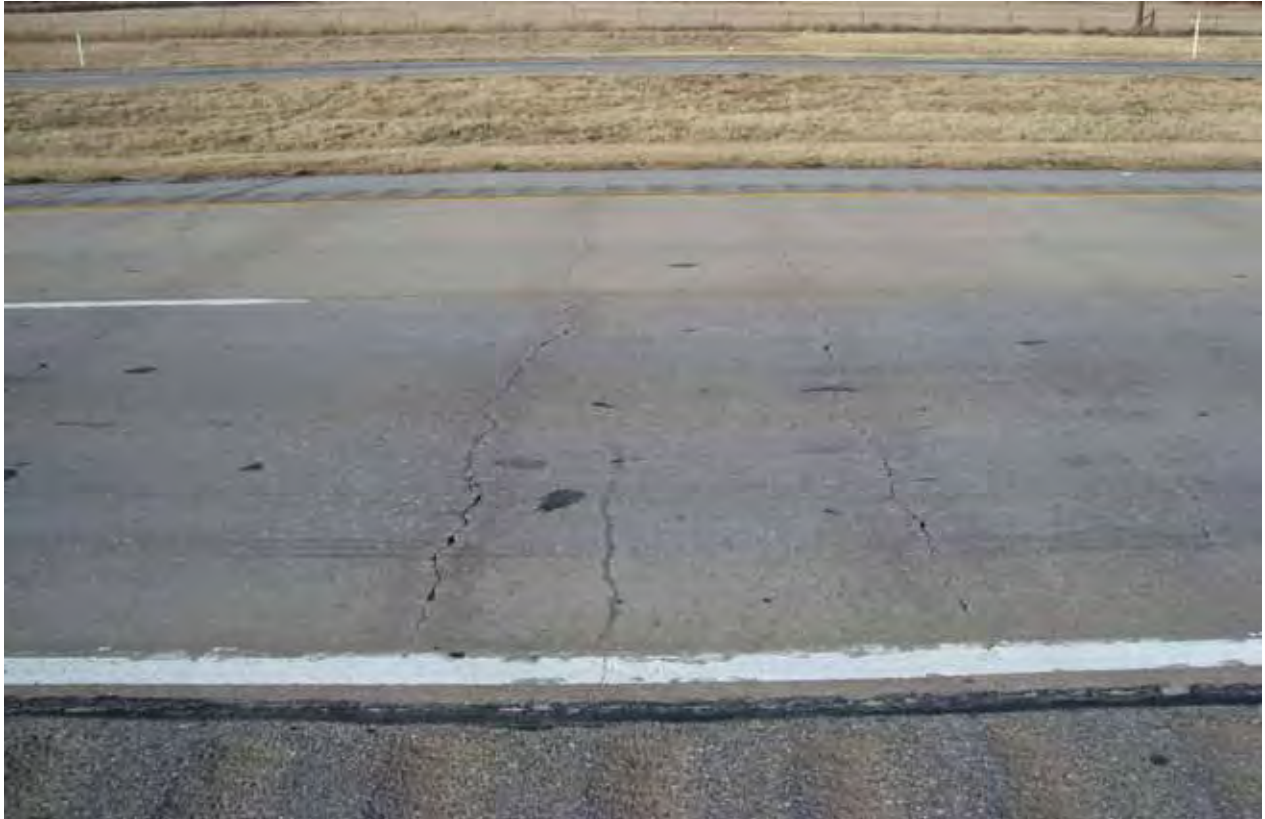
Figure 4.11: Transverse fatigue crack formed between two old transverse cracks

In Figure 4.11, a transverse crack is shown in between two transverse cracks. The section shown here is in US 287 section discussed in Chapter 3. This picture was taken in January 2009, so this pavement was more than 38 years old. The width of this crack at the pavement edge is larger than the widths of the other two transverse cracks. There were a number of transverse cracks that formed between two transverse cracks that run through the whole slab widths. These cracks appear to have formed rather recently, because they look tighter than adjacent cracks and started at the pavement edge and are progressing towards the inside of the slab. Because the stress due to wheel loading is quite large when it is applied near slab edge, especially when asphalt shoulder is used, it is believed that these cracks were formed due to the fatigue of concrete from repeated wheel loading applications near the slab edge.
