1. Report No. FHWA/TX-04/0-4185-1	2. Government Accession No.	3. Recipient's Catalog No.	
4. Title and Subtitle CORRELATION OF FIELD PERFORMANCE TO HAMBURG WHEEL TRACKING DEVICE RESULTS		5. Report Date October 2001

**CORRELATION OF FIELD PERFORMANCE TO
HAMBURG WHEEL TRACKING DEVICE RESULTS**

Research Report 0-4185-1

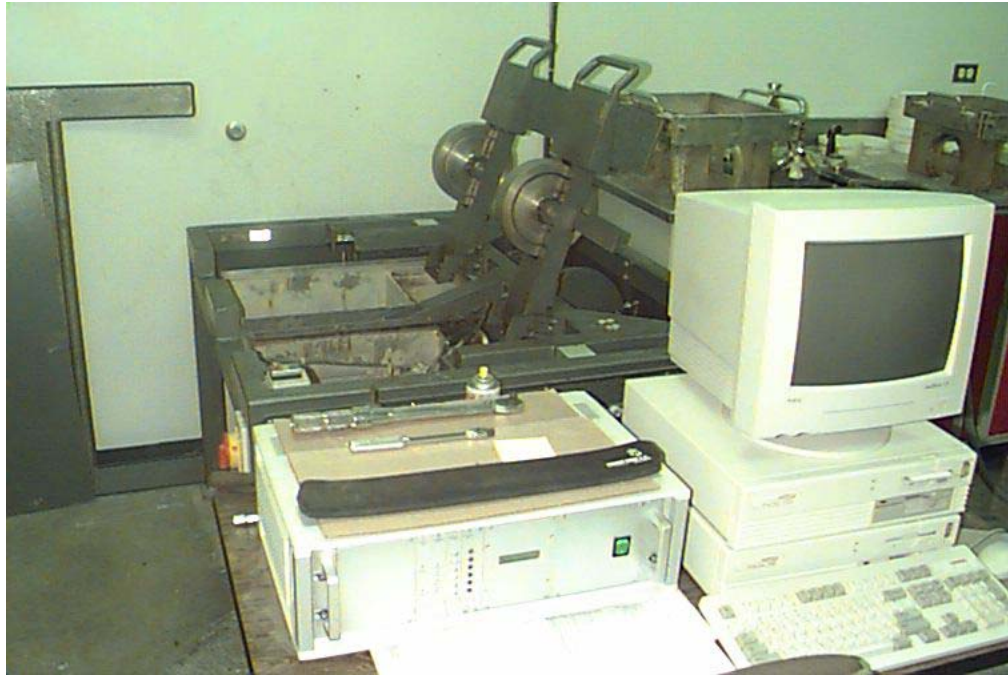
Figure 2.1 Hamburg Wheel Tracking Device

The HWTD test is conducted on a pair of samples simultaneously. Originally, only cubical shaped specimens could be tested. The test can now be performed on both cubical and cylindrical specimens. The cubical specimens are approximately 320 mm long, 260 mm wide, and 40 mm thick. The cylindrical specimens are 150 to 300 mm in diameter and about 40 mm thick. The sample is typically compacted to 7 ± 1 percent air voids. The plate type compactor has been proposed for compacting the specimens. However, use of cylindrical specimens makes it possible to obtain compacted specimens very easily with the aid of the gyratory compactors. Figure 2.1 shows the HWTD equipment.

Traditionally the tests have been performed underwater at 50 °C, even though the temperature can vary between 25 °C to 70 °C. A steel wheel, 47 mm wide, loads the sample with 705 Newtons of load. The wheel makes 50 passes per minute over each sample. The maximum velocity of the wheel is 340 mm/sec in the center of the sample. Each sample is loaded for 20,000 passes or until 20 mm of deformation occurs. Approximately 6.5 hours are required for a test, even though in many cases the samples have failed in a much shorter period of time.

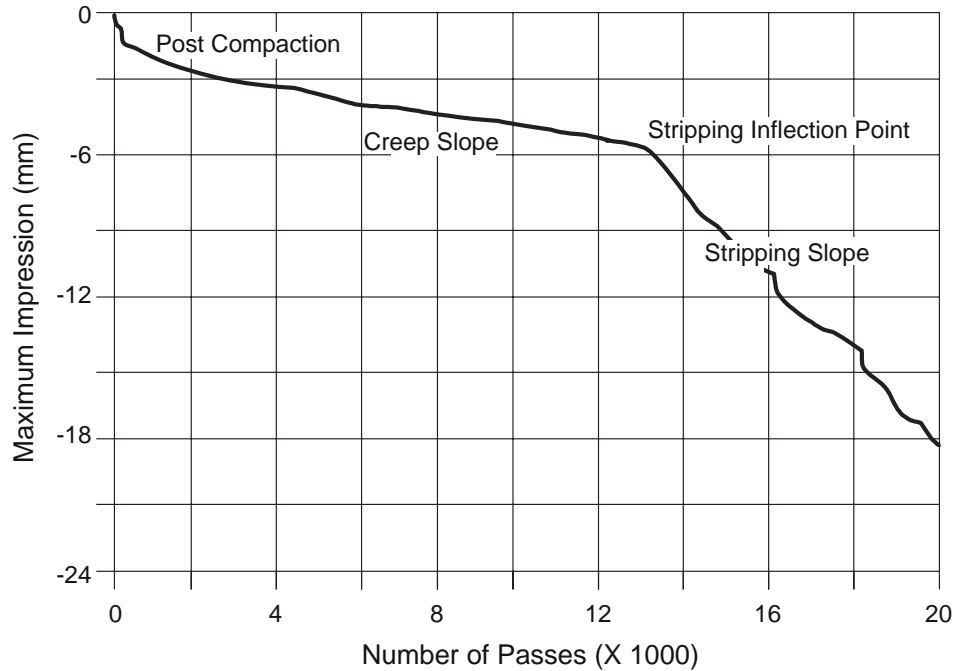
Figure 2.2 Definition of the Hamburg Wheel Tracking Device Results (1)

The test results from the HWTD include the post-compaction consolidation, the creep slope, stripping slope, and stripping inflection point (Figure 2.2). The results have been defined by Hines (1). The post-compaction consolidation is the deformation (mm) at 1,000 wheel passes. It is called post-compaction consolidation because it is assumed that the wheel is densifying the mixture within the first 1,000 wheel passes.

The creep slope relates to rutting from plastic flow. It is the inverse of the rate of deformation (wheel passes per 1 mm rut depth) in the linear range of the deformation curve, between the post-compaction consolidation and the stripping inflection point. The creep slope is used to measure rutting susceptibility. It measures the accumulation of permanent deformation primarily owing to mechanisms other than moisture damage. Creep slopes have been used to evaluate rutting susceptibility instead of rut depths because the number of wheel passes at which moisture damage starts to affect performance varies widely from mixture to mixture. Furthermore, the rut depths often exceed the maximum measurable rut depth of 25 to 30 mm, even if there is no moisture damage.

The stripping slope is the inverse of the rate of deformation in the linear region of the deformation curve, after stripping begins and until the end of the test. This slope measures the accumulation of permanent deformation primarily owing to moisture damage. It is the inverse of the rate of deformation (wheel passes per 1 mm rut depth) after the stripping

inflection point. The stripping slope would then represent the number of passes required to create a 1 mm impression from stripping. The stripping slope is related to the severity of moisture damage.

The stripping point is the number of passes at the intersection of the creep slope and the stripping slope. It is related to the resistance of the hot mix asphalt (HMA) to moisture damage. After this point moisture damage starts to dominate performance. The Colorado Department of Transportation (CDOT) reports that an inflection point below 10,000 wheel passes indicates moisture susceptibility (3).

To report the creep slope and the stripping slope in terms of wheel passes, inverse slopes are used. Higher creep slopes, stripping inflection points, and stripping slopes indicate less damage (4). The City of Hamburg specifies a rut depth of less than 4 mm after 20,000 passes. A previous study (2) found that this specification is very severe for pavements in Colorado. A rut depth of less than 10 mm after 20,000 passes may be more reasonable. Additionally, the test temperature should be adjusted based upon the environment in which the mixture will be placed. The recommendation has been documented elsewhere (3).

The shape of the curve in Figure 2.2 is the same as typical permanent deformation curves provided by creep and repeated load tests. The curves from these tests are also broken down into three regions. The final region, called the tertiary region, is where the specimen is rapidly failing. Based on the examination of many slabs and pavement cores, the tertiary regions of the curves produced by the HWTD appear to be primarily related to moisture damage, rather than to other mechanisms that cause permanent deformation, such as viscous flow. Mixtures that are susceptible to moisture damage also tend to start losing fine aggregates around the stripping inflection point, and coarse aggregate particles may become dislodged. However, there is no method for separating the deformation owing to viscous flow from the deformation resulting from moisture damage, because dry specimens cannot be tested. There is also no method for determining the amount of

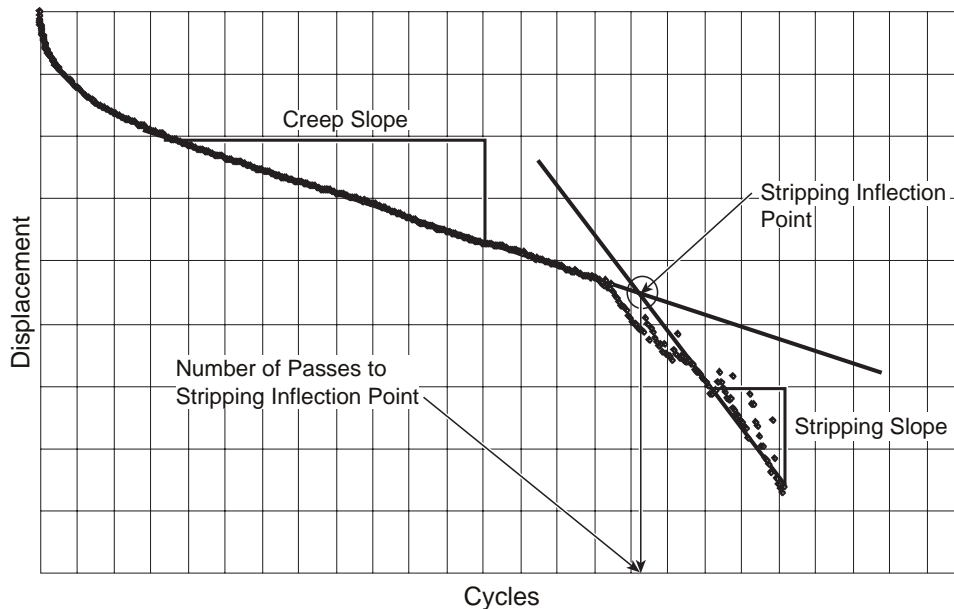
Figure 4.2 Rut Depth versus Number of Wheel Passes Graph with Test Parameters

The HWTD test data was analyzed to determine the post-compaction consolidation, creep slope, stripping inflection point, stripping slope, and deformation values at 20,000 wheel passes. Figure 4.2 shows an example of a test result with these parameters. The post-compaction consolidation data, which shows the densification of the mix in the early stages of the testing, was recorded. The creep slope of the test data, which is used to measure rutting susceptibility, was measured. The creep slope measures the accumulation of permanent deformation primarily owing to mechanisms other than moisture damage. The stripping inflection point is the number of wheel passes at the intersection of the creep slope and the stripping slope. After this point, moisture damage starts to dominate performance. The stripping slope measures the accumulation of permanent deformation primarily owing to moisture damage.
