1. Report No. FHWA/TX-05/0-4178-1	2. Government Accession No.	3. Recipient's Catalog No.
4. Title and Subtitle Fatigue Strength of Fillet-Welded Transverse Stiffeners with Undercuts		5. Report Date July 2002 *Revised October 2004*

FATIGUE STRENGTH OF FILLET-WELDED TRANSVERSE STIFFENERS WITH UNDERCUTS

Research Report 0-4178-1

FILLET WELD DETAILING FOR STIFFENER

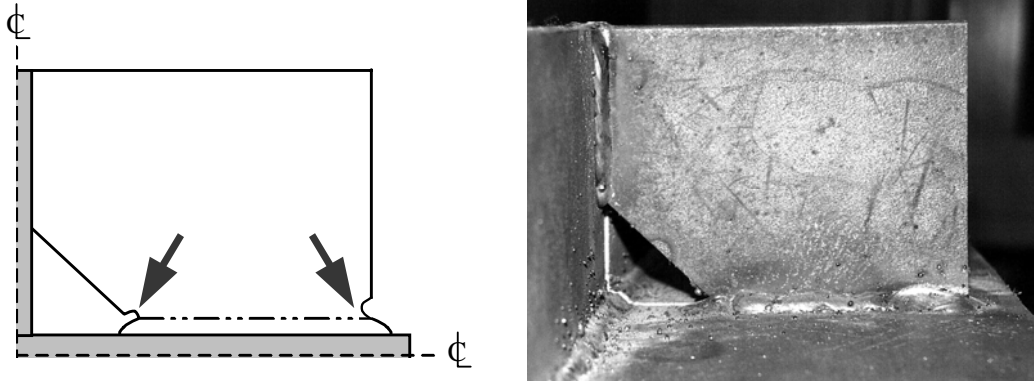
Figure 2-18: Location of Undercut for Specimen Type A

Type A specimens were used to investigate the influence of undercutting on the fatigue performance caused by wrapping the stiffener weld around the interior clip and exterior edges of the stiffener. A close-up of the type A stiffener detail is shown in Figure 2-18. Arrows are used in the figure to indicate the points of undercutting.

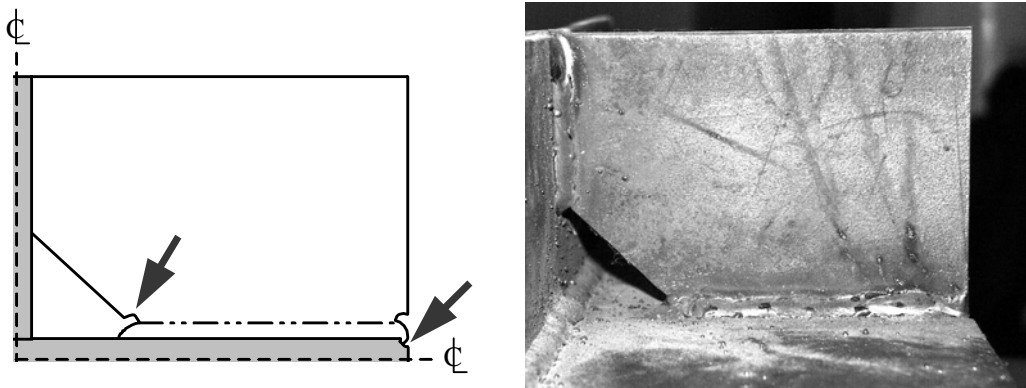
Figure 2-22: Location of Undercut for Specimen Type B

The Type B stiffener detail is shown in Figure 2-22. Type B specimens were used to observe undercutting effects at both the interior clip weld wrap and the exterior stiffener-to-flange weld wrap. The stiffener extended to the edge of the flange in order to produce undercutting of the edge of the flange plate. Wrapping the weld around the exterior edge also caused small undercuts of the stiffener as shown in Figure 2-23.

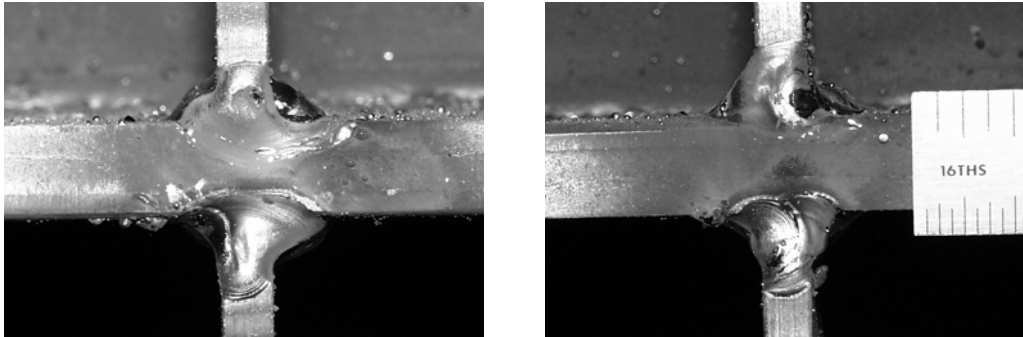
Figure 2-24: Specimen B Flange Undercuts

Flange undercuts occurred as the stiffener weld was wrapped around the exterior edge of the stiffener. The flange undercuts were shaped like an hourglass and were consistent among specimens. Figure 2-24 shows photographs of the flange undercuts.

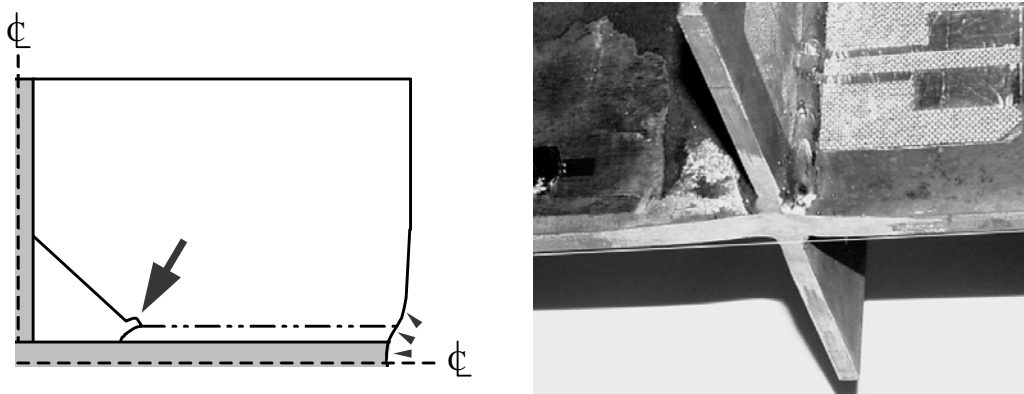
Figure 2-25: Location of Undercut for Specimen Type C

Type C specimens are identical to type B specimens with the flange edge undercut removed by grinding after welding. The type C stiffener detail is shown in Figure 2-25. The photograph in Figure 2-25 shows the depth of grinding into the flange needed to remove the flange undercut.

AASHTO AWS D1.5-95 Bridge Welding Code guidelines (section 3.2) were employed for the removal of the edge undercuts. The AWS procedure and requirements are identical to the TxDOT fracture critical defect repair procedures. The undercut was removed by grinding past the maximum undercut depth with a finished surface slope not greater than one in ten in the direction of loading. Grinding marks were finished parallel to the direction of loading as pictured in Figure 2-26.

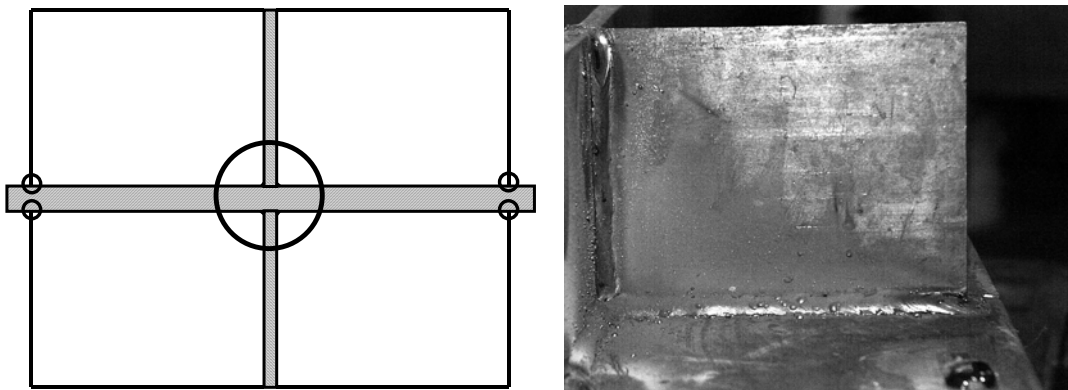
Figure 2-27: Specimen Type D Showing No Clip

Type D specimens were used to investigate the impact on the fatigue life caused by minimizing the clip size and completely welding this area closed. The clip size was reduced to 0.375 in. (10 mm) and welds were overlapped to completely eliminate the opening as shown in Figure 2-27. Similar to the type A specimens, minimal to no undercutting occurred at the exterior edge of the stiffener in the type D specimens.

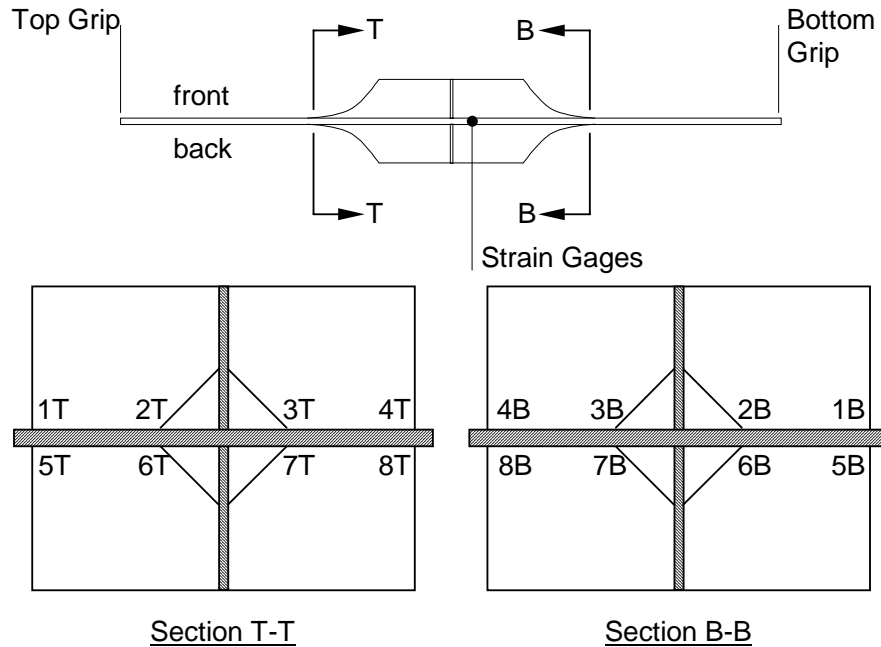
Figure 2-28: Specimen A Undercut Identification

Undercut locations were labeled based on their orientation with respect to their location in the test frame. Figure 2-28 shows the location and nomenclature used for classification of type A specimen undercuts. The interior and exterior stiffener undercuts were located on the top half (T) or bottom half (B) of the specimen midsection.

Table 2-1 shows that specimen 2A consistently had larger undercuts than specimens 1A and 3A. Specimen 2A had the most undercuts of the three specimens. Specimen 3A had the smallest measured undercuts.

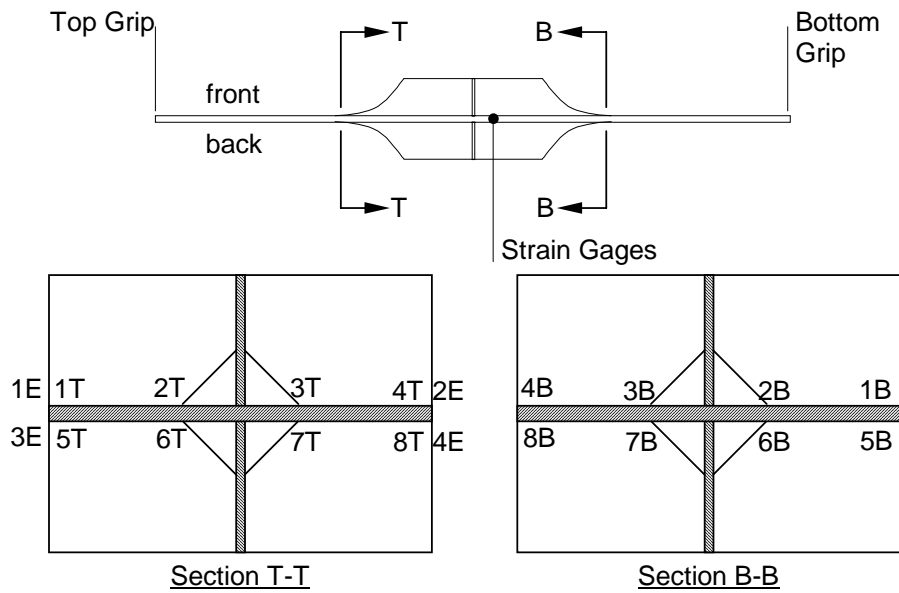
Figure 2-30: Specimen B Undercut Identification

Figure 2-30 shows the location and nomenclature used for classification of type B specimen undercuts. The flange undercuts (E) are located on the free edge of the flange plate at the stiffener location.

Table 2-2 lists the stiffener-undercut dimensions corresponding to the locations in Figure 2-30. It should be noted that small undercutting occurred at the exterior stiffener locations 1, 4, 5, and 8. The stiffener-undercut sizes were consistent among the three specimens. The average length of the undercuts was approximately 0.16 in. (4 mm), and the average height was 0.052 in (1.3 mm). The average depth was 0.044 in (1 mm).

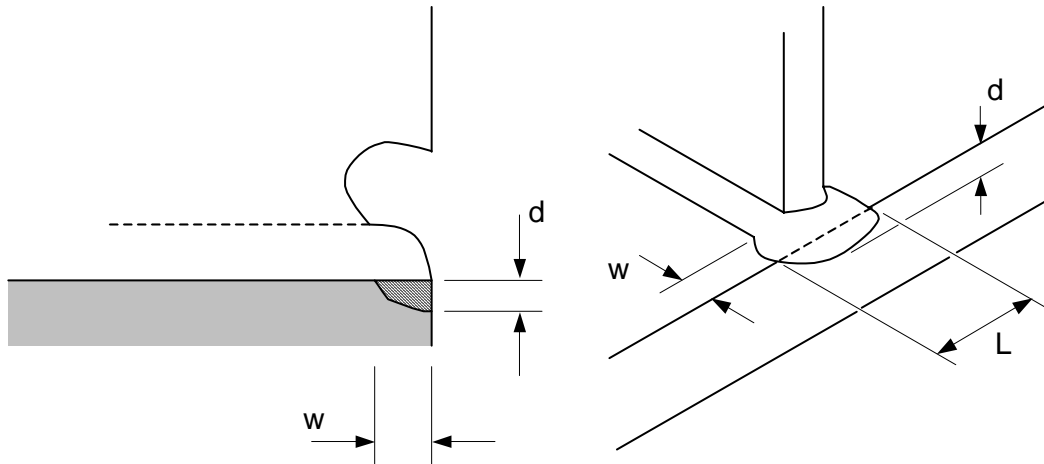
Figure 2-31: Specimen B Flange Undercut Dimensions

Table 2-3 lists the flange undercut dimensions corresponding to the "E" locations in Figure 2-30. Figure 2-31 illustrates the dimensions that were measured for the specimen B flange undercuts. It should be noted that the flange undercuts were considered more detrimental to the fatigue life of the specimen than the exterior stiffener undercuts because of their direct orientation to loading. Average measured values were consistent among all three specimens. The average length of the flange undercuts was approximately 0.5 in. (13 mm), and the average depth was over 0.125 in. (3 mm). The average width of the flange undercuts was 0.072 in. (2 mm).

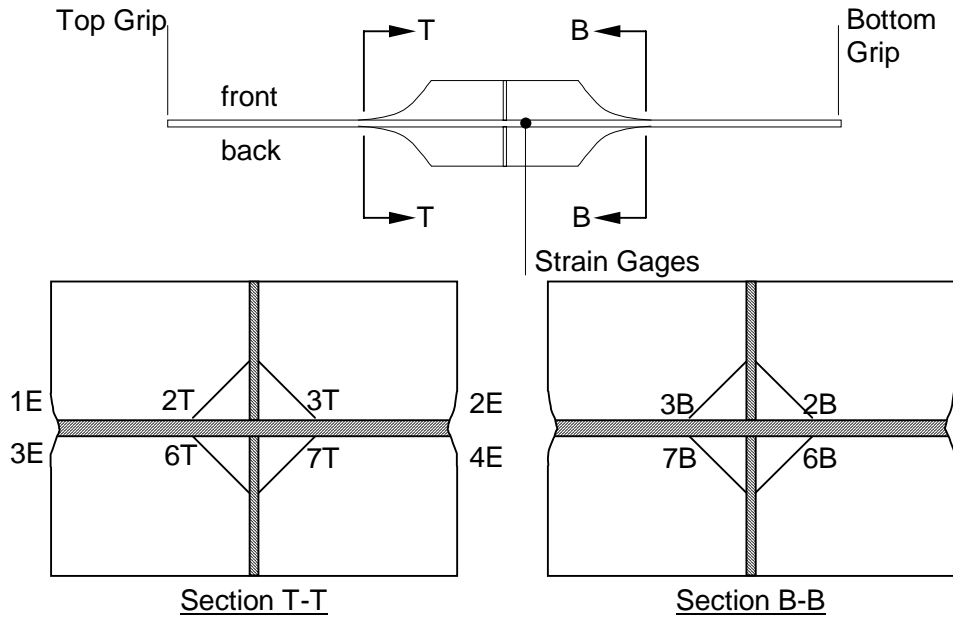
Figure 2-32: Specimen C Undercut Identification

Table 2-4 lists the interior stiffener undercut dimensions corresponding to the locations in Figure 2-32. It should be noted that the undercuts at the exterior stiffener edge were removed during grinding of the flange undercut. Therefore, only interior stiffener undercuts were listed. The flange undercuts were recorded prior to removal by grinding. These values are given in Table 2-5, and the dimensions are illustrated in Figure 2-31.

The length, height, and width of the stiffener undercuts listed in Table 2-4 were consistent among specimens 7C, 8C, and 9C. The average length, height, and depth of the stiffener undercuts were 0.04 in. (1 mm), 0.03 in. (0.8 mm), and 0.04 in. (1 mm). Similarly, the length, depth, and width of the flange

undercuts listed in Table 2-5 were consistent among all three specimens. The average length, depth, and width of the flange undercuts were 0.64 in. (16 mm), 0.14 in. (3.6 mm), and 0.094 in. (2.4 mm).

After the undercuts were documented, a disk grinder was used to remove the flange undercuts. The repair was done on both sides of the flange. Prior to grinding, the flange undercuts were referred to as 1E, 2E, 3E, and 4E. Two surfaces are left after grinding. These surfaces correspond with locations 1E and 2E in Figure 2-32. Table 2-6 lists the post-grinding dimensions of the flange undercut locations. Figure 2-33 illustrates the flange grinding surface dimensions. The width, w, in Figure 2-33 was taken as the deepest point of grinding on the flange edge. The final slope of the grinding surface complies with specifications and is less than one in ten.

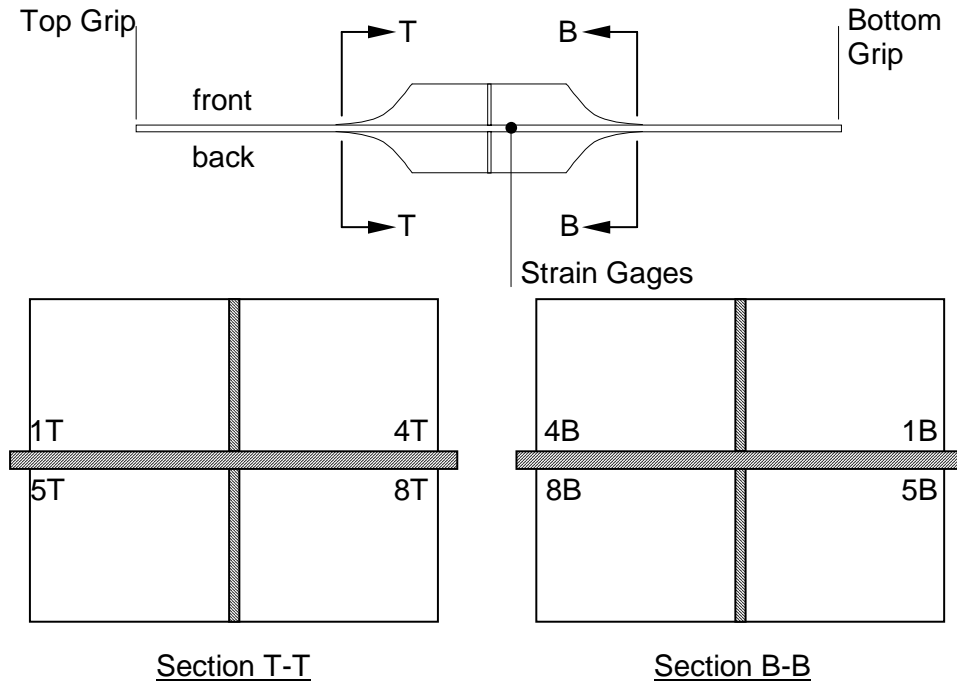
Figure 2-35: Specimen D Undercut Identification

Table 2-7 lists the stiffener undercut dimensions corresponding to the locations in Figure 2-35. The average length, height, and depth of the stiffener undercuts were 0.05 in. (1.3 mm), 0.044 in. (1.11 mm), and 0.05 in. (1.3 mm) for specimens 10D, 11D, and 12D.

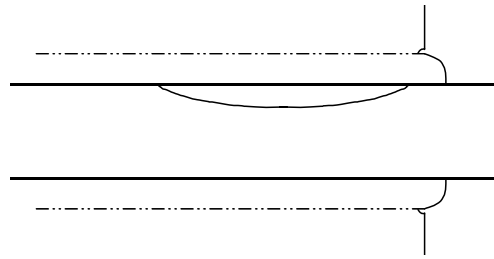
Figure 4-2: Stage 1

Four stages of cracking are shown in Figure 4-1. A close-up of stage 1 crack section is shown in Figure 4-2. Smaller cracks form at the weld toe and eventually coalesce in stage 2 to form a larger, shallow fatigue crack as shown in Figure 4-3. In stage 3, the crack continues to grow through the flange as shown in Figure 4-4. The crack growth is quicker along the surface of the flange due to the stress concentration at the weld toe.

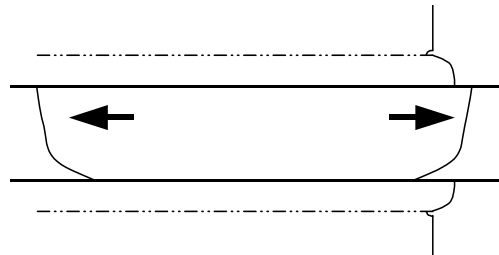
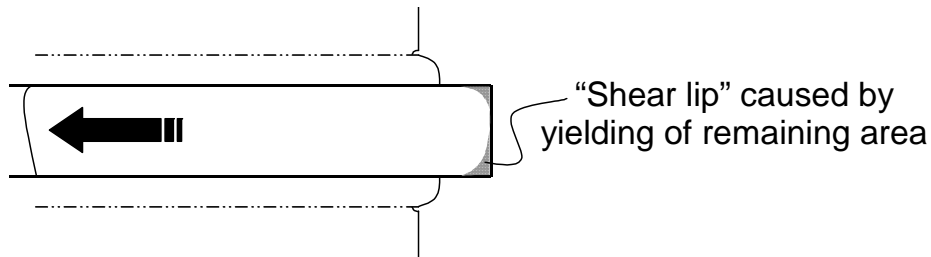
Figure 4-6: Failure

Crack growth becomes more rapid in Stage 4. Figure 4-5 shows the double-edged crack expanding along the length of the weld toe. Eventually, the remaining flange edge will tear and the fatigue crack will rapidly propagate across the rest of the flange. Figure 4-6 shows the resulting single-ended crack direction of propagation leading to failure of the specimens.

"Shear lip" caused by yielding of remaining area

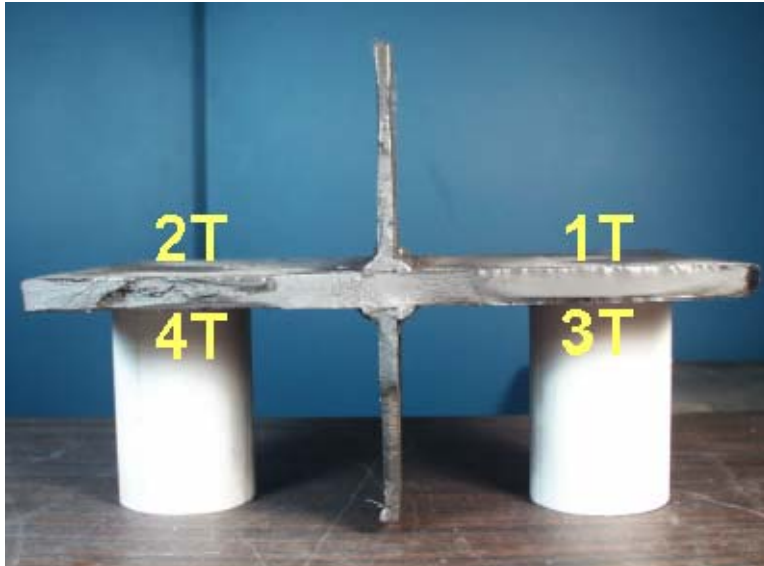
Figure 4-9: Fracture Surface 1A-1

Specimen 1A was tested at a nominal stress range of 20 ksi (138 MPa). The actual stress range for specimen 1A was not measured. Specimen 1A failed at 508,199 cycles due to fatigue cracks at the toe of the stiffener-to-flange weld locations 1T, 2T, and 4T. Failure occurred as these cracks propagated into the flange causing total rupture of the cross-section by yielding. No cracks were found to have initiated at an undercut location.

Fracture surface 1 is shown in Figure 4-9. Weld locations are numbered in the figure. The large elliptical crack on the right half of the photograph in Figure 4-9 occurs at the toe of weld 1T. A close-up of this crack is shown in Figure 4-10. Stage 3 of the crack (refer to Figure 4-4) is highlighted in the figure. Following this stage, yielding of the edge of the flange occurred as evidenced by the shear lips in Figure 4-10. Rapid crack propagation took place in stage 4 and failure occurred. Note the change in texture from a smooth surface in Stage 3 to a more roughened surface in Stage 4.

The smaller cracks on the left side of Figure 4-9 occur at the toe of welds 2T and 4T. A close-up of these cracks is shown in Figure 4-11. These cracks were in stage 2 of their development when rupture of the specimen occurred due to the rapid crack extension of the fatigue crack that had initiated at weld toe 1T.

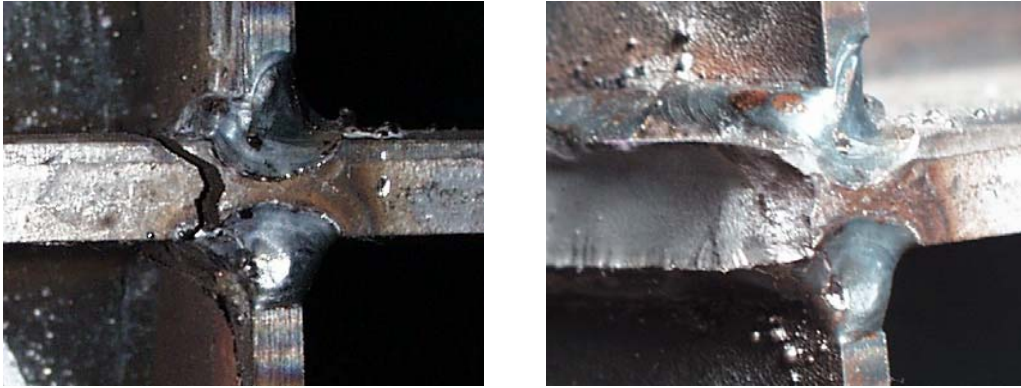
Specimen 5B was tested at a measured stress range of 21.1 ksi (145 MPa). Specimen 5B failed at 628,377 cycles due to fatigue cracks at the toe of the stiffener-to-flange weld locations 2 and 4. Figure 4-16 shows the toe crack along weld location 2T. A displacement over the 0.10 in. limit halted the actuator prior to total rupture of the specimen.

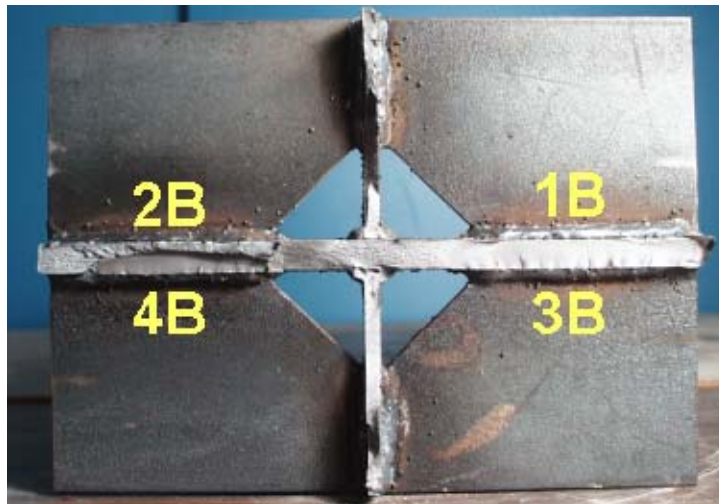
Figure 4-18: Fracture Surface 6B-1

Specimen 6B was tested at a measured stress range of 20.8 ksi (143 MPa). Specimen 6B failed at 503,978 cycles due to fatigue cracks at the toe of the stiffener-to-flange weld locations 1B, 2B, 3B, and 4B. Failure occurred as these cracks propagated into the flange causing total rupture of the cross-section by yielding. No cracks were found to have initiated at an undercut location.

Figure 4-18 shows fracture surface 1. Fatigue cracks are shown growing from the toe of the stiffener-to-flange welds. Figure 4-19 and Figure 4-20 show close-up views of these fatigue cracks.

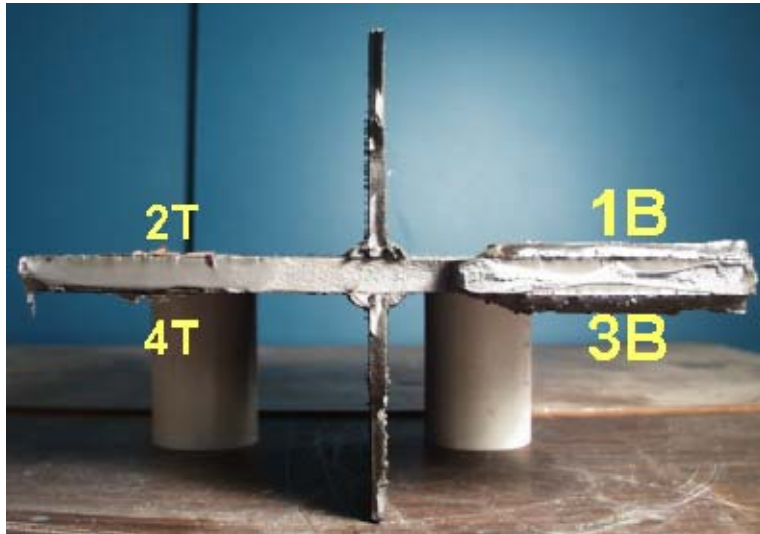
Figure 4-22: Fracture surface 7C-1

Specimen 7C was tested at a measured stress range of 20.9 ksi (144 MPa). Specimen 7C failed at 574,097 cycles due to fatigue cracks at the toe of the stiffener-to-flange weld locations 2T, 4T, 1B, and 3B. Failure occurred as these cracks propagated into the flange causing total rupture of the cross-section by yielding. The remaining stiffener welds were ruptured during failure as shown in Figure 4-21. No cracks were found to have initiated at an undercut location.

Figure 4-22 shows fracture surface 1. Note that welds 2T and 4T do not share the same plane as welds 1B and 3B. Fatigue cracks in Figure 4-23 originated from the toe of the stiffener-to-flange weld toe at weld locations 2T and 4T. Fatigue cracks in Figure 4-24 originated from the toe of the stiffener-to-flange weld toe at weld locations 1B and 3B.

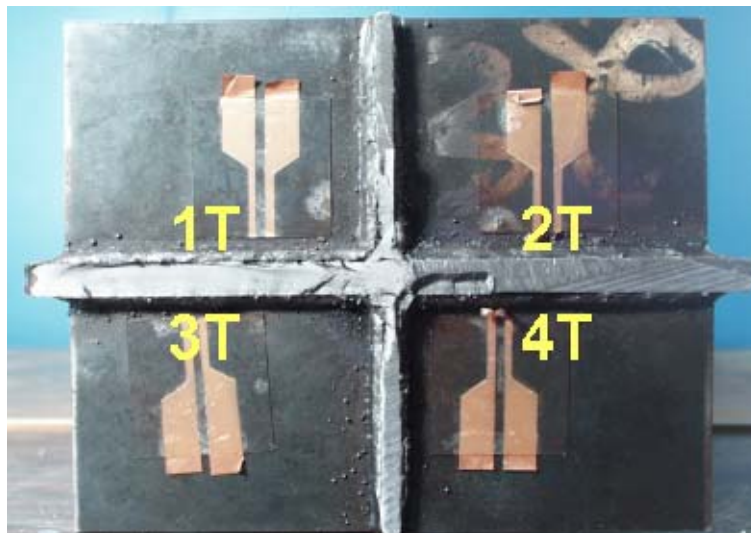
Figure 4-26: Fracture Surface 11D-2

Specimen 11D was tested at a measured stress range of 19.7 ksi (136 MPa). Specimen 11D failed at 492,794 cycles due to fatigue cracks at the toe of the stiffener-to-flange weld locations 1T, 3T, and 4T. A displacement over the 0.10 in. limit halted the actuator prior to total rupture of the specimen. No cracks were found to have initiated at a stiffener-undercut location.

Figure 4-26 shows fracture surface 2. A close-up of the fatigue cracks at the toe of welds 1T and 3T is shown in Figure 4-27. A shear lip is also indicated in the figure. Again, this specimen follows the same failure sequence as discussed in Section 4.1.

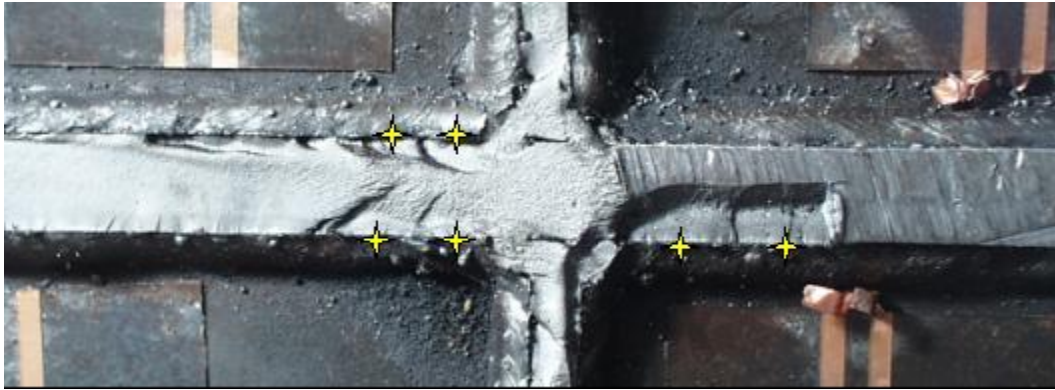
Figure 4-28: Center of Fracture Surface 11D-2

Figure 4-28 shows the center of the fracture surface including the cracks at the toe of weld 4T. Recall that the stiffener clip was eliminated for type D specimens. As a result, cracks grew further along the toe of the stiffener-to-flange weld closer to the centerline of the specimen as shown in Figure 4-28. The fracture surfaces of specimens 10D and 12D were similar to the fracture surface of 11D.

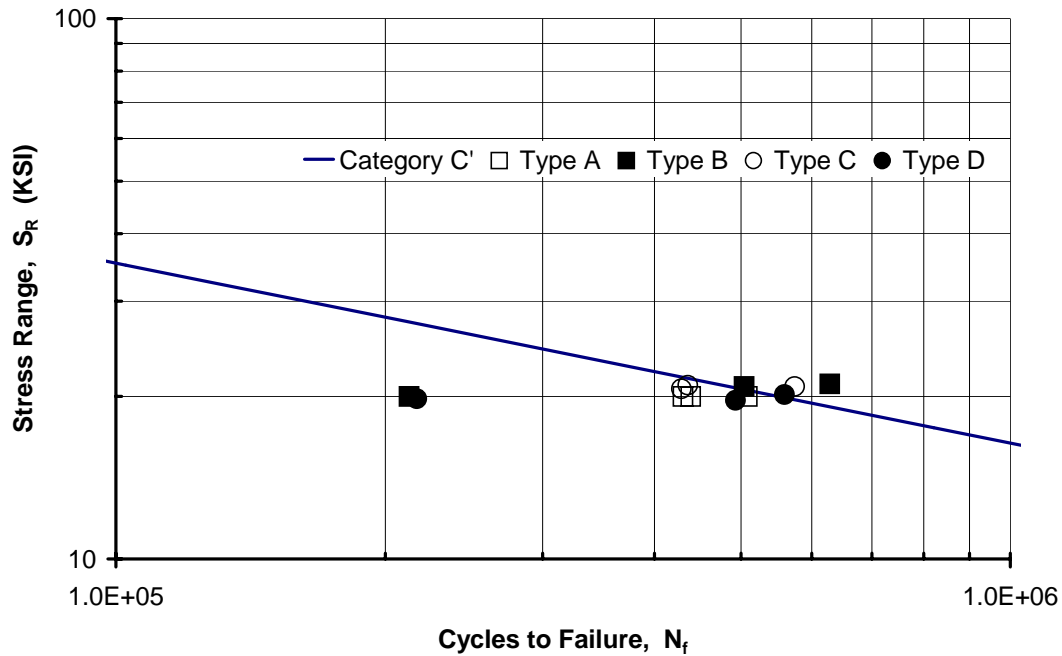
Figure 4-29: Comparison with Category C' Fatigue Resistance

Figure 4-29 shows the results of the fatigue tests plotted along with the category C' nominal fatigue resistance line. The design fatigue life of the specimens is 550,000 cycles at a stress range of 20 ksi (138 MPa). The average fatigue life of all specimens tested was 452,533 cycles with an average measured stress range of 20.5 ksi (141 MPa).

This is the equation of the C'-line shown in Figure 4-29. Table 4-3 lists the stress range and fatigue life of the experimental values in comparison to the AASHTO C'-line equation. Based on the minimum and maximum measured stress range of 19.7 ksi (136 MPa) and 21.1 ksi (145 MPa), the AASHTO nominal fatigue life ranges from 575,511 cycles to 468,388 cycles, respectively. At an average measured stress range of 20.5 ksi (141 MPa), the average fatigue life of specimens 1A through 12D was 452,533 cycles.

This average is 15,855 cycles lower than the minimum nominal fatigue life based on the AASHTO C'-line equation using a stress range of 21.1 ksi (145 MPa).

The undercuts present in the specimens were not the cause of the shorter fatigue life relative to the category C'. All of the failures initiated at the toe of the weld connecting the stiffener to the flange not from the severe undercuts in the specimens. The lower life is most likely due to the slightly higher and non-uniform stress in the flange plate and to the larger stress concentration resulting from the stiffener on both sides of the flange.

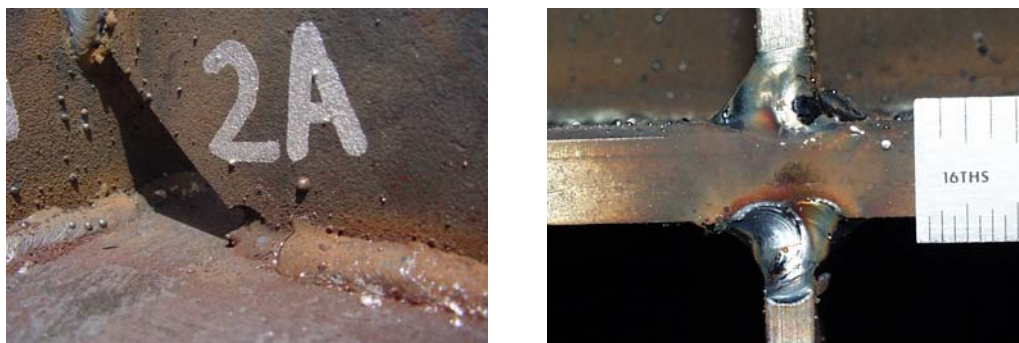
Figure 5-1: Stiffener and Flange Undercuts

Wrapping the welds around the stiffener with large undercuts had no impact upon the fatigue life of the stiffener-to-flange connection. None of the 12 specimens tested had a fatigue crack initiate at either a stiffener or flange undercut. Even the largest stiffener and flange undercuts, such as those shown in Figure 5-1, had no impact on fatigue life. All fatigue cracks initiated at the weld toe of the stiffener-to-flange weld.

Based upon the results of these tests, wrapping of the stiffener-to-flange welds to prevent corrosion of the stiffener should be employed on exposed exterior stiffeners to seal the interface between the stiffener and the flange. The attendant undercutting that may occur was not found to be detrimental to the performance of the structure and can be left in place. Stiffener and flange undercuts were intentionally exaggerated during the welding process to produce worst-case scenarios. The average and maximum measured stiffener undercut values are listed in Table 5-1. The average and maximum depths of the stiffener undercuts were 0.05 in. (1.2 mm) and 0.125 in. (3.2 mm). Undercuts as large these in stiffener can be left in place. With good welding practice, fillet welds can be wrapped around the stiffener with minimal undercutting as documented in the FHWA tour of steel bridge fabrication. A 1.5-in. (38-mm) clip opening allowed adequate space to maneuver the welding gun to wrap the weld around the stiffener. Depending on the size of the web-to-flange welds, a clip size of 1.0 in. (25.4 mm) may be sufficient.
