RESEARCH REPORT 2945-1

EVALUATION OF CATHODIC PROTECTION SYSTEMS FOR MARINE BRIDGE SUBSTRUCTURES

DECEMBER 1998

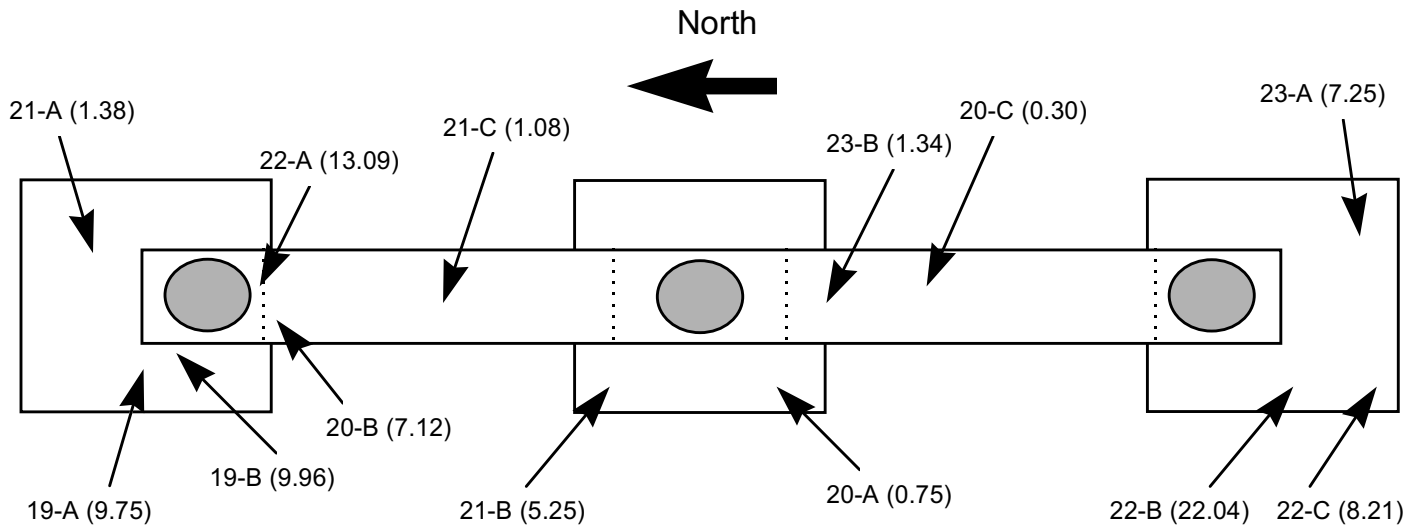
Figure 4.8: Total chloride contents at the level of the reinforcing steel

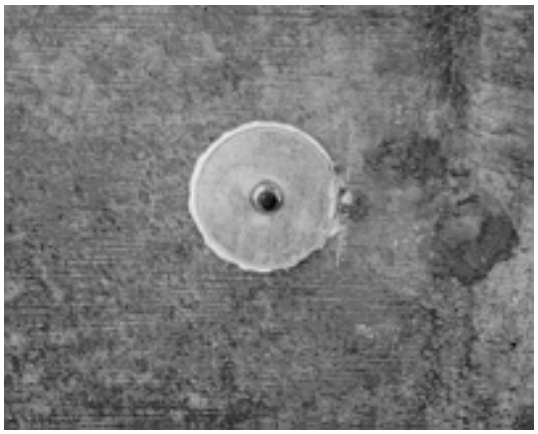
Application. The primary anodes for the zinc systems consisted of 3.5-in. (89-mm) diameter circular plates, which served as current distributors. Each current distributor plate was secured to the concrete surface by means of a galvanized stud. The galvanized stud was inserted in a drilled hole with epoxy. In two instances, an excess of epoxy was placed in the drilled hole. The excess epoxy deposited between the current distributor plate and the concrete surface nullified the current distribution. Figure 5.7 shows one of the current distribution plates where excessive epoxy was placed. The plate had to be removed, and the area under the plate was sandblasted to remove the excess epoxy.

Figure 5.7: Excessive epoxy under a current distributor plate

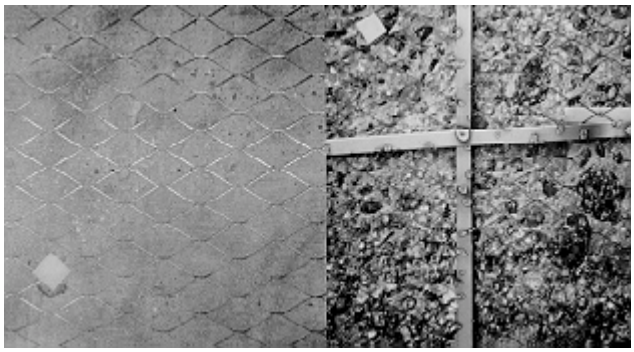
The main reason for the failure of the second trial was inadequate surface preparation. Bonding of the overlay to the substrate was complicated by the presence of the titanium mesh, which acts as a bond breaker, and by the vertical and overhead orientation, which hinders proper consolidation. The surface preparation for the first two trials on Bent 21 was identical to the surface preparation selected for the bents where metallizing was used. Using a rough profile with exposed aggregate to achieve interlock of the overlay with the aggregate would have prevented premature failure of the overlay in this trial.

Figure 5.14: Concrete surface preparation comparison. Figure on left represents the lightly sandblasted surface used in the first two trials. The right figure shows exposed aggregates from heavier sandblasting used in the third trial.

The surface preparation for the third trial included scabbling with handheld milling machines in addition to sandblasting, which was a procedure common to all bents. It took five workers, each equipped with one scabbler, 32 hours to achieve the desired profile and density. The productivity for the scabbling operation was 41 ft^2/hr (3.8 m^2/hr), which is equivalent to 12.2 mhr/100 ft^2 (1.3 mhr/m^2). The exposed aggregate profile and density achieved were comparable to CSP-6, according to the International Concrete Repair Institute

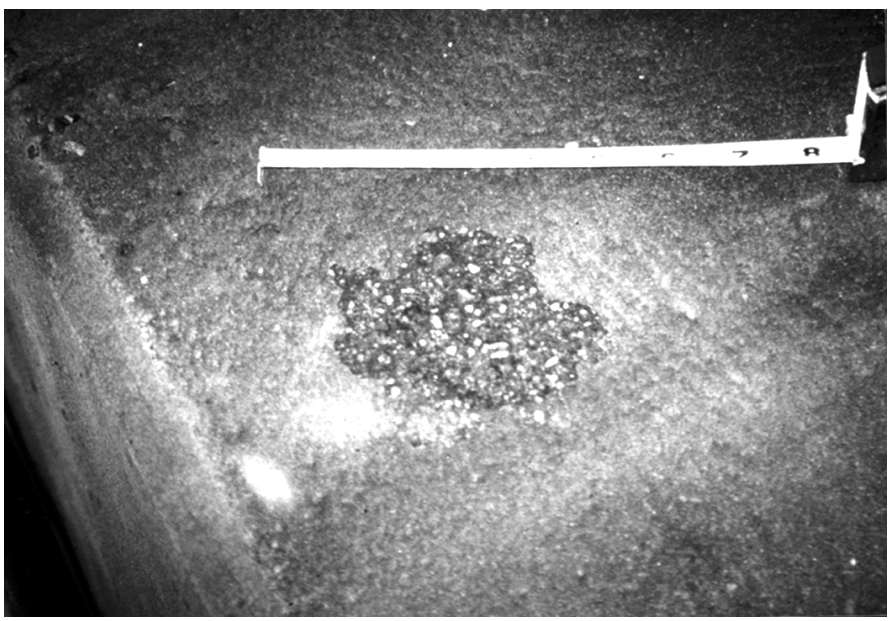
Figure 6.4: Sprayed titanium debonded

Figure 6.5: Corrosion of wire ties for Bent 21

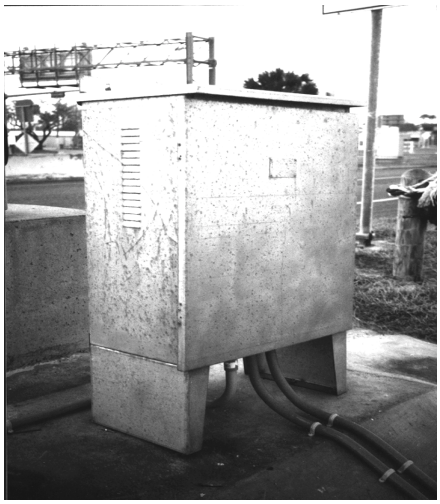
6.7). This was probably due to a lack of a sufficient number of expansion joints at that location. The remaining cathodic protection system components were in good condition.

Figure 6.6: Corrosion of the rectifier box

Figure 6.7: Disjointed conduit segments

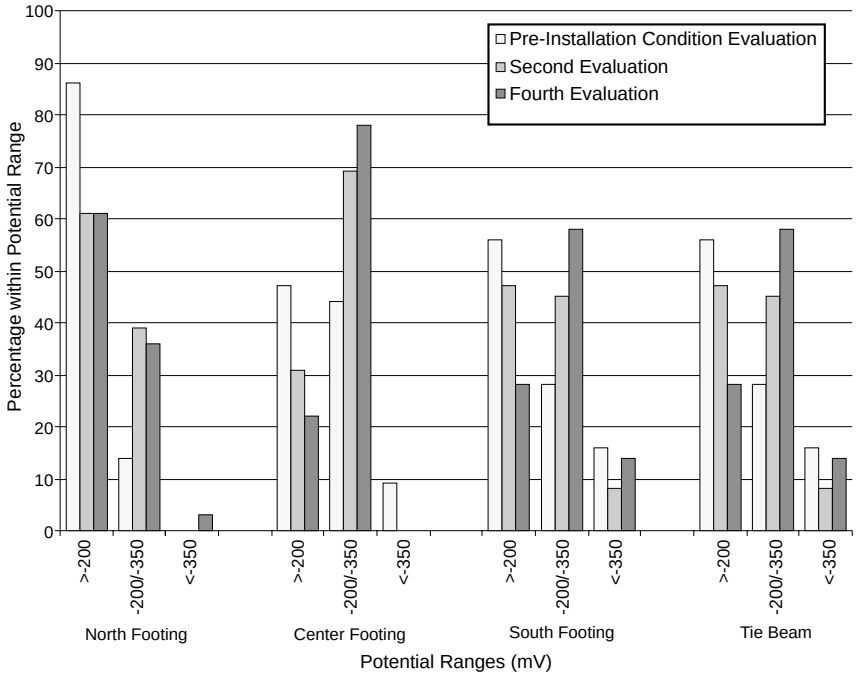
Figure 6.8: Corrosion potential ranges in different evaluations for Bent 23

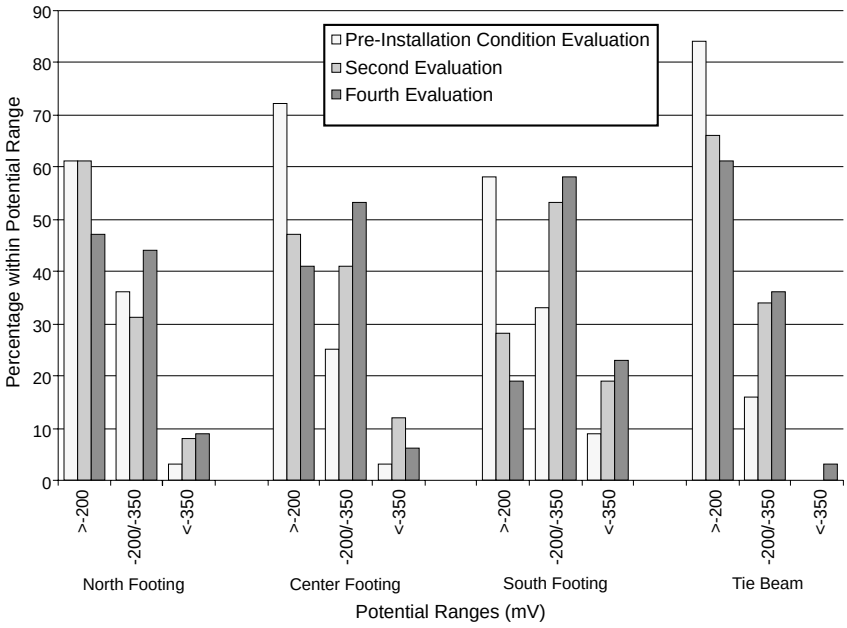
Figure 6.9: Corrosion potential ranges in different evaluations for Bent 24

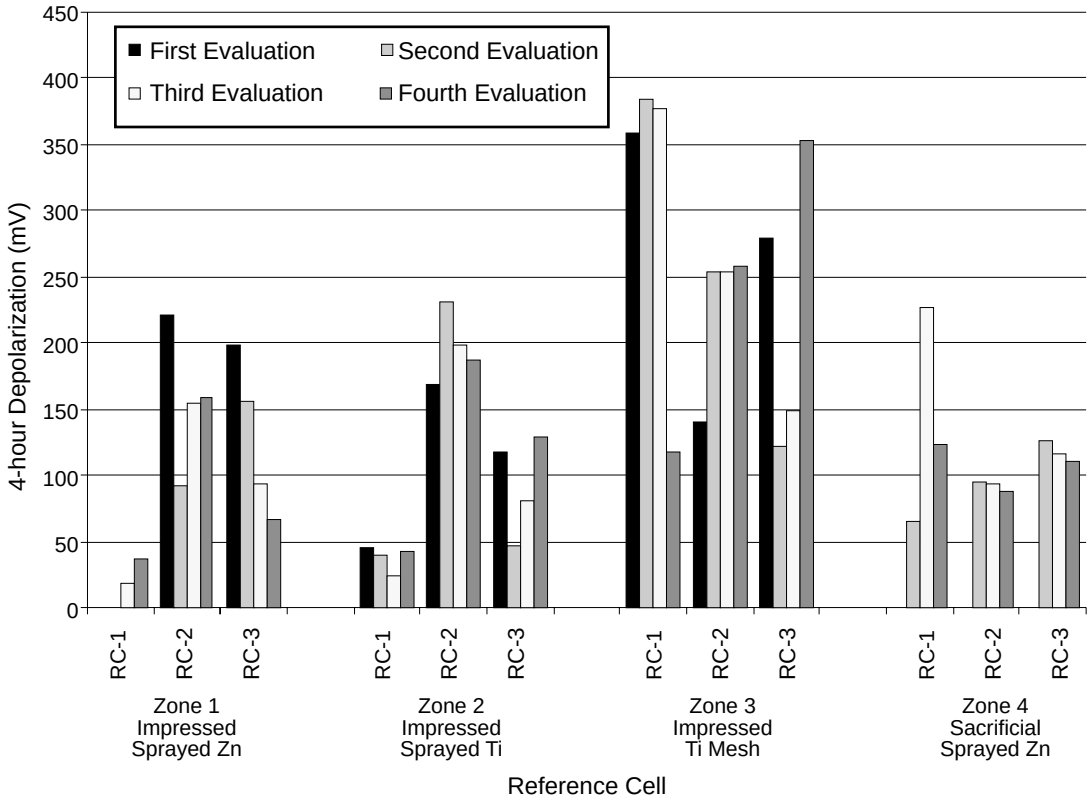
the low conductivity of the catalyzed titanium spray coating. The high resistivity of the coating resulted in a decrease in protection in areas located far from the positive connections. This would also indicate that two positive connections for this installation were not sufficient.

The impressed current sprayed zinc in Zone 1 exhibited adequate depolarization. The behavior of Reference Cell 1 was not normal and was probably affected by electrical noise. The titanium mesh with overlay in Zone 3 had consistently the highest depolarization values. Considering the sacrificial nature of the system in Zone 4, the sacrificial sprayed zinc exhibited high depolarization values.

Figure 6.10: Four-hour depolarization for all reference cells

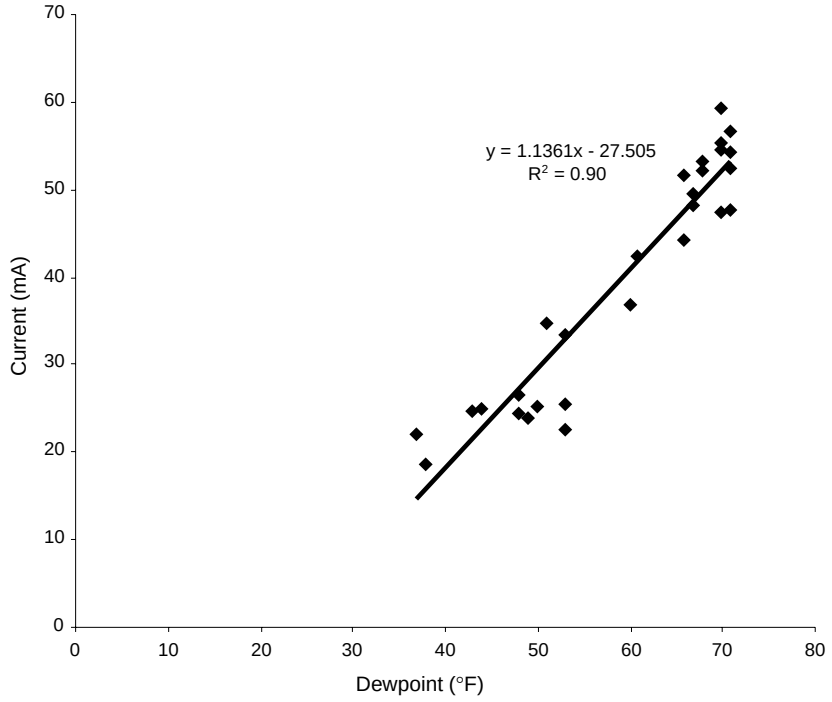
The coefficient of determination was obtained between February and mid-April, between mid-April and June, and between February and June. Very good correlation was found between dew point and current between February and mid-April. The coefficient of determination between dew point and current output in this period was 0.90. Presented in Figure 6.11 is the graph of current output versus dew point between February and mid-April. The coefficient of determination between dew point and current throughout the data collection period (February through June) was the highest among the variables studied.

Figure 6.11: Dew point versus current between February and mid-April

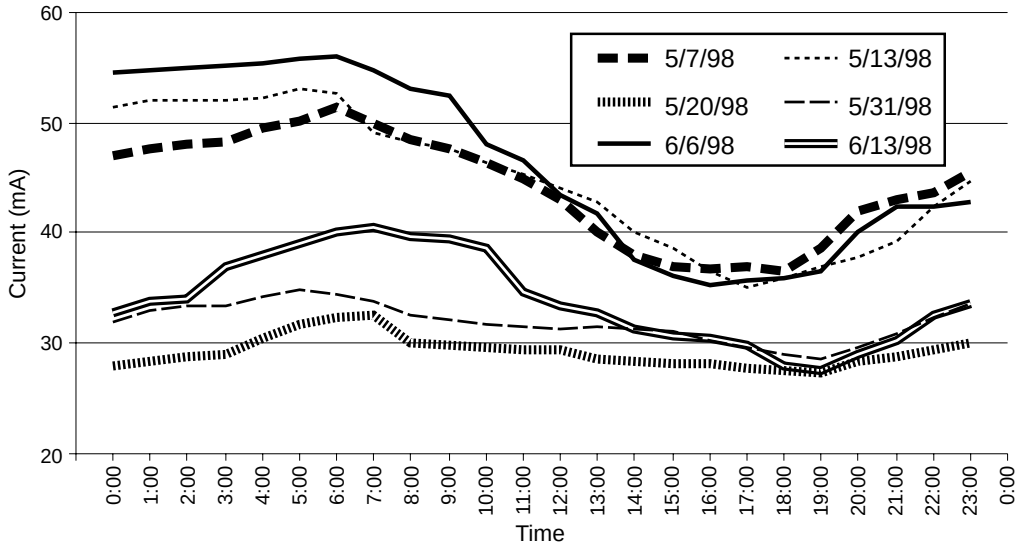
From mid-April to June, a decrease in the output current was observed during the daytime hours. At any given dew point, the current values were lower between mid-April and June than between February and mid-April. During the night hours, for any given dew point, the output current was comparable to the levels obtained between February and mid-April.

Because the tie beams were not in the splash/evaporation zone, the current output from the galvanic sprayed zinc in this area was very much dependent on the atmospheric conditions. The dependency of the galvanic current in this area was higher than that in the footings, where the concrete moisture content was relatively high and constant. The results of an investigation in which the relationship between relative humidity and galvanic current was studied for laboratory specimens indicated that surface wetting might increase the fraction of the anode in contact with concrete surface and, therefore, the current delivery would increase (Ref 36). Another similar factor could be dew point, which is a measure of the total amount of moisture in the air. It is defined as the temperature to which air must be cooled to reach its saturation point. Between mid-April and June, the higher temperatures and the solar radiation present during the daytime hours could have resulted in the drying of concrete and, consequently, a decrease in the currents measured. The cyclic behavior of current over a 24-hour period is presented in Figure 6.12. The current measurements were collected every hour over a 24-hour period for 6 days in May and June 1998. The lowest current readings occurred between 4 and 7 p.m., and the highest readings occurred between 5 and 8 a.m. The highest current readings occurred following or during cloudy days.

Figure 6.12: Cyclic current behavior
