PROJECT SUMMARY REPORT 2954-3F

**EVALUATION OF THE PERFORMANCE OF
PERMANENT RUNOFF CONTROLS:
SUMMARY AND CONCLUSIONS**

Michael E. Barrett, Michael V. Keblin, Patrick M. Walsh,
Joseph F. Malina, Jr., and Randall J. Charbeneau

**CENTER FOR TRANSPORTATION RESEARCH
BUREAU OF ENGINEERING RESEARCH
THE UNIVERSITY OF TEXAS AT AUSTIN**

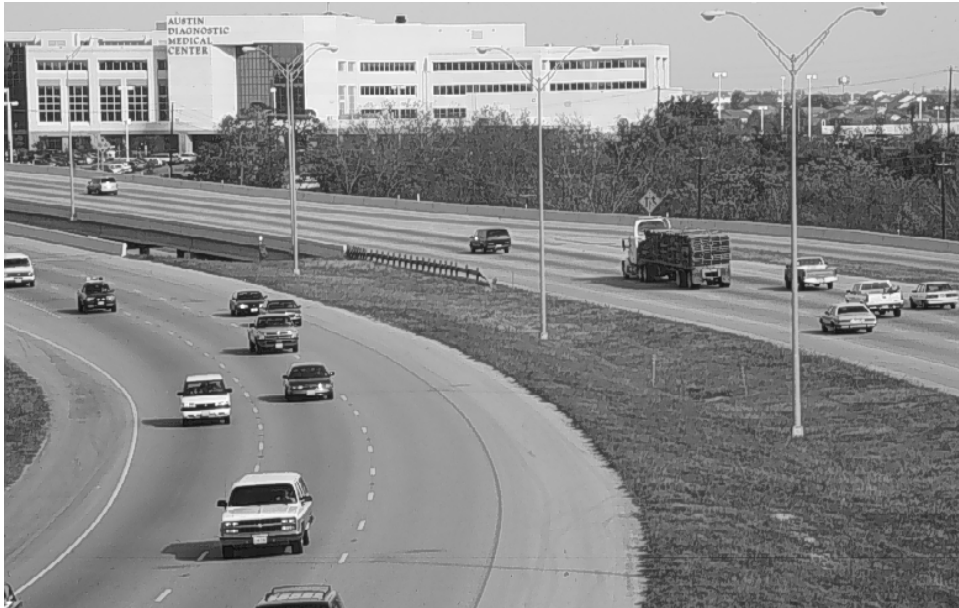
Figure 2.1 MoPac at Walnut Creek Filter Strip

The vegetated buffer strip at Walnut Creek is a section of highway median that collects runoff from the northbound and southbound lanes of MoPac just south of Walnut Creek in Austin, Texas (Figure 2.1). The median was designed originally as a hydraulic conveyance and not as a runoff treatment device. The median cross section is V-shaped with a rounded bottom. Runoff from the highway flows as sheet flow down the sides of the grassy slope and then along the center of the median to four drop inlets situated along the centerline of the median. The drop inlets discharge to a storm drain that conveys the runoff to Walnut Creek. This storm drain collects runoff from the road and median, as well as from several grassy shoulder areas. Runoff directly from the highway was collected from the MoPac bridge over Walnut Creek.

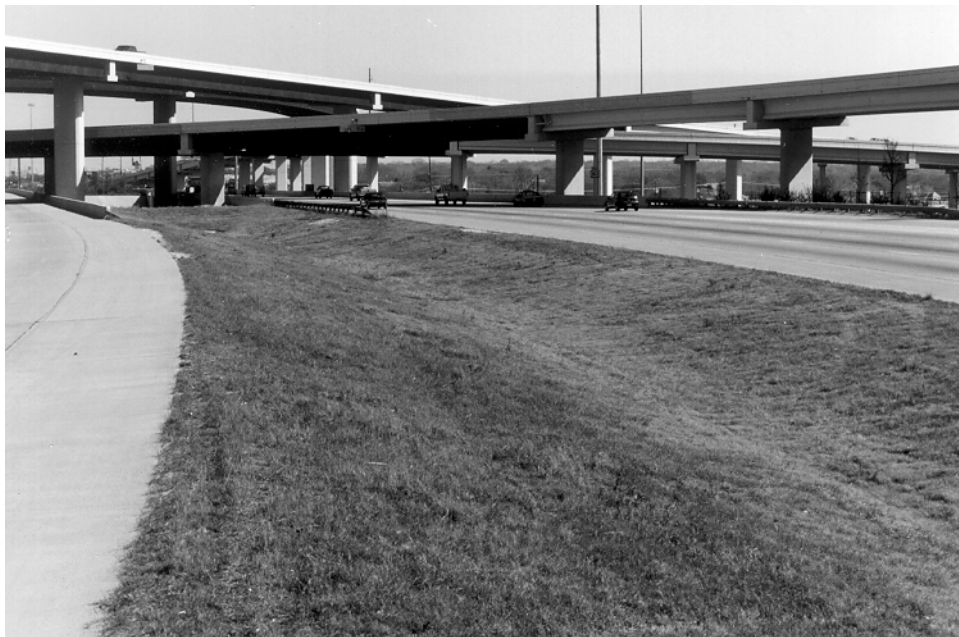
Figure 2.2 Vegetated Buffer Strip at US 183 Site

The vegetated buffer strip monitored at US 183 at MoPac is the grassy median of US 183 just north of MoPac (Figure 2.2). This median also was designed originally for hydraulic conveyance. Only the three southbound lanes of 183 drain into the median, which is V-shaped with a rounded bottom. The northbound lanes drain to a curb-and-gutter storm drain, providing an appropriate location for sampling road water quality at this site. This site

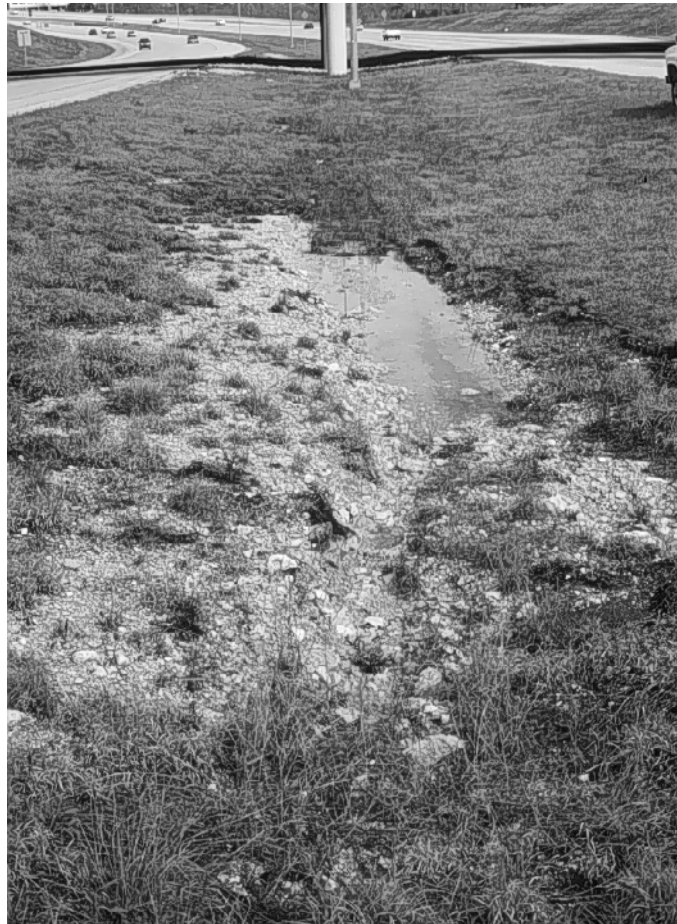
Figure 2.4 Erosion at the Walnut Creek Vegetated Buffer Strip

During the monitoring phase of this study, two important observations were noted regarding filter strips; both observations demonstrate the need for proper design. Significant erosion occurred at the bottom of the Walnut Creek median in seven locations. The erosion exposed bedrock, which was devoid of vegetation (Figure 2.4). These areas diminish the effectiveness of filter strips by contributing sediment to receiving waters and reducing the amount of treatment that occurs along the length of the median. In addition, erosion can result in maintenance problems, hindering routine activities such as mowing. No erosion was noted at the US 183 site, which has a lower average slope than Walnut Creek. The use of additional drop inlets along the median may alleviate the erosion at the Walnut Creek site.

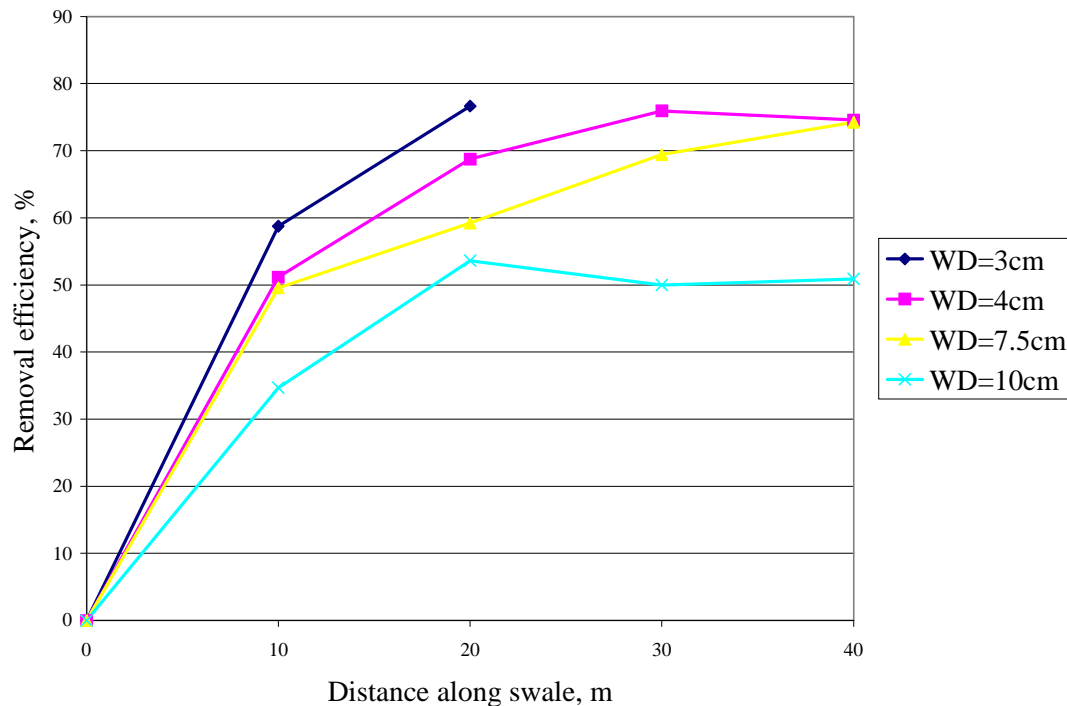
Figure 2.6 Effect of Water Depth and Swale Length on TSS Removal Efficiency

removal of total suspended solids after 20 meters accounts for 92%, 80%, and 105% of the total removal observed at 40 meters at water depths of 4, 7.5, and 10 cm, respectively.

- Most of the reduction in the concentration of constituents in runoff occurred in the first 20 meters of the swale. Little improvement in water quality was observed during the last 20 meters.

- The removal efficiency for suspended solids, organic material, and most metals decreased with increased water depth. No relationship between water depth and removal efficiency was observed for nitrate and total Kjedahl nitrogen.

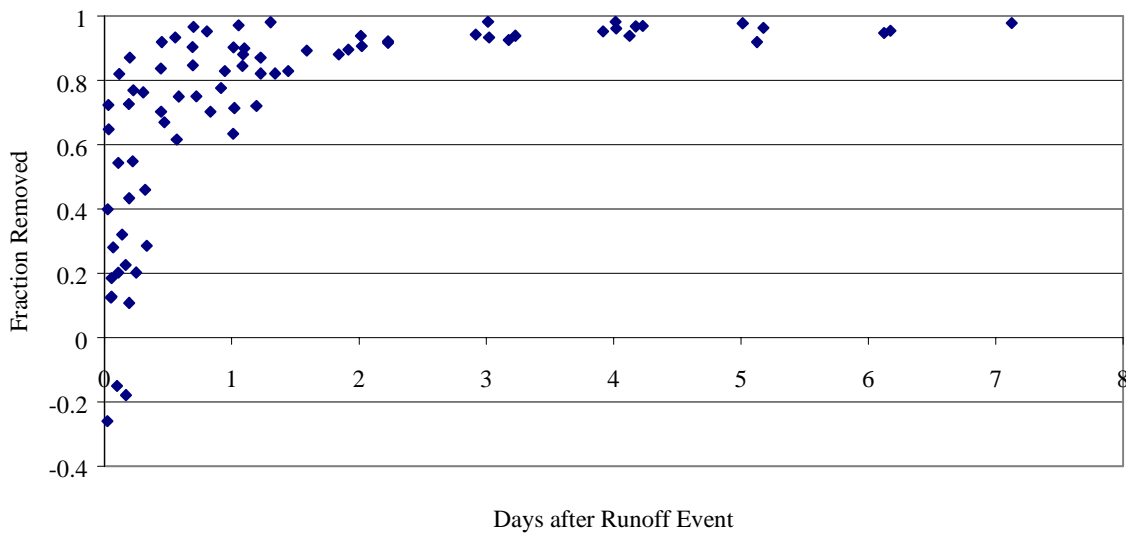
Figure 3.4 Fraction of TSS Removed over Time

Figure 3.4 shows the reduction in TSS concentration in the sedimentation basin relative to the influent quality for all monitored events. The data show that maximum removal occurs at a detention time of approximately 36 hours, with little improvement in water quality beyond that time. Most other constituents exhibited similar removal patterns. Unfortunately, the highest discharge rate from water quality devices normally occur immediately after the storm event, when water levels in the sedimentation basin are highest and little removal has occurred. Consequently, basins designed to drain completely in 24 hours can be expected to reduce TSS loads by less than 50%. Optimum performance can be expected for sedimentation basins that drain completely in 72-96 hours.
