5-9014-01-P8

CURRENT PRACTICES AT TxDOT/DPS BORDER SAFETY INSPECTION FACILITIES AND OPPORTUNITIES FOR DATA SHARING WITH FEDERAL AGENCIES

Project 5-9014: Criteria and Design for a Model Border Crossing

JULY 2003; REVISED JUNE 2005

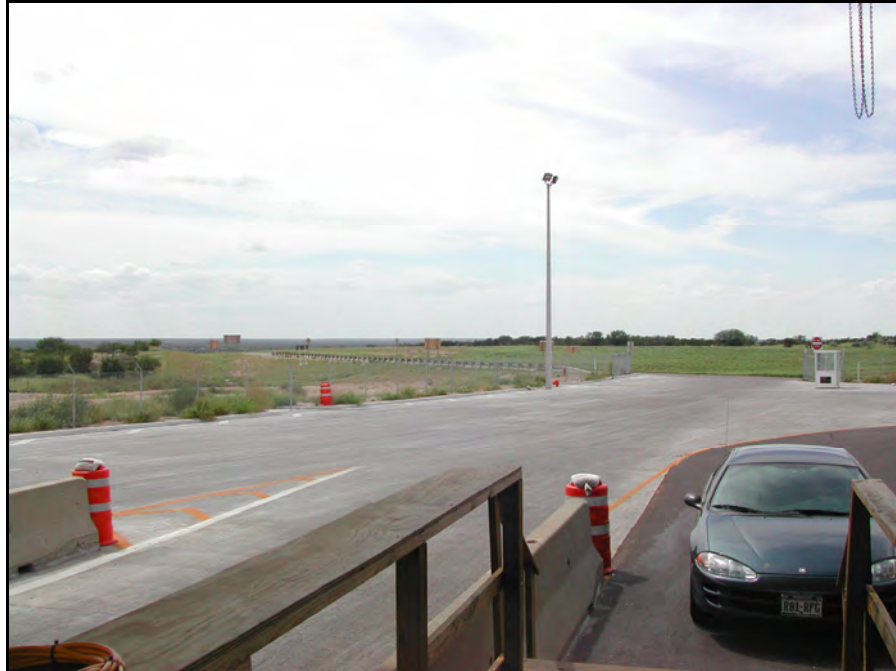
*Figure 1: Entrance into the Colombia-Solidarity International Bridge
DPS Safety Inspection Station*

As trucks enter the inspection station, their weight is measured using a weigh-in-motion scale and the trucks come to a stop at the preliminary inspection station (Figure 1). The truck's weight is reported on a laptop computer, monitored by the inspection staff, who review the driver's cargo manifest and immigration documents (Figure 2). The inspectors also visually inspect the truck's and trailer for obvious safety violations or risks and may check the truck and trailer's turn and brake lights. If the paperwork is in order, the truck is not overweight, and it is judged to be in compliance with safety requirements during the preliminary visual inspection, the driver is typically waved through the facility and allowed to continue to the final destination within the border zone. Trucks with a CVSA sticker are typically not required to have a secondary inspection unless an inspector notices a problem during the preliminary inspection. However, if the truck is judged unsafe, is suspected of being overweight, or is randomly selected for inspection, then it will be directed to the secondary inspection facility.

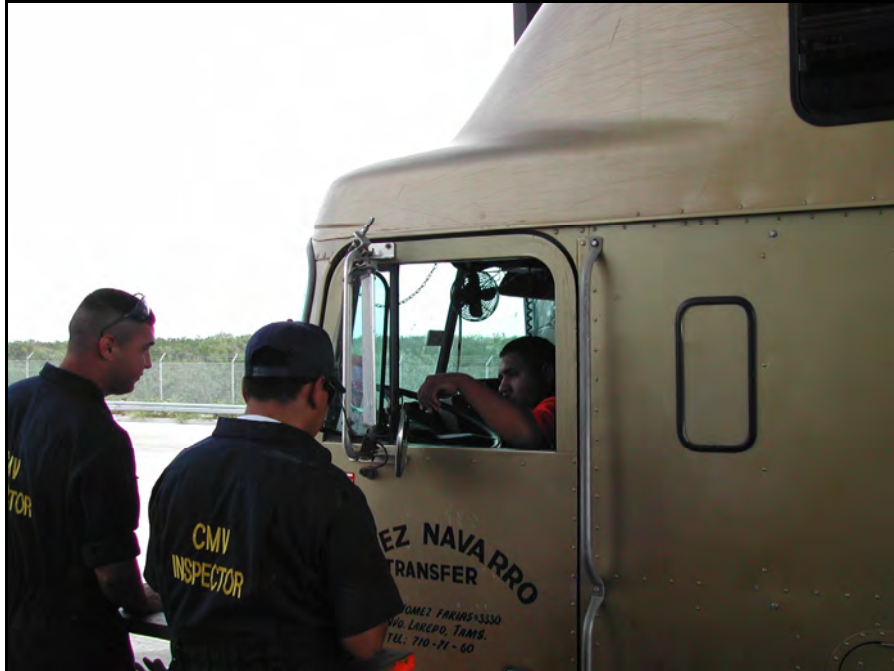
Figure 2: DPS Inspectors at the Preliminary Inspection Station at the Colombia-Solidarity International Bridge

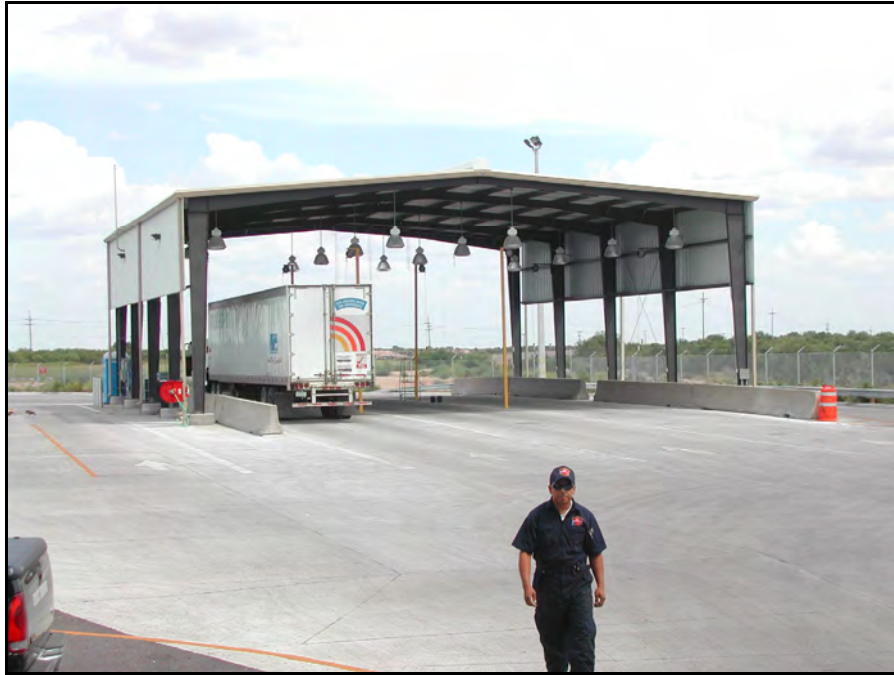
Figure 3: DPS Secondary Inspection Facility at the Colombia-Solidarity International Bridge

The secondary inspection facility is a covered area beyond the preliminary inspection station where inspectors perform their detailed work (Level 1 and Level 2 inspections), checking engines, brake systems, axles, etc. The DPS inspectors who work at the Colombia-Solidarity International Bridge perform about 600 secondary inspections per month (about 2 to 3 percent of all trucks) and estimate about 60 percent of those inspections result in a vehicle being taken out of service. Many of these vehicles are removed for relatively minor violations, such as brake misalignment or being overweight. Once the DPS removes a truck from service, the owner has 72 hours to repair it and remove it from the DPS lot or it is towed back to Mexico, at the owner's expense. The DPS's 72-hour grace period is considerably more generous than the USDOT rules, which immediately tow out-of-service trucks back to Mexico from its inspection station, at the owner's expense. If the driver is unable to repair the truck, the trucking companies will either send a mechanic to make repairs or, if the truck is immobile or not allowed to be driven, will send a wrecker to tow it back to Mexico. If the driver is the problem, then a new driver must be sent to the inspection facility before the truck is allowed to leave. Although it is a relatively rare occurrence, some of the reasons a driver may be taken out of service include: the lack of a valid driver's license; a missing logbook or logbook violation; or, in the rarest cases, intoxication.

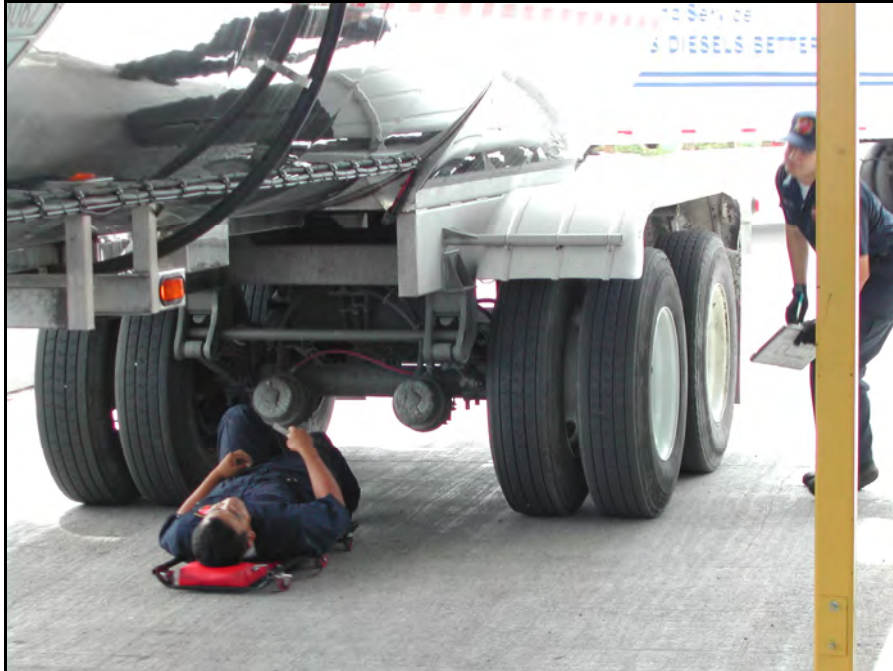
Figure 4: Inspectors Examining Truck Axle and Tires during a Secondary Inspection at the Colombia-Solidarity International Bridge

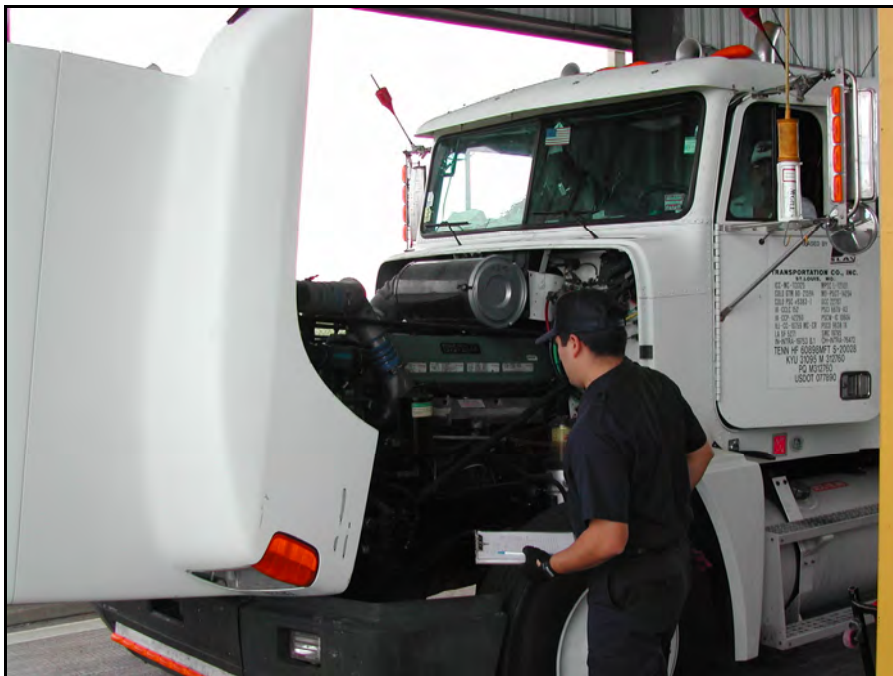
Figure 5: DPS Inspector Examining a Truck Engine during a Secondary Inspection at the Colombia-Solidarity International Bridge

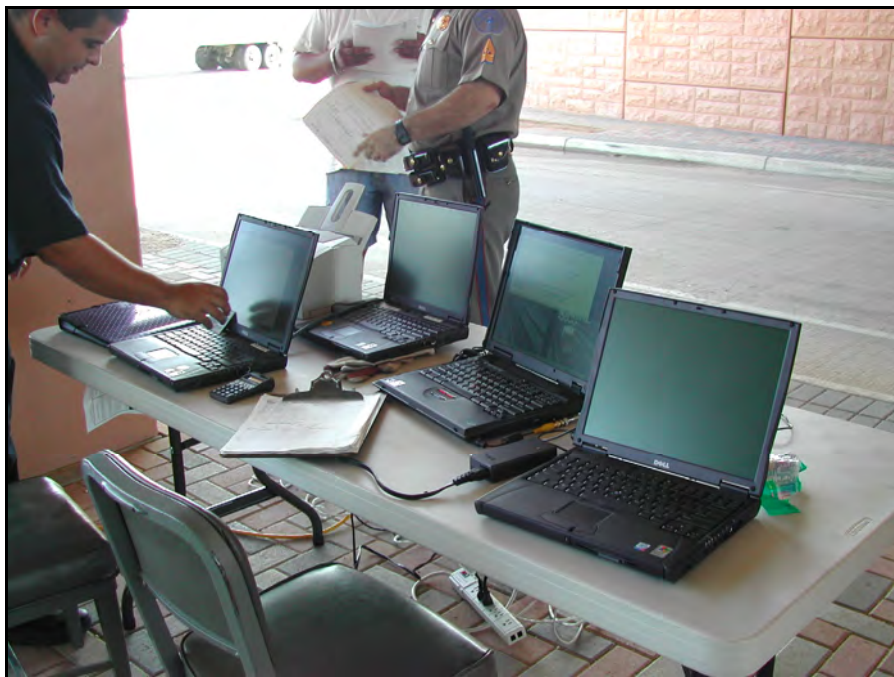
*Figure 6: Temporary Computer Work Station at the World Trade Bridge
Temporary Weighing Facility*

Truck weights at the World Trade Bridge are initially measured using a weigh-in-motion scale that is mounted into an overpass leaving the bridge. The truck weights are reported to a computer station below. If a truck is believed to be overweight or if one of its axles has exceeded a weight limit, then flashing lights on the overpass notify the truck to exit the roadway and go to the weigh station for a more accurate weighing. Thus, after leaving the federal compound of the World Trade Bridge, the only commercial vehicles that are typically stopped by the DPS are those trucks that have been identified as having a potential weight problem by the weigh-in-motion scale.¹ The DPS has also mounted a camera on the overpass that captures an image of the overweight trucks and these images can be viewed on a laptop screen below (Figure 6). The DPS uses these images to ensure that suspected overweight trucks exit for inspection and the images can also help the DPS troopers identify trucks whose drivers have disregarded the signal to exit.

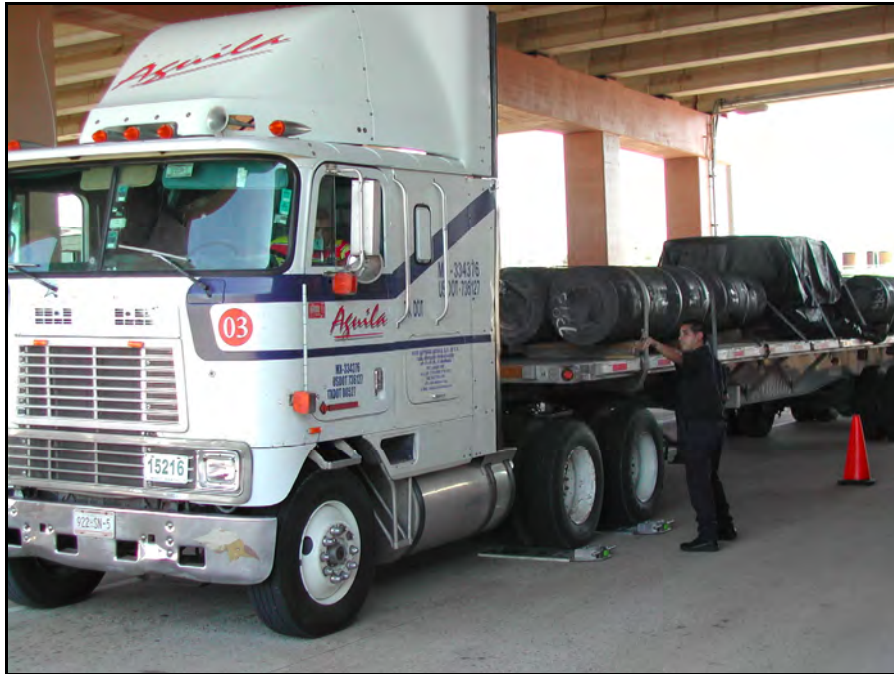
Figure 7: Suspected Overweight Truck Being Weighed at the World Trade Bridge

The trucks are weighed at a turnaround lane beneath the overpass where DPS inspectors are stationed with axle scales (Figure 7). These moveable axle scales are placed in front of the truck tires by the inspector, typically two axles at a time, and the truck driver is instructed to

move the truck forward onto the scales. The axle weights are measured for each tire to determine whether any of the truck's axles are overweight or if the cargo has been stowed unevenly.

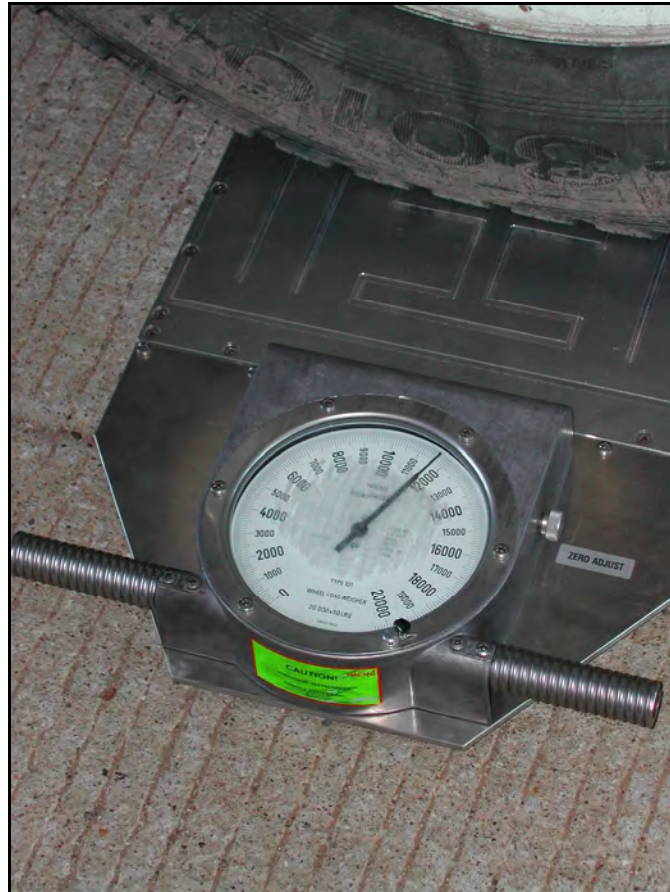
Figure 8: Close-up of a Truck Axle Being Weighed at the World Trade Bridge

Figure 8 is a close-up of the scales used by the DPS inspectors to measure the weights of commercial trucks.

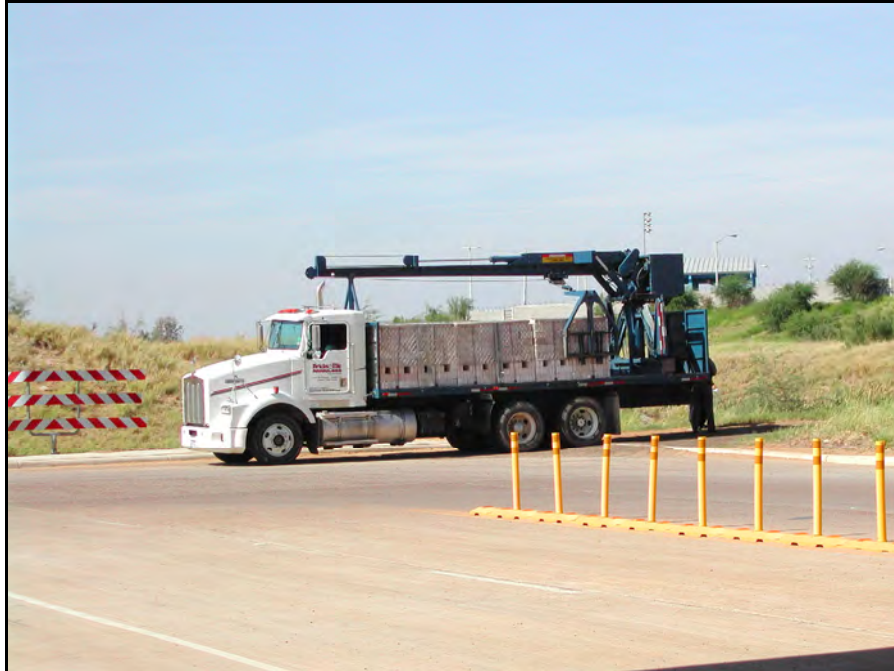
Figure 10: Overweight Truck Removed from Service and Waiting to Be Off-Loaded at the World Trade Bridge Weight Inspection Station

Trucks that are placed out of service at the World Trade Bridge are parked nearby until they are off-loaded and become compliant. Figure 10 shows a small, three-axle commercial truck carrying palettes of bricks that was overloaded by several thousands pounds. DPS troopers at the station identified this driver and his company as a habitual overweight offender and, in this instance, the driver was issued a citation. Soon after this photograph was taken, another truck arrived to take part of his load so that the overweight truck would be in compliance with the law. The driver was then allowed to continue to his final destination within the border zone.

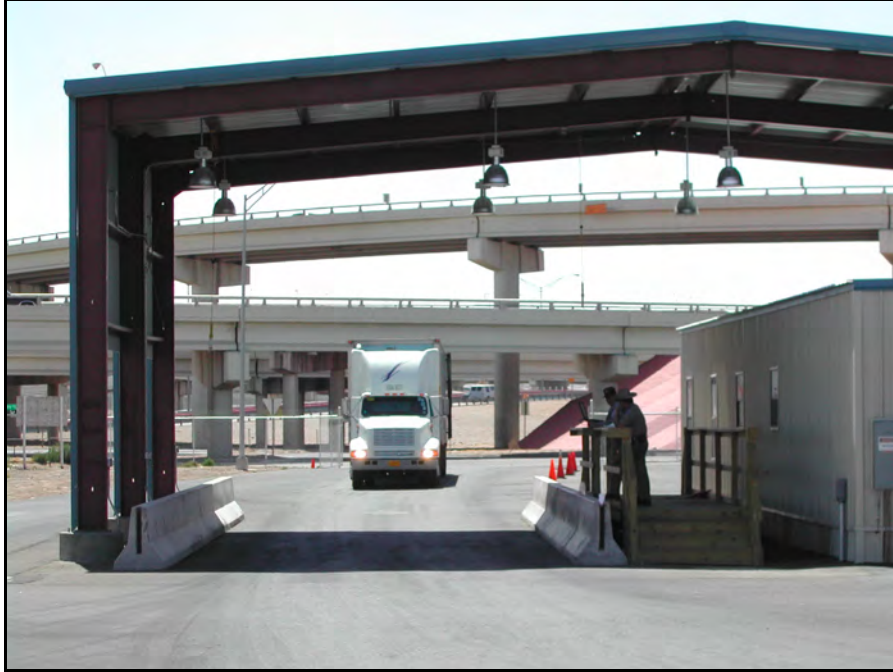
Figure 11: Truck Entering the DPS Commercial Vehicle Safety Inspection Facility at the Bridge of the Americas

The Bridge of the Americas crossing in El Paso (referred to as the BOTA by local users) has facilities similar to the Colombia-Solidarity International Bridge in Laredo. The DPS safety inspection facility is located immediately adjacent to the federal compound, so that all trucks enter the facility immediately after leaving the federal inspection compound. As the trucks leave the compound, their weight is measured using a weigh-in-motion system that is located on the roadway underneath the overpass (Figures 11 and 12).

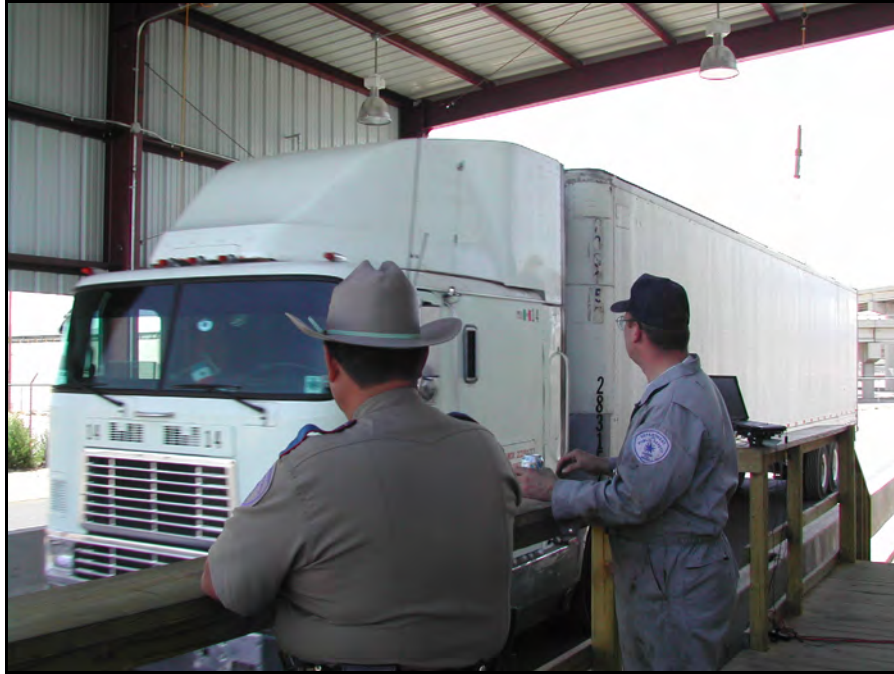
Figure 12: DPS Trooper and Inspector at the Preliminary Inspection Facility at the Bridge of the Americas

Trucks pull into the covered preliminary inspection facility where the driver's paperwork is reviewed and the truck is given a visual inspection. The truck's weight from the weigh-in-motion scale is reported on a laptop computer mounted on the deck railing and is monitored by the inspectors.

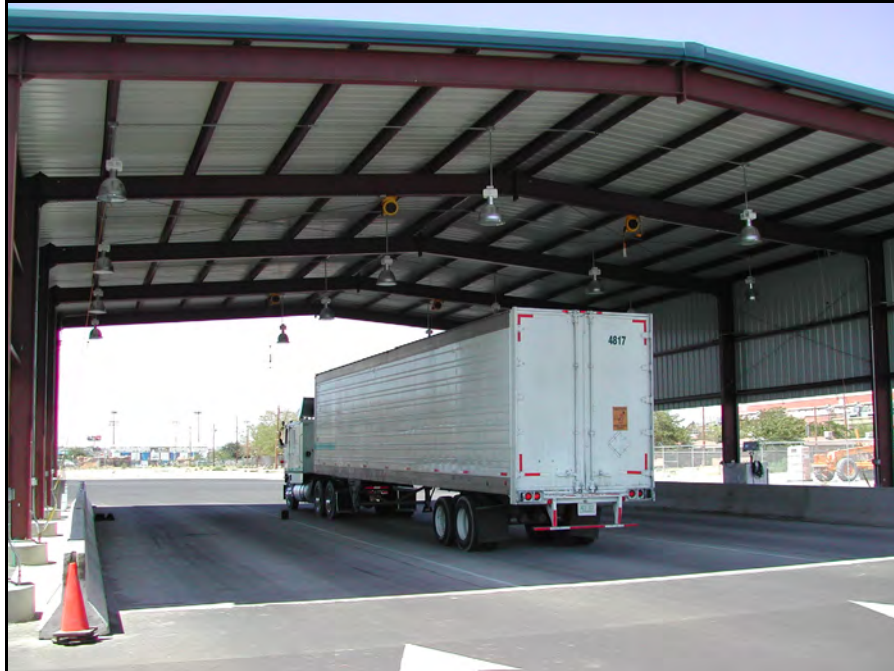
Figure 13: Truck Awaiting Inspection at the Secondary Inspection Facility at the Bridge of the Americas

Like the other bridge crossings, if the inspectors at the preliminary inspection notice a problem with the truck, if it is suspected of being overweight, or if the truck is randomly selected for inspection, then it is sent to the secondary inspection facility (Figure 13).

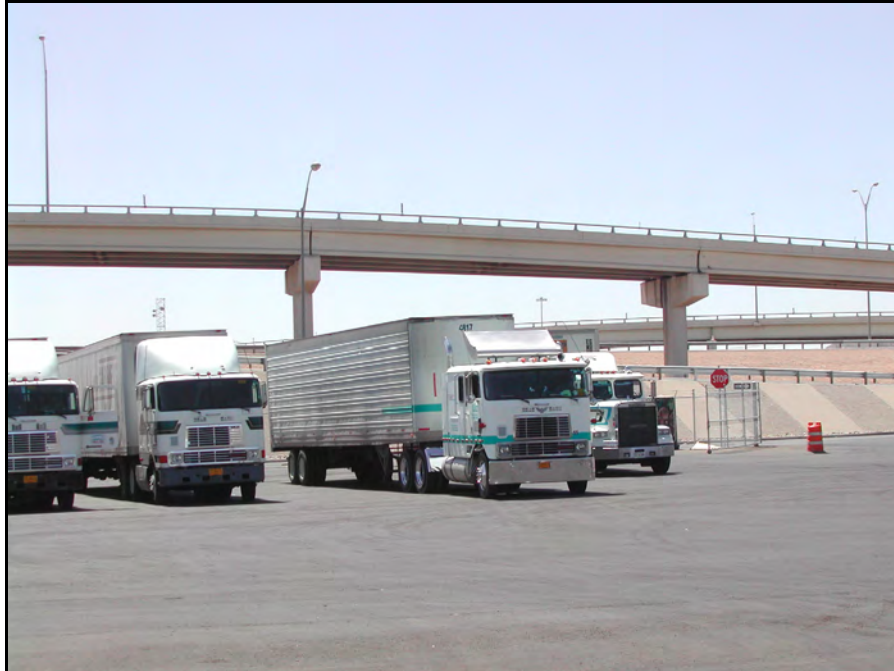
Figure 14: Trucks Removed from Service at the Bridge of the Americas

Trucks that are taken out of service are sent to a parking lot within the inspection facility to await repairs (Figure 14). Depending on the nature of the repairs, the truck may stay in the out-of-service parking area for a few hours to a few days. Trucks are most frequently removed from service because their brakes need realignment, which is a relatively easy task that can usually be performed by a trained driver. Thus, if a driver is able to make the repair to the satisfaction of the DPS inspectors, then the driver is allowed to continue. In other cases, however, trucks may need tires changed or mechanical work done in which case the carrier must send a mechanic to make the repairs. If the truck is not removed within the allocated period of time, it is towed back across the border at considerable expense to the trucking company, whose trucks are not allowed to cross again until the towing fees have been paid.

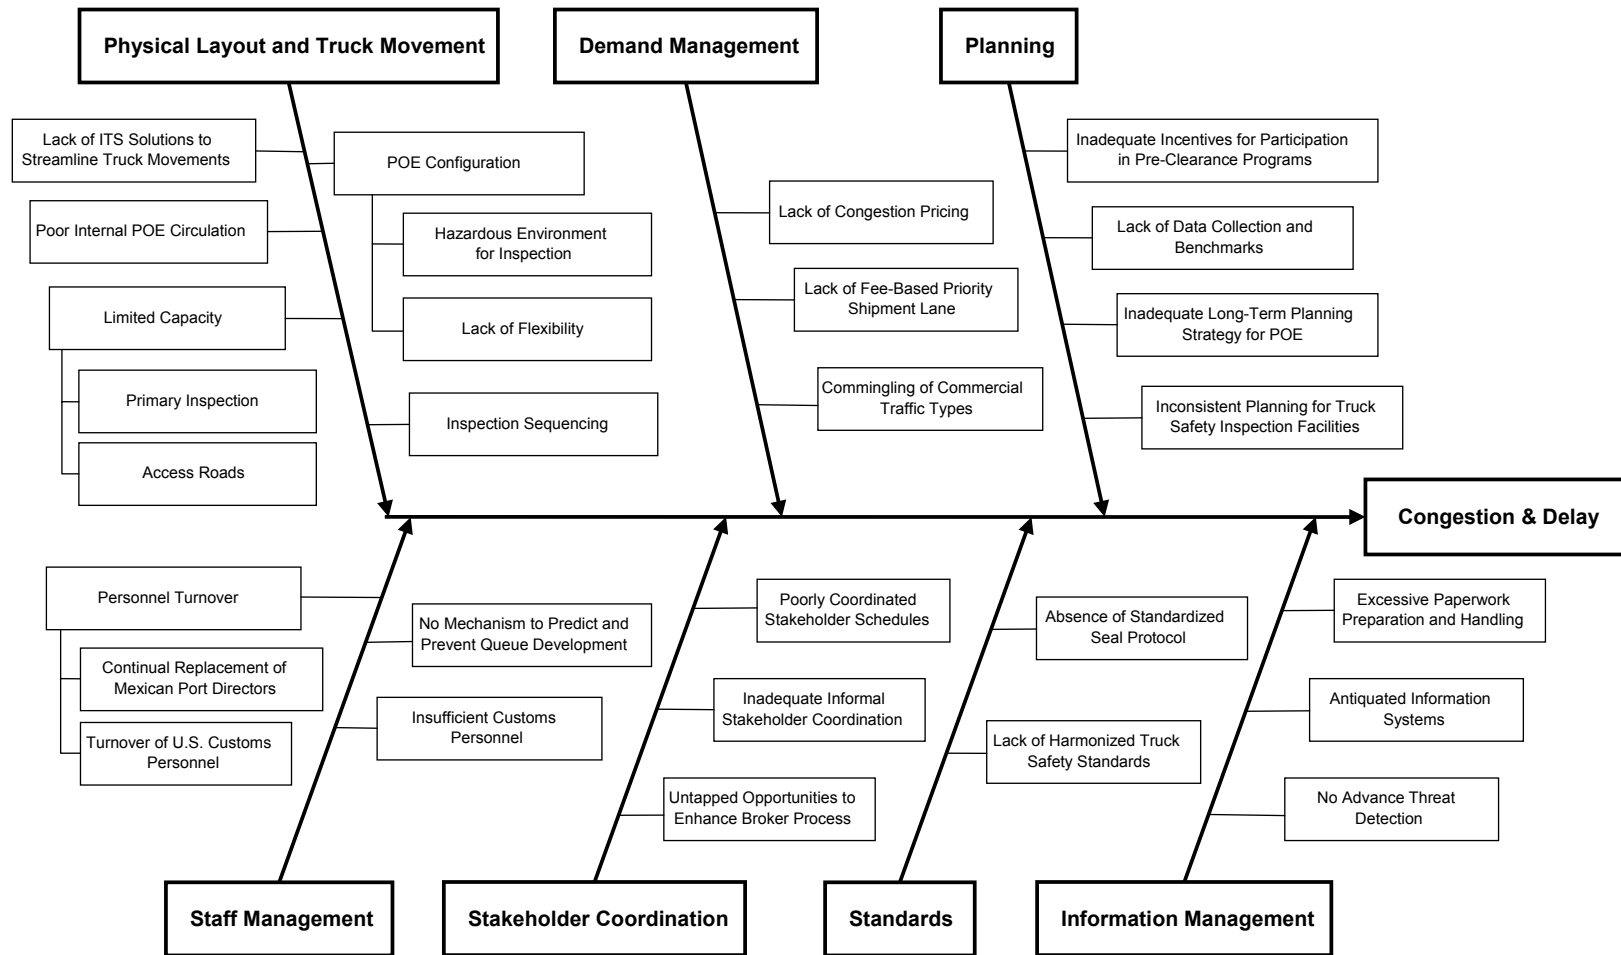
Figure 15: Classification of Border Coordination Problems and Issues

Federal and state agencies need to continue initiating new efforts, as well as maintaining existing ones, for data sharing and improved coordination between agencies. In particular, federal and state agencies should look for new ways to share safety data on commercial vehicles. A recent study conducted for the binational Joint Working Committee, which was coordinated and funded by TxDOT, focused on the impact of limited coordination among the key public and private stakeholders in the transborder movement of freight. The study concluded that there were twenty documented shortcomings in coordination that had substantial impacts on trade flow, security, or operational efficiencies of either the public or private sector. Those shortcomings are illustrated

in the diagram shown in Figure 15, which provides the seven major categories of issues identified by the authors. The authors found that some of the issues have been known since the early 1990s but have not been resolved due to the absence of overarching coordination mechanisms.
